BEACH ECOSYSTEM-BASED ADAPTATION

Abaiang, Kiribati

Beach ecosystem-based adaptation: Abaiang, Kiribati.
Apia, Samoa : SPREP, 2016.

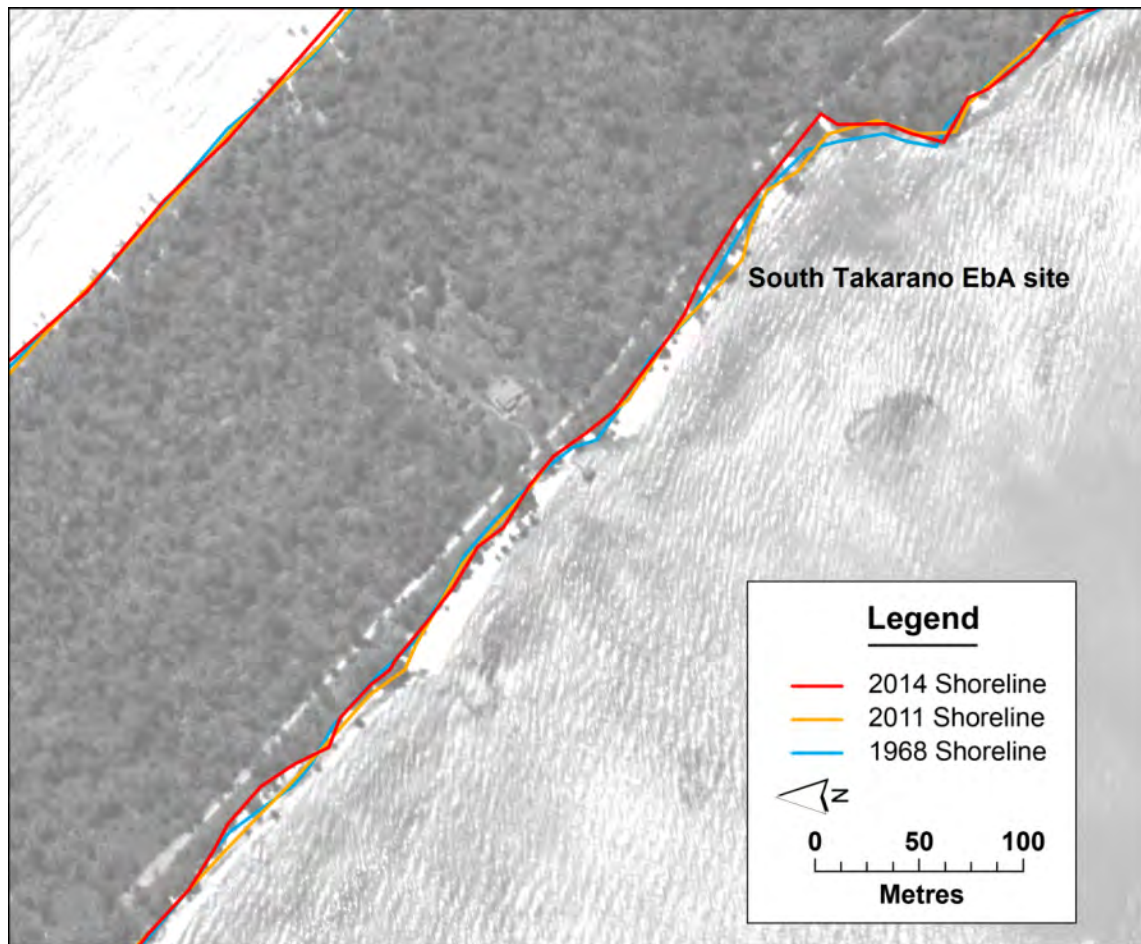
Figure 2. GIS analysis of coastal change at south Takarano.

January 2015. GIS results showed coastal retreat of most of the northern lagoon shoreline, with significant loss in the last 3 years (Figure 2). South of Takarano (Table 1, Figure 2) the beach had eroded to undercut the main road, with a 50 cm scarp above a concave beach profile (Figure 3). A brush structure was built of 5.9 m in length and up to 1.85 m in width, by 6 volunteers from Takarano village.

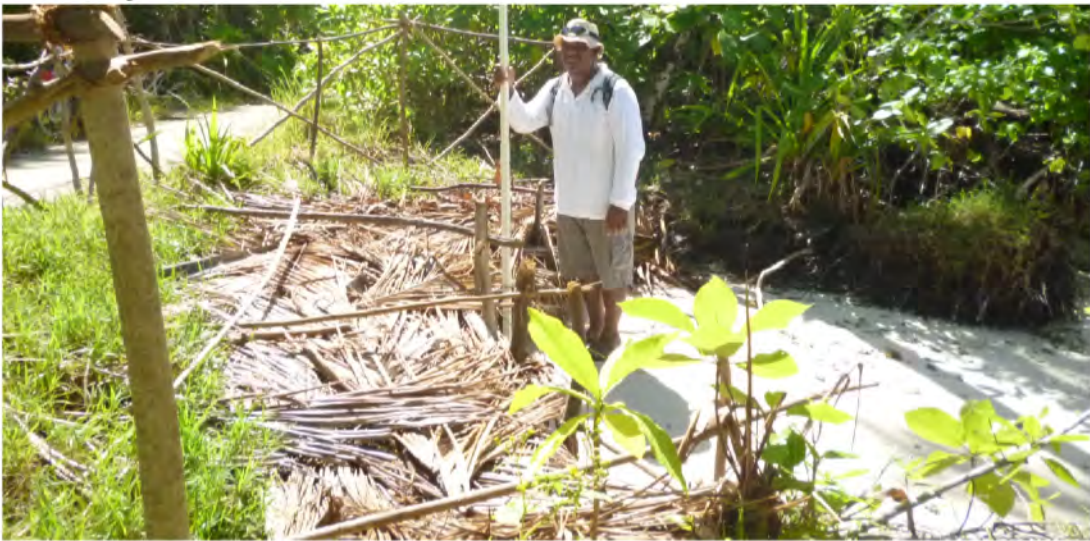
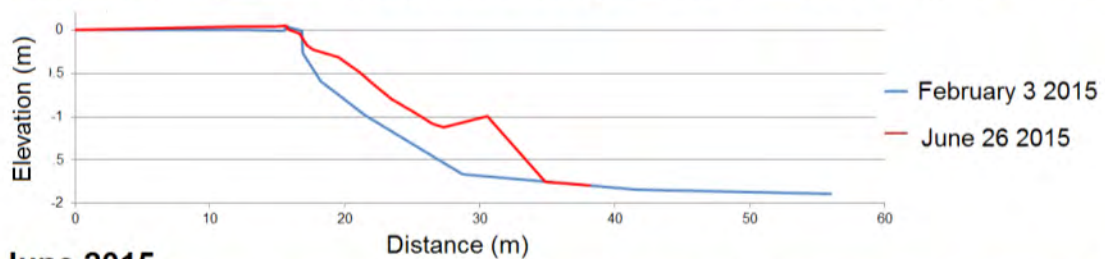
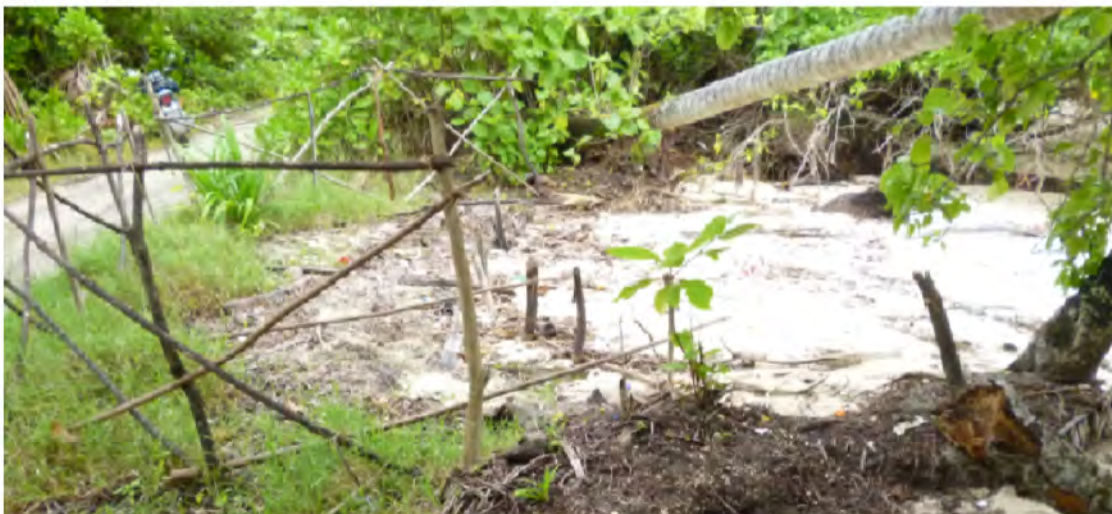
Figure 3. Profile diagram of EbA works south of Takarano.

In June 2015 the beach had accreted to cover the brush structure, and the profile of the beach had become convex, and using the guidelines in Ellison et al. (2015) the beach had recovered to a level 3/2. The beach sand offshore of the brush structure had accreted about 50 cm (Figure 3). Other erosion sites on this section of road identified in MISA (2008) all showed the road to remain to be undercut, with no beach infill. This site could recover further if revegetated, with beach vines, grasses and tree seedlings, to give it resilience against storm swell events.

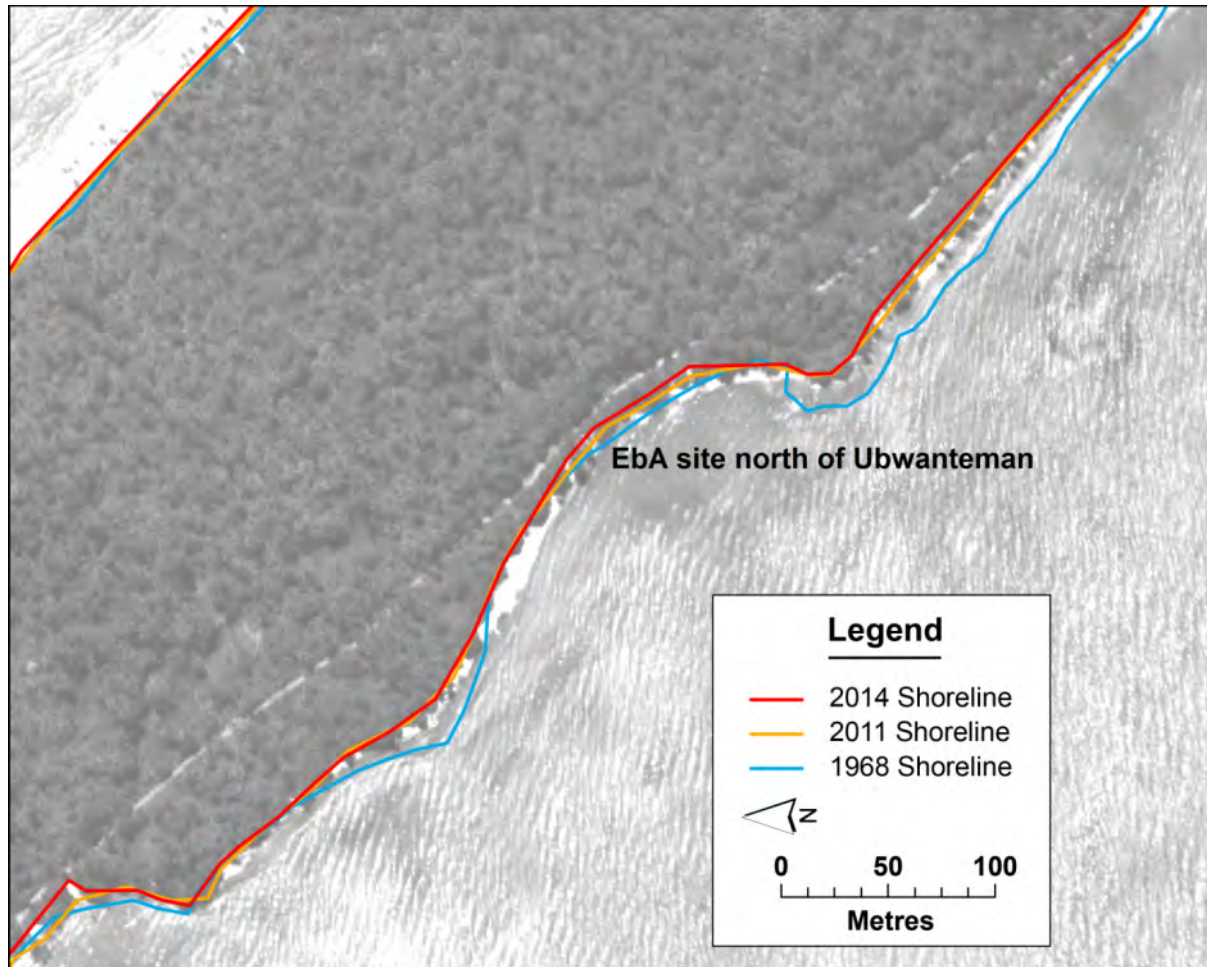
Figure 4. GIS analysis of coastal change at north Ubwanteman.

North of Ubwanteman (Table 1, Figure 1) the beach had eroded to undercut the main road, with a 0.5 m scarp above a concave beach profile (Table 3). GIS analysis showed significant retreat along this whole section of lagoon shoreline (Figure 4).

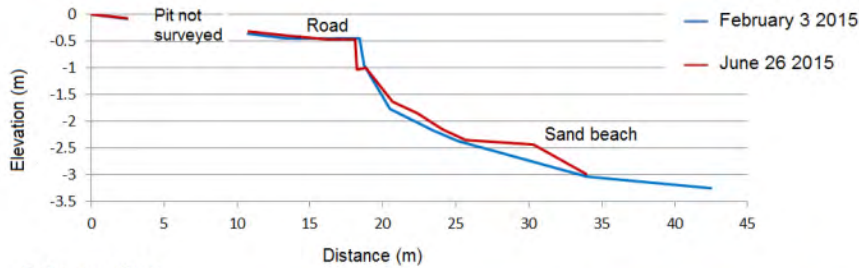
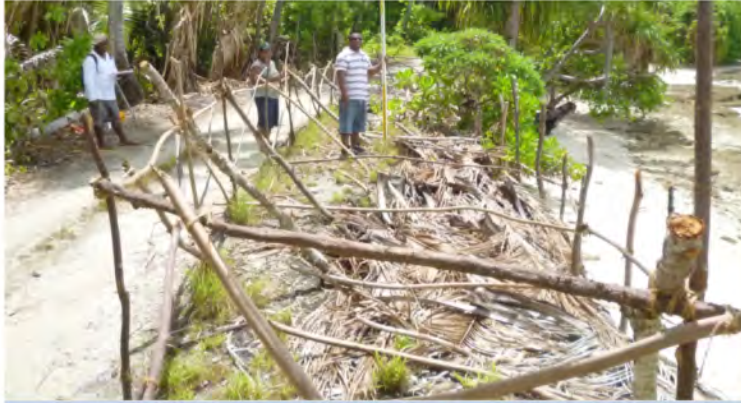
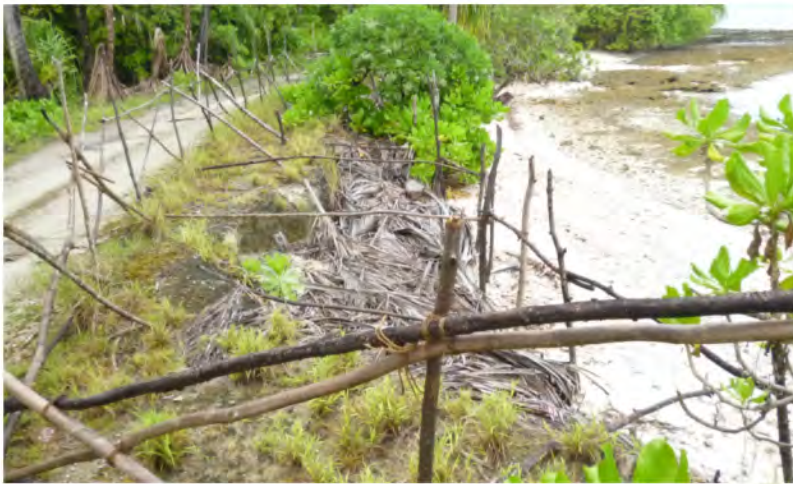
Figure 5. Profile diagram of EbA works north of Ubwanteman.

A brush structure was built of 23.4 m in length, and up to 2.9 m in width, with a small *Messerschmidia* tree in the centre (Figure 5). In February 2015, the high tide mark was inside the brush structure, indicating the high tide waters were washing at the sand in the scarp below the road edge.

In June 2015, the brush had compacted and sunk, and needed maintenance and infill, which police have volunteered to undertake. Resurvey of the beach showed that while the road base has eroded a little, the majority of the beach has accreted by at least 0.2 m (Figure 5). The upper beach remains concave in profile, while the lower beach has developed a convex bar. This site could be further stabilised with maintenance and repair of the brush structure, along with the planting of beach vines around the top of the beach.

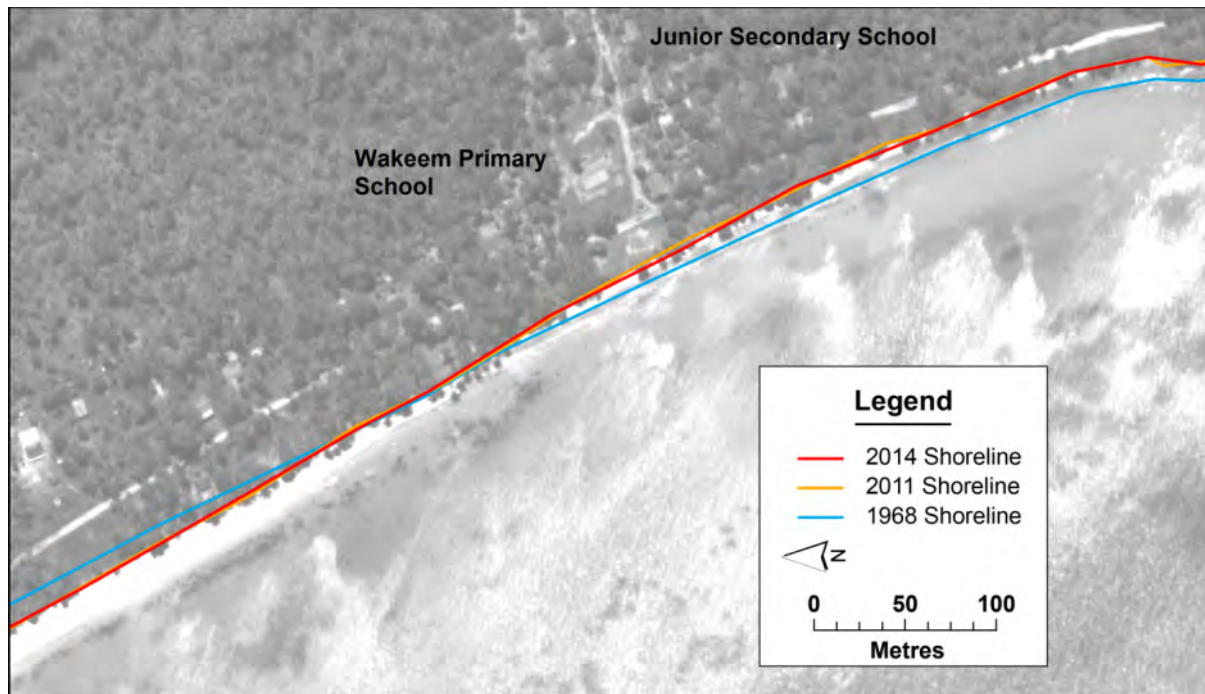
Figure 6. GIS analysis of coastal change at Wakeem Primary School.

(level 4), with disturbed vegetation and a sand cliff at the top of the beach of up to 80 cm. Teachers said that the school was established in 1999, and soon after lost a number of classrooms and a maneaba on the seaward side of the road, with loss of about 30 m of land bit by bit. GIS analysis showed this coastal retreat (Figure 6).

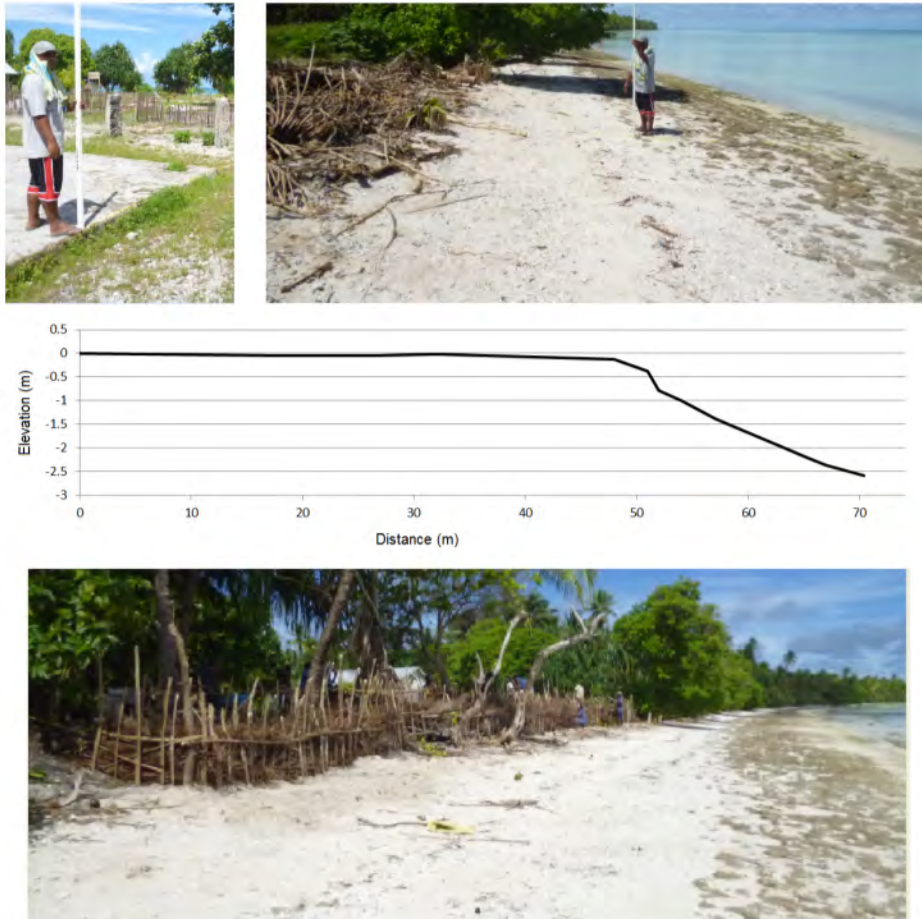
Figure 7. Beach profile diagram and EbA works at Wakeem Primary School.

A large brush structure was built of 36 m in length, with the northern half built by 20 volunteers from Aonbouaka village, and southern half by Koinawa village (Figure 7, base). The width was up to 2.8 m, and infilled by dense coconut fronds and woody brush. Two access pathways were created within the brush structure, and *Pandanus* seedlings and cuttings planted behind this by school children.

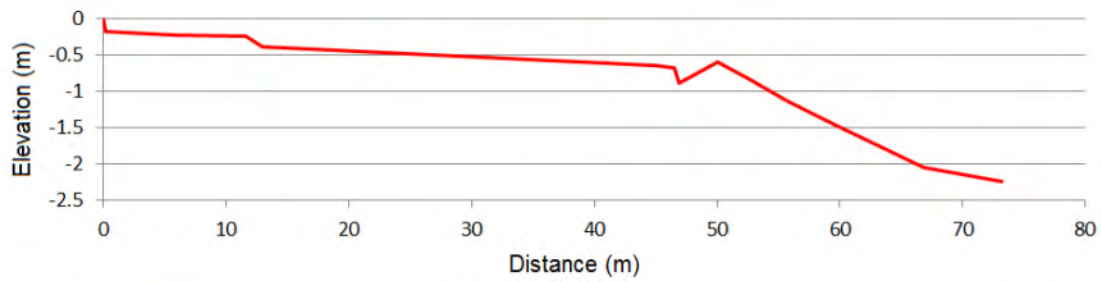
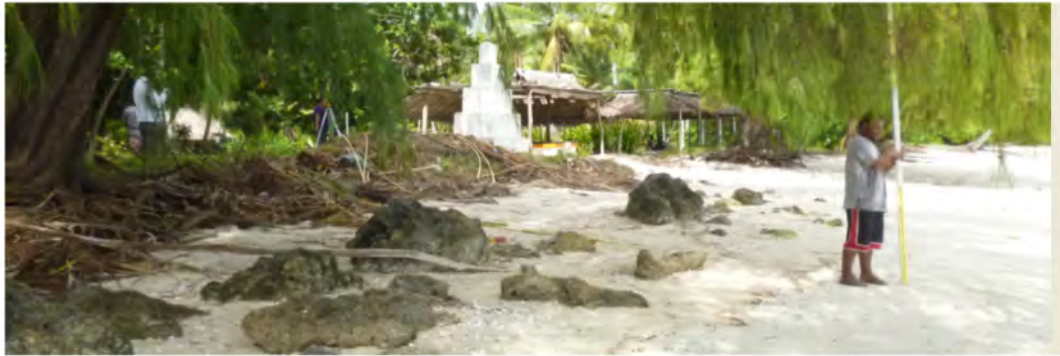
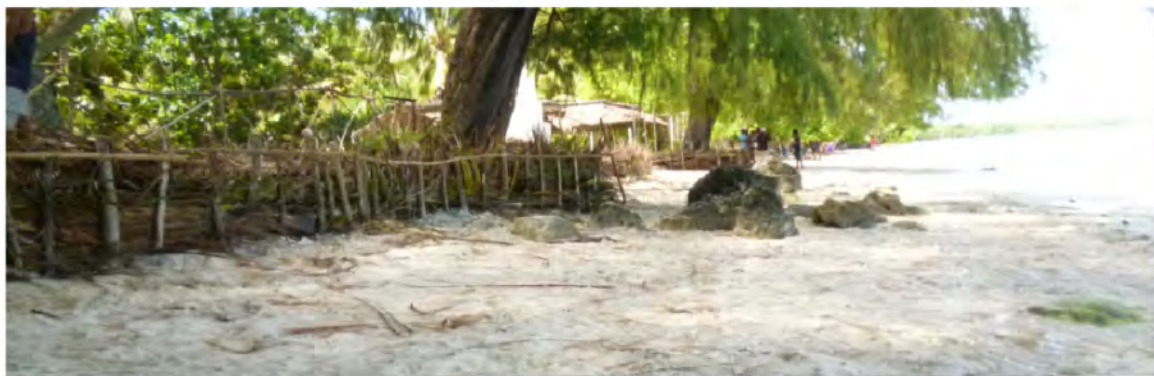
Figure 8. Beach profile diagram and EbA works at St Joseph’s College (north).

To the north of the access road from the junction, where a stone crucifix stands above the beach, a brush structure of 90 m in length was built (Figure 8), of 1.3-2.2 m in width increasing up to 3.9 m where brush surrounded the seaward roots of large trees. Heights of the structure matched decreasing height of the eroding scarp from up to 0.8 m high at the southern section reducing to 0.5 m at the northern end. An access path was created though this about half way along this 90 m length. The northern half of this 90 m structure was built by 20 volunteers from Ewena village, and the southern half built by 27 volunteers from Taburo village (the closest village to the site).

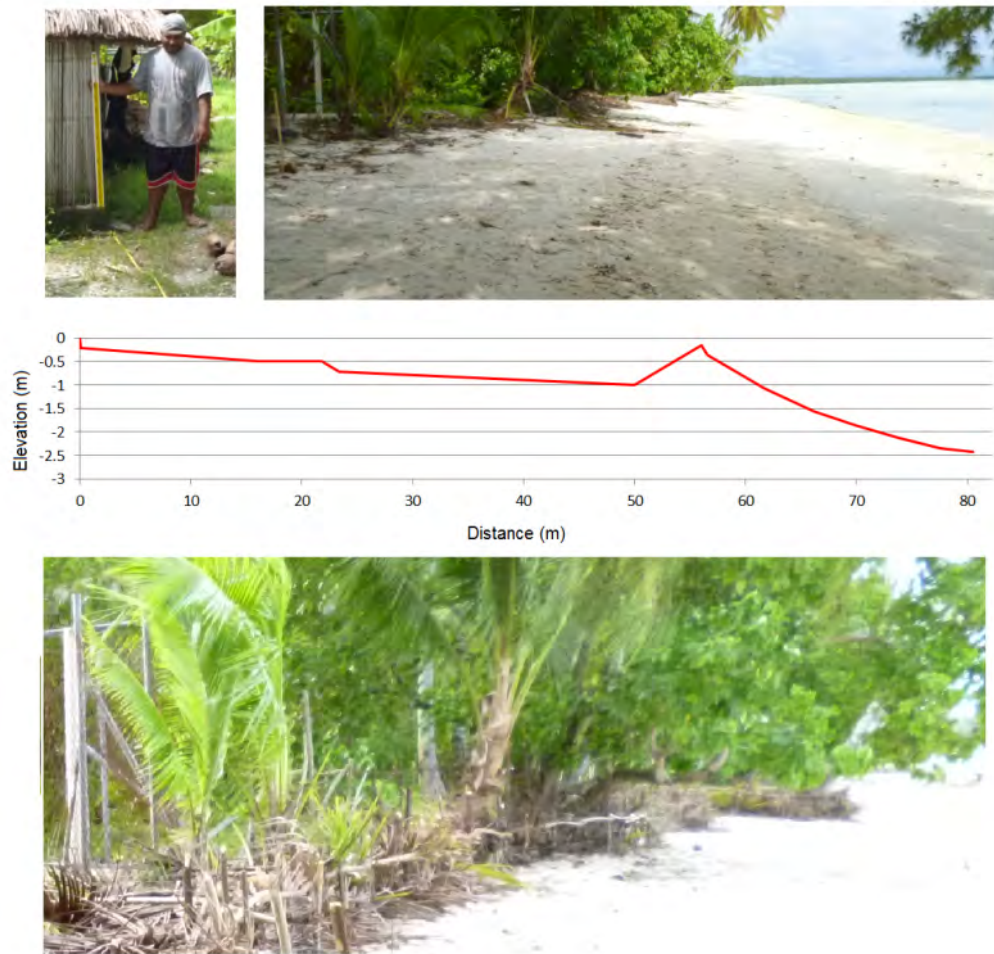
Figure 9. Beach profile diagram and EbA works at St Joseph's College (south).

To the south of the access road from the junction, a brush structure of 50.3 m in length was built by 21 volunteers from Tuarabu village (Figure 9), and included protection to the seaward side of the pre-school playground that had been undercut. Widths were 1.7-3.0 m with the wider sections surrounding the seaward roots of large trees, and heights from 0.5-0.8 m. Staff of St Joseph's College agreed to maintain and monitor the brush structure.

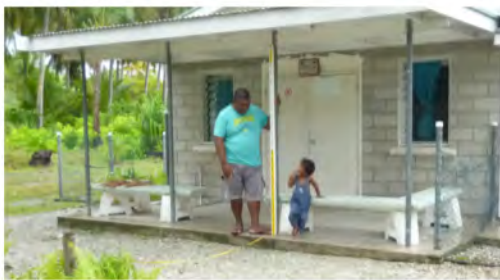
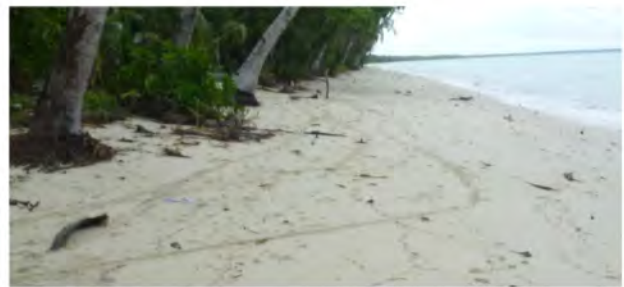
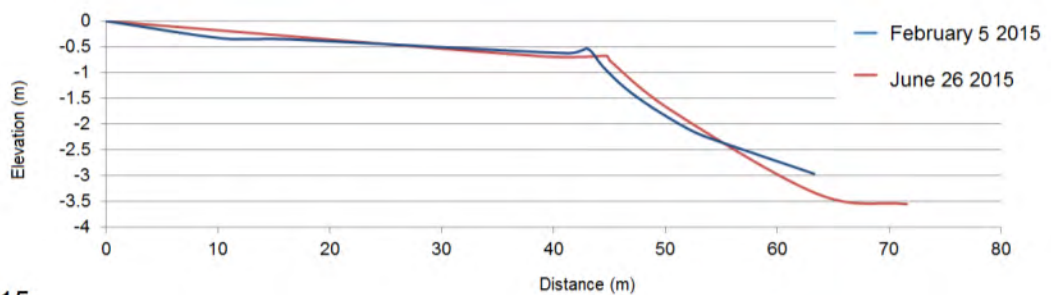
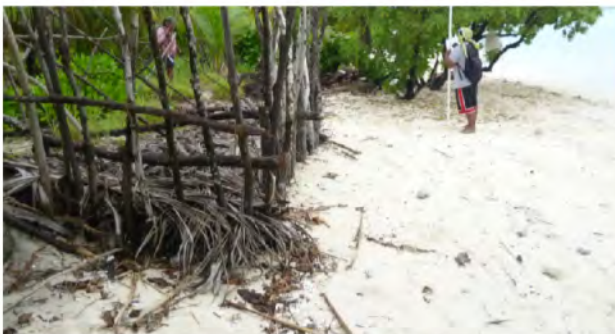
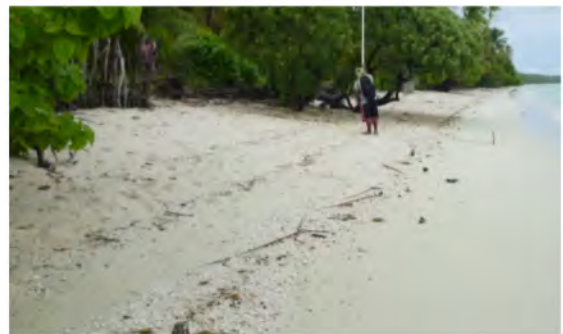
Figure 10. Beach profile diagram and EbA works at Tanimaiaki Clinic.

Opposite a new medical clinic built with European funding, this beach was in a moderately degraded condition, with the high tide mark extending into upper beach vegetation, and some of this had been cut and damaged. GIS results showed <10 m of accretion 1966-2011, and stability with a little erosion 2011-2014. A beach monitoring profile was surveyed, and benchmarked to the floor of the entrance to the medical clinic (Table 7), showing a flat beach profile (Figure 10). A brush barrier was constructed of about 5 m in length, and a further 6 m of access control fencing installed to alleviate pressure on an eroding section with an access path through. This involved the work of 15 volunteers from Tanimaiaki village.

In June, the access fence was no longer there, but the brush structure had largely remained and become infiltrated by sand deposits. This site lacks maintenance as is outside one of the villages. The beach profile results showed accretion of the upper beach by 0.2 m.

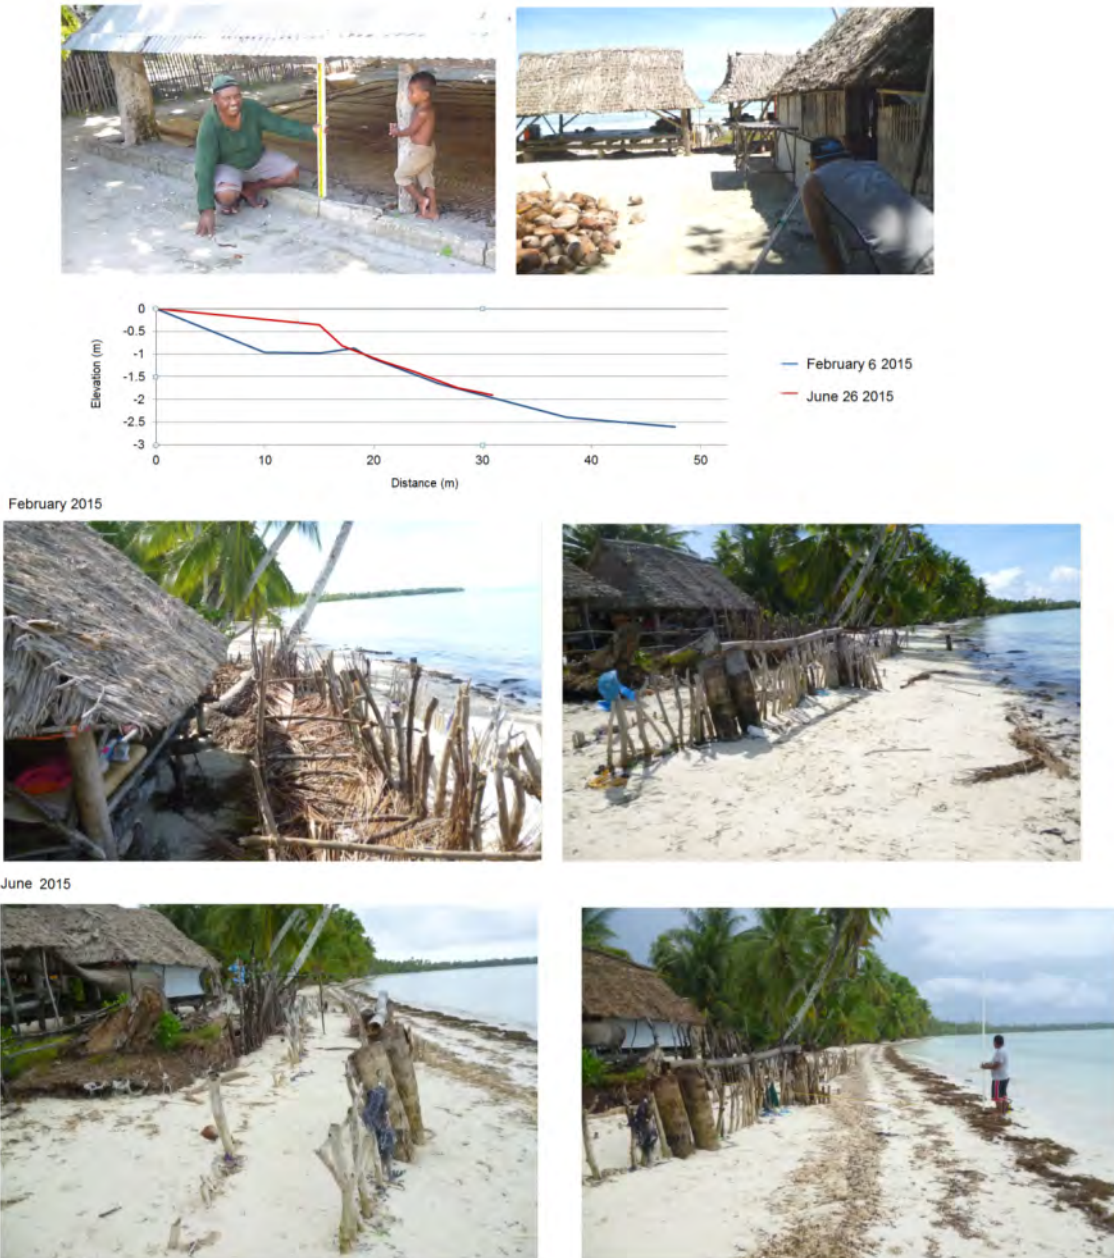
Figure 11. Beach profile transect and EbA works at Taniau.

When revisited in June, residents reported that during two high tides in late February had coincided with high waves from Cyclone Pam. Sand under the village houses had eroded, and waves damaged the brush structure, with cross bracing broken by waves such that the brush washed out. Following this, poles in the brush structure were replaced, these made shorter to reduce drag on waves, matting added, and the structure was extended to the south. The February work proved to be a demonstration, and the design was modified following experience. Sand was also mined from the lower beach and brought up to raise the ground level under village houses, as shown on the left of the profile diagram (Figure 11). The beach part of the profile showed no change.

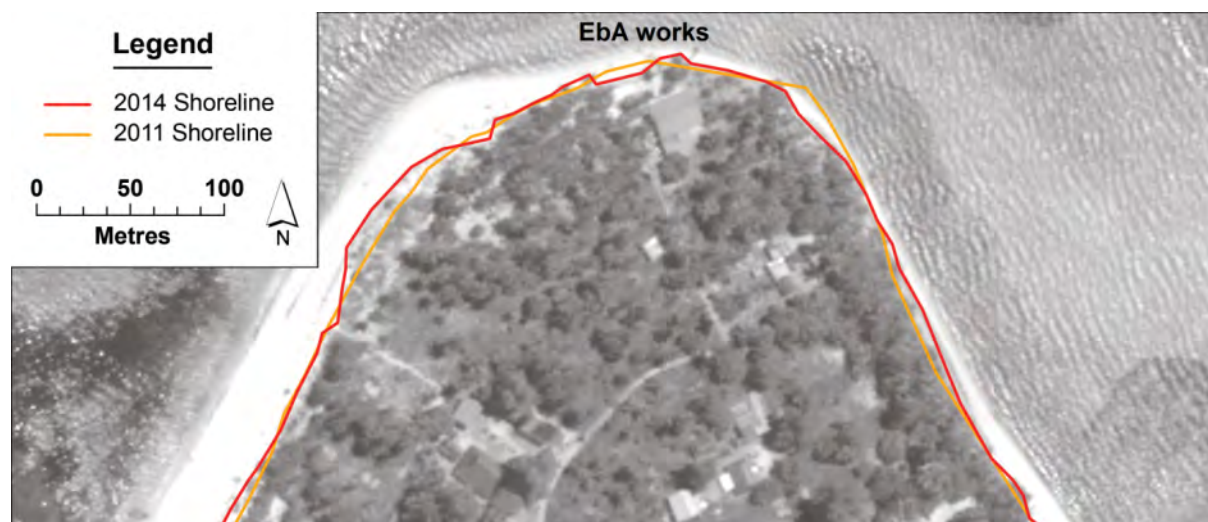
Figure 12. GIS analysis of coastal change at Tabontebike north western coast.

GIS analysis was unable to incorporate 1968 data owing to poor quality of the image. Shoreline change 2011-2014 was variable around the point (Figure 12) with erosion found to the north of the Icehouse building where the profile (Figure 13) was surveyed.

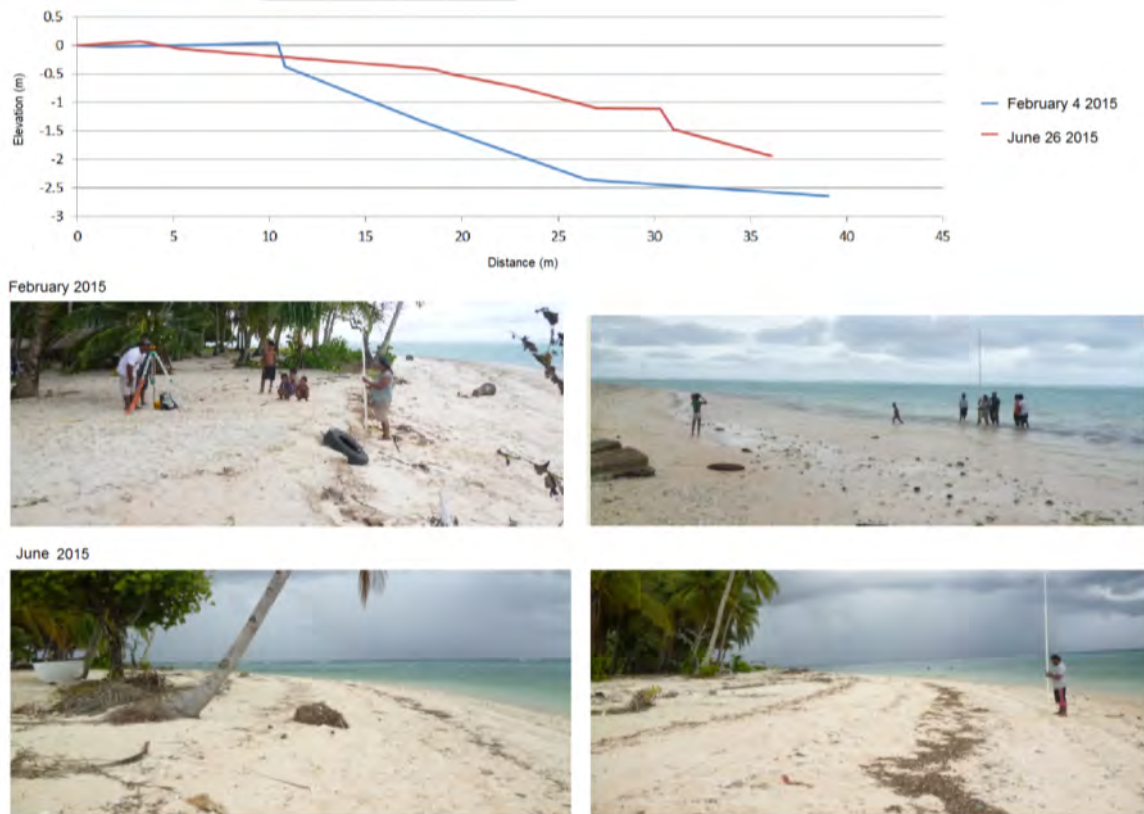
Figure 13. Beach profile transect at Tabontebike.

At the south end of the village, the beach was in a badly degraded condition, with a 1.10 m cliff eroded in the sand beach, which had eroded back to within 10 m of the icehouse (CPPL building). Community members described this as occurring in the last few years, when king tides combine with winds. While EbA is not the best technique for a windward shore, a demonstration was undertaken. A beach monitoring profile was surveyed (Table 9), and benchmarked to the concrete base of the icehouse building.

Volunteers from the community, 16 in number, gathered materials from inland, and also provided coconut string. They built a brush barrier of 8 m in length, and 1.7 m wide, using *te uri* poles and coconut branches. Towards the end of this work a storm occurred at high tide, during which waves were even washing through the ice house from front to back, and further beach erosion was evident. The brush barrier mostly held up even though not completed at the time, and sand was washed through it to deposit and become more solid. In June, the brush structure was still in position, even though storms and people had removed all of the poles. The brush was firm with sand washed through it, and the shoreline has accreted sediment.
