Existing and Proposed Extension to
Gabion Seawall Protection
in Tokelau:

Environmental Impact Assessment

by
Roger McLean

January 1993

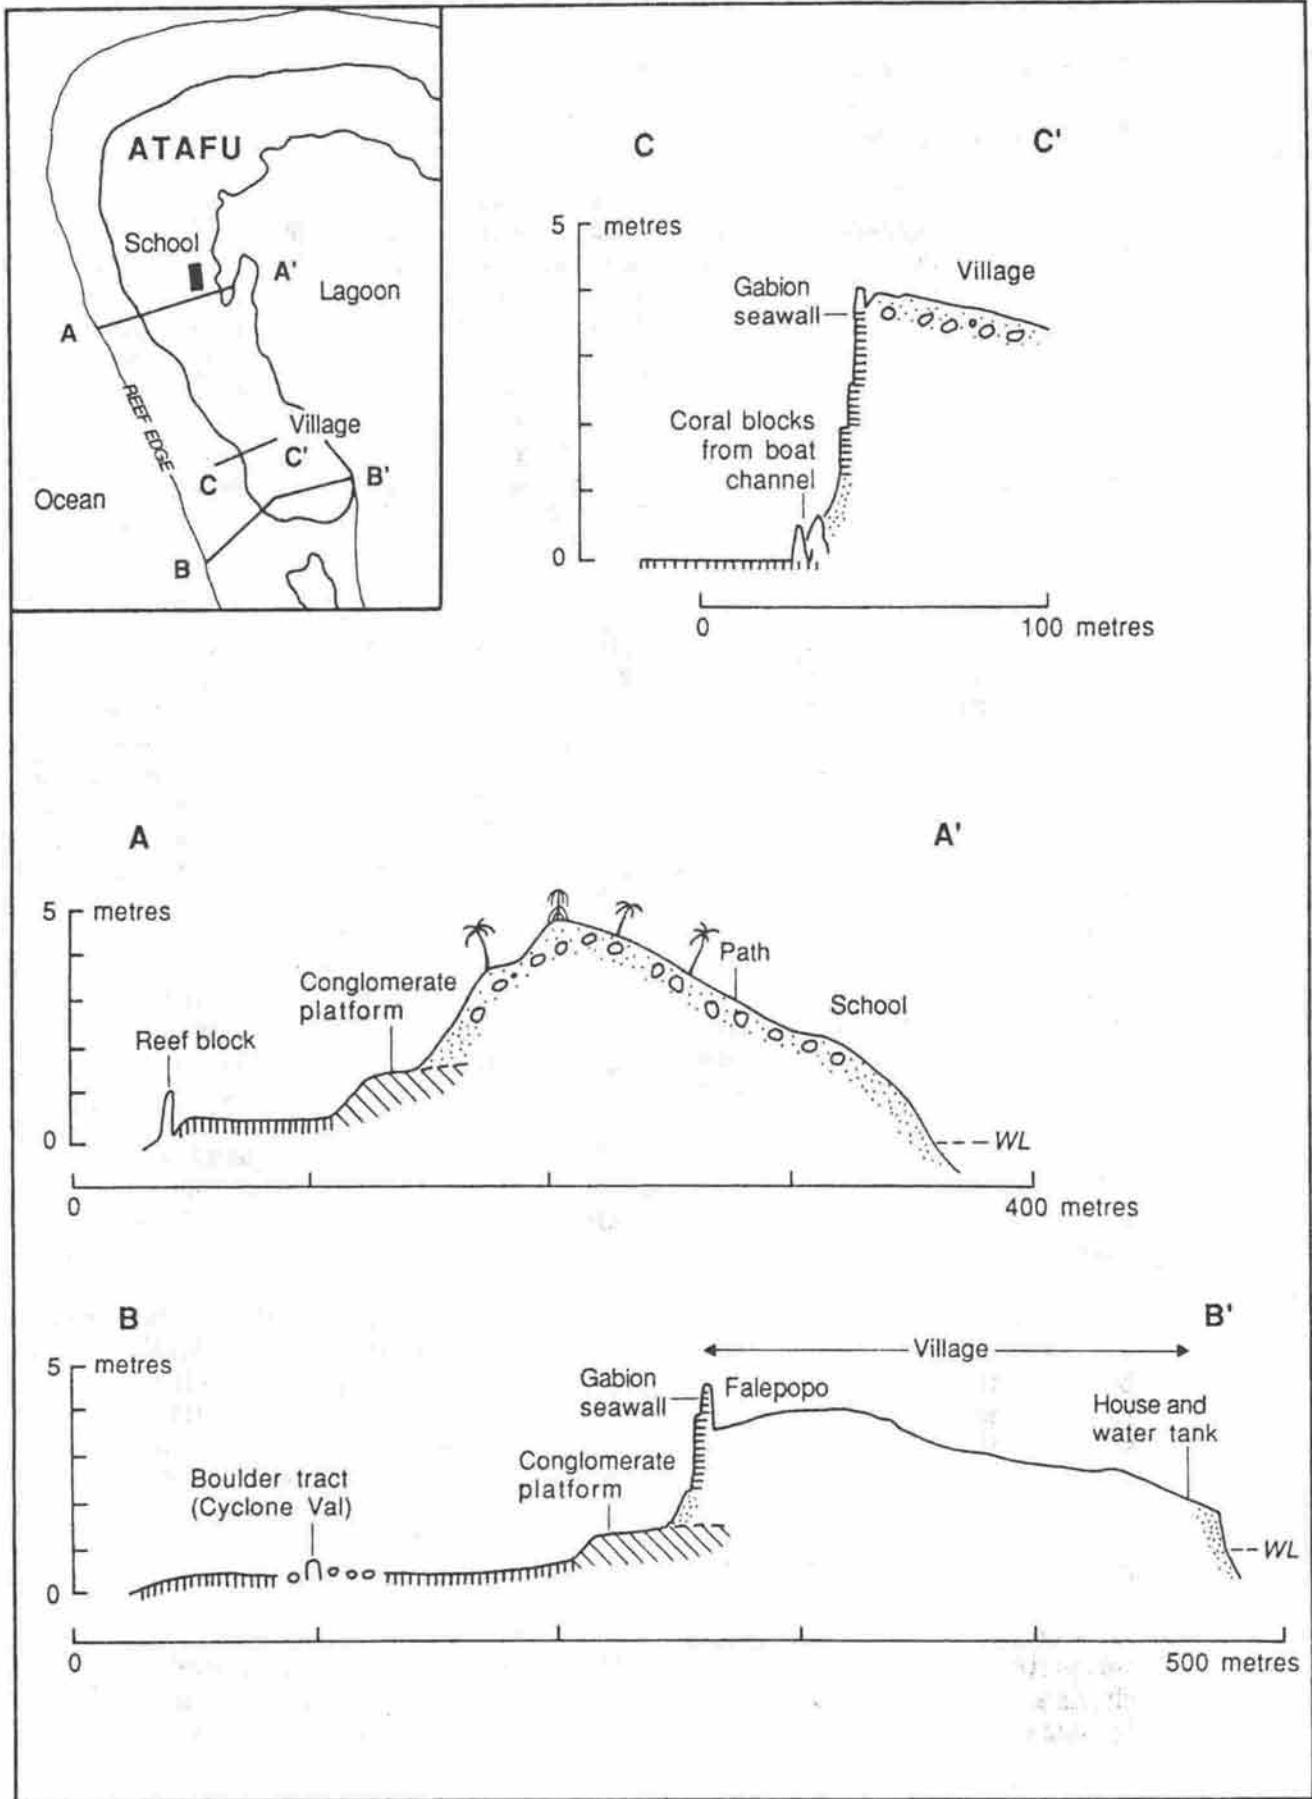
Figure 3: Atafu surveyed cross-sections.

A final local proposal is to remove the row of large coral blocks from in front of the present northern end of the seawall and to use these for backfill (Fig. 3C). Such removal is not recommended for two reasons. First, they provide a natural baffle that reduces wave action against the seawall, and second they provide a potential locus for inducing further sedimentation particularly of coarser gravel and rubble. However, because of the concentration of flow in a southern direction towards the boat channel during the ebbing tide sands are unlikely to accumulate in this area in the short term. It is one area that needs further investigation.

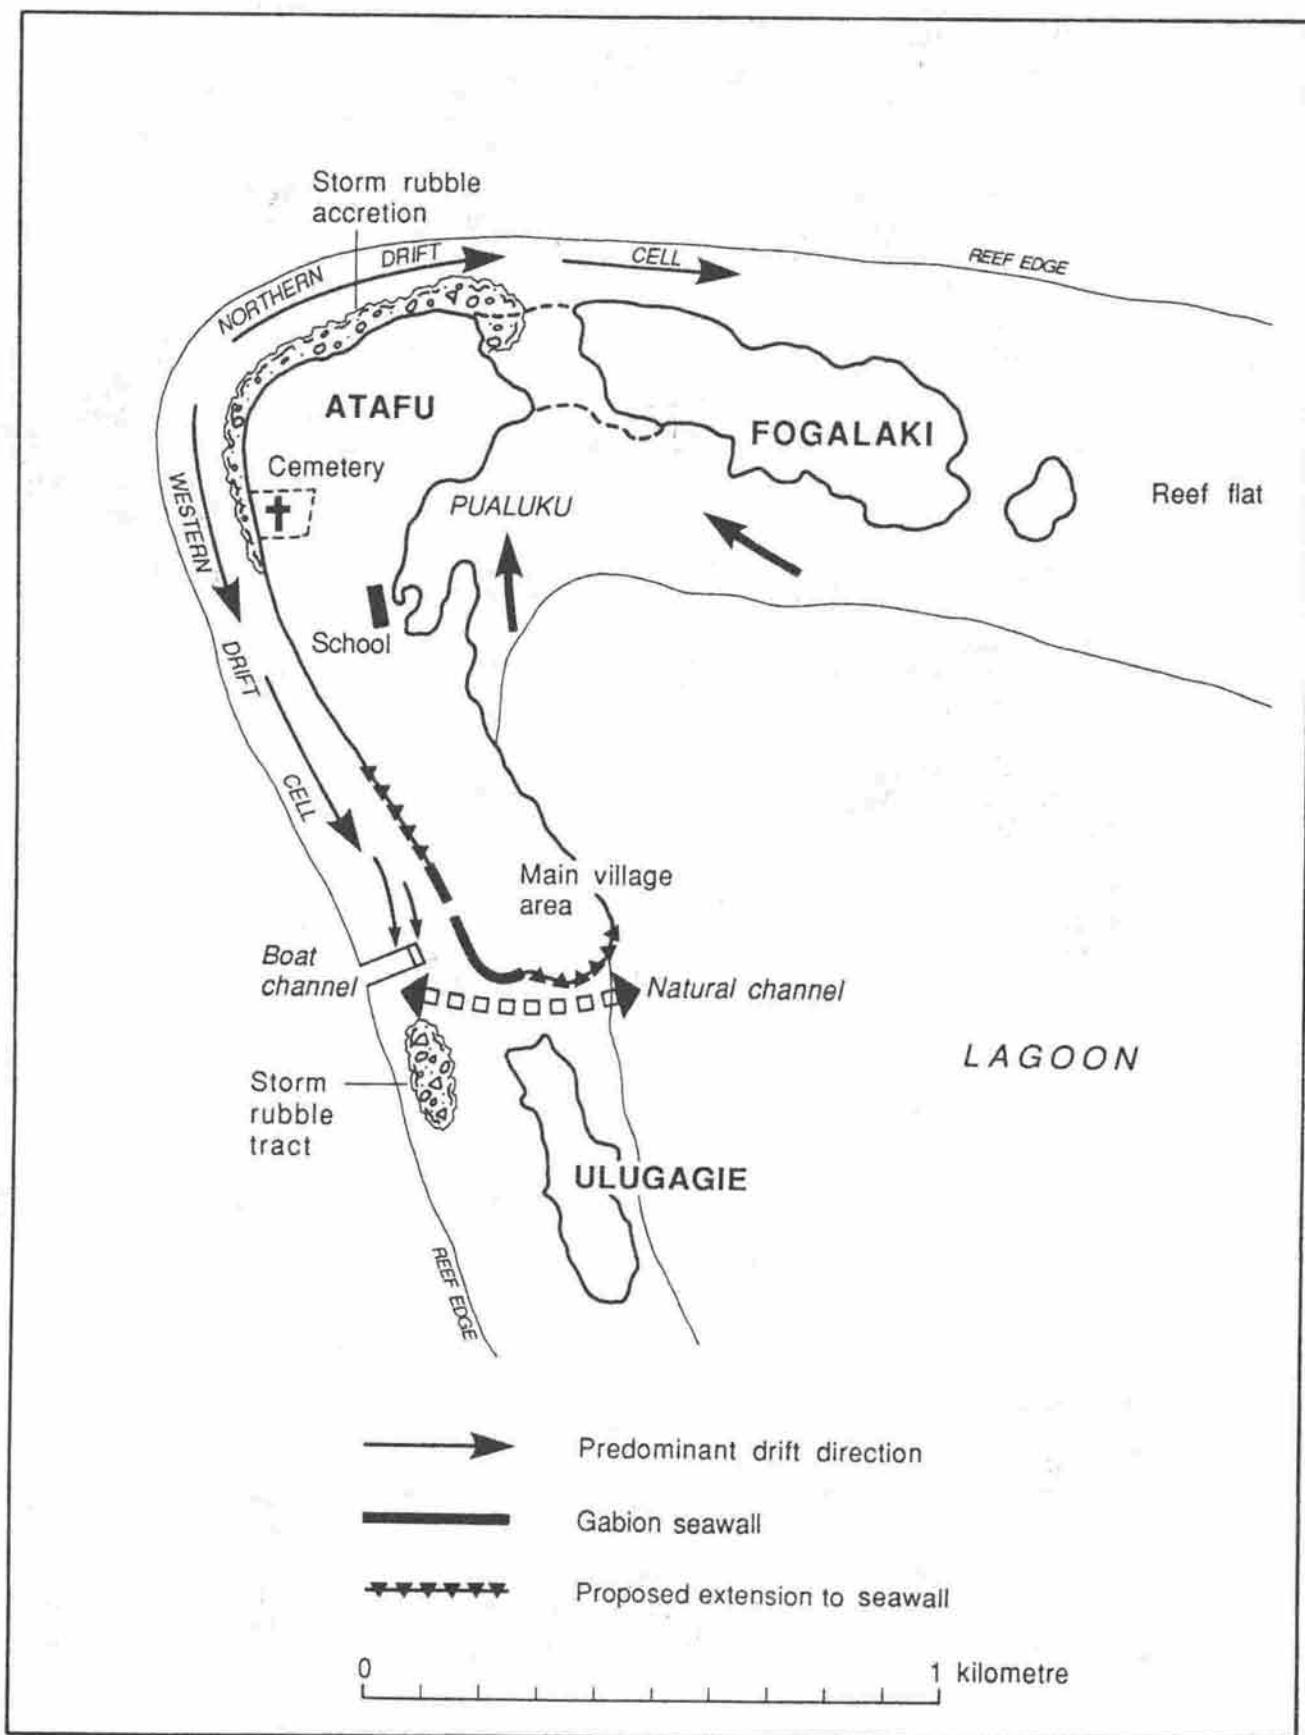
Figure 4. Atafu: coastal drift patterns, stone fill sources and existing and proposed extensions to seawalls.

- (1) only stage 2 should be proceeded with. This work involves extension of the existing seawall (a) to the southeast by some 150 m around the southern end of the island towards the lagoon (Fig. 5A); and (b) a further 180 m northwards along the oceanside (Fig. 4).

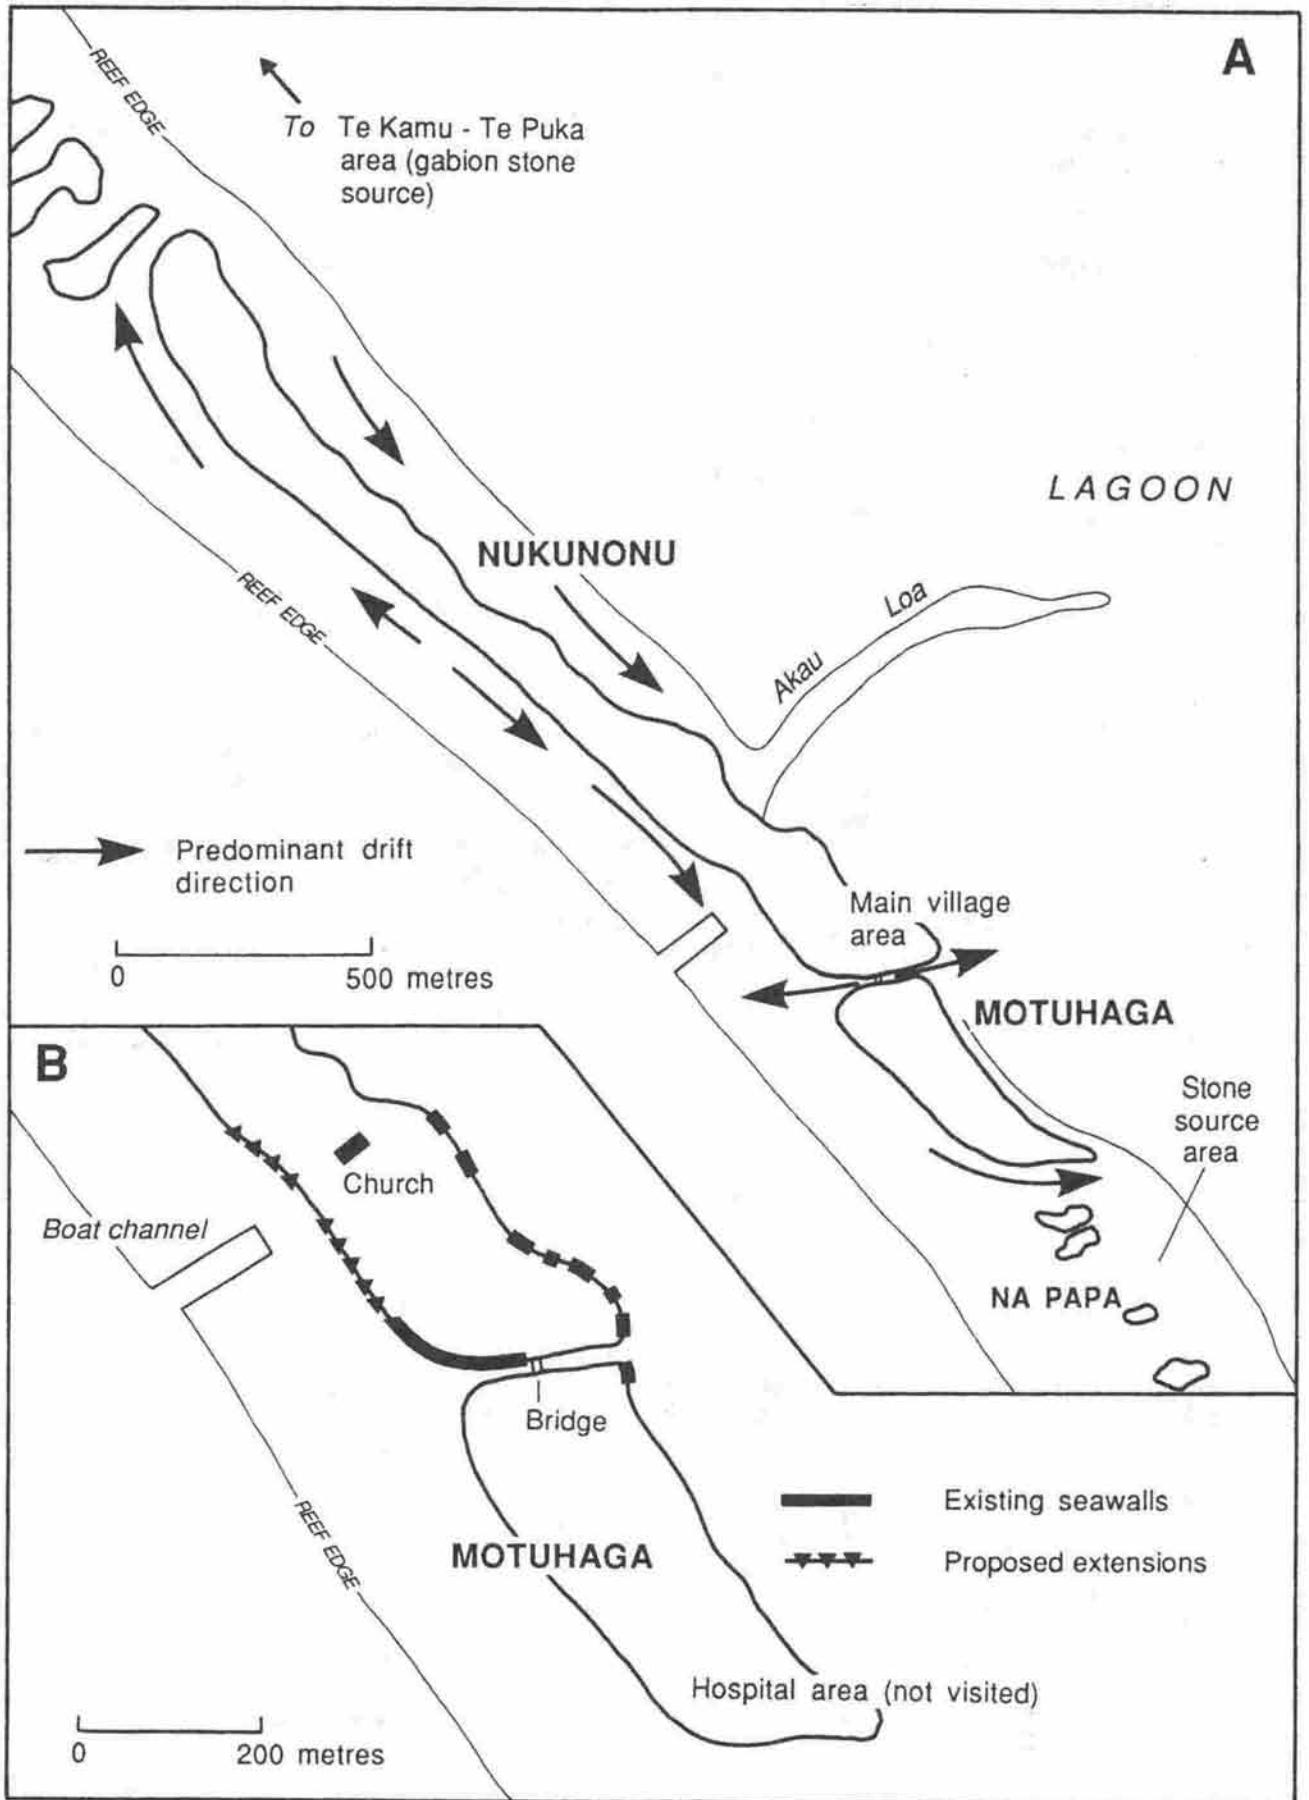
Figure 7: Nukunonu and Motuhaga: A. Drift patterns and location of stone fill source areas. B. existing seawalls and proposed extensions.

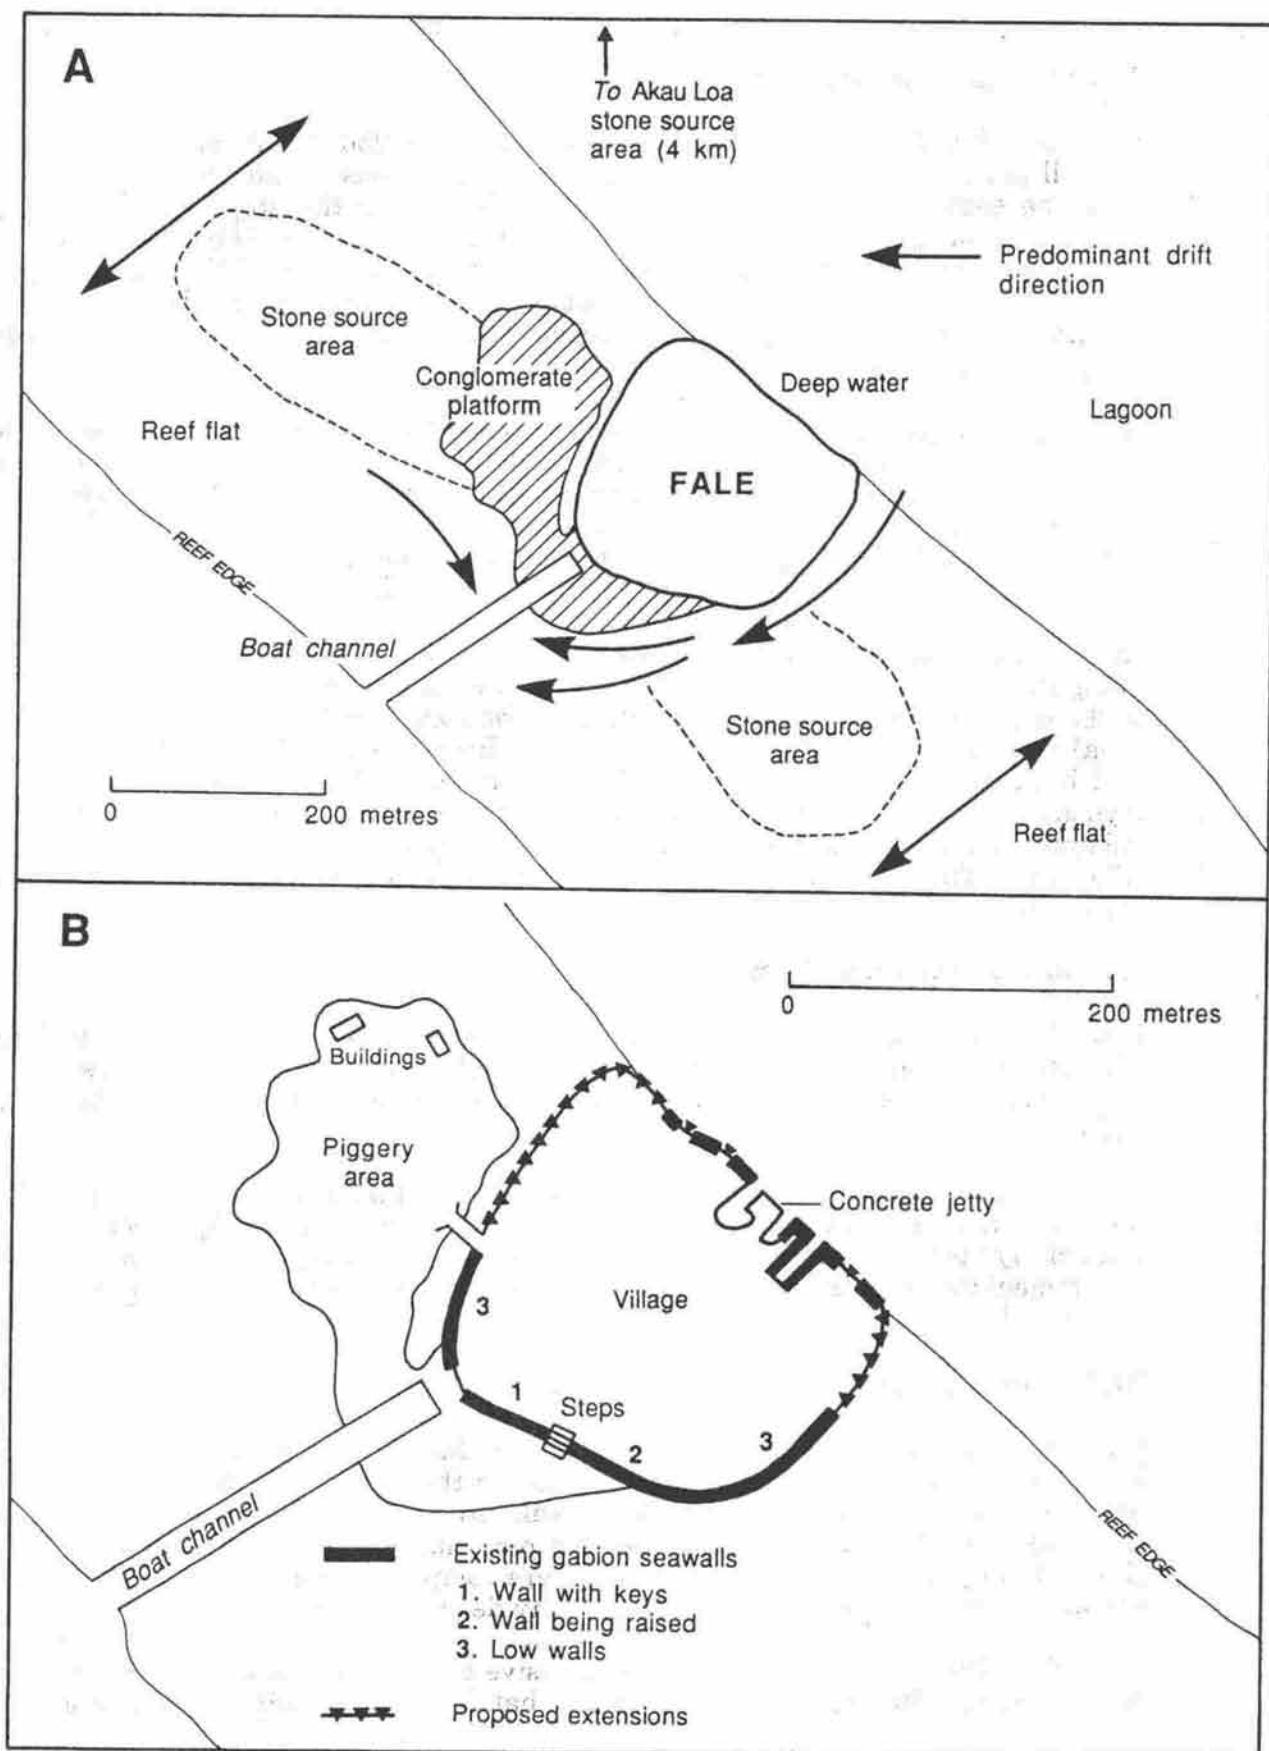
Figure 11: Fale (Fakaofu): A. Drift patterns and stone fill source areas. B. Existing seawalls and proposed extensions.

Of the three present sites where fill is taken from, there should be no further exploitation of the two reef flat areas near Fale (Fig. 11A) which afford a measure of natural protection to the oceanside of the island. Sediments in both areas, which presently veneer the surface, have the potential to be built into rubble tracts under storm conditions, such as that at Atafu (Fig. 6A, B) which result in even greater protection in the long term. Moreover, the quantities involved in these areas would not be sufficient to satisfy requirements.

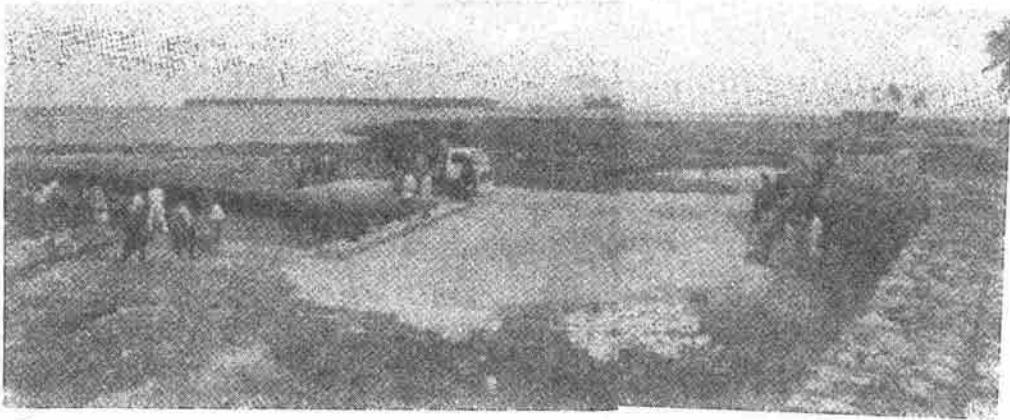
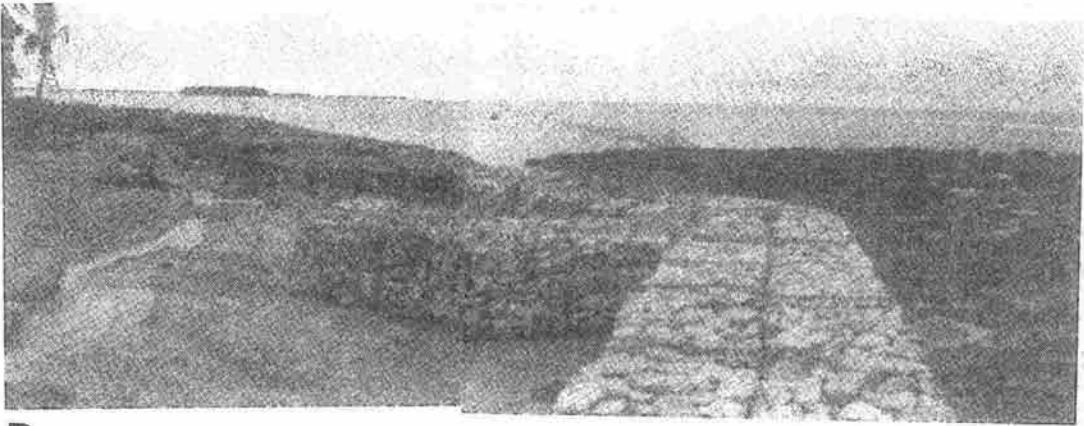
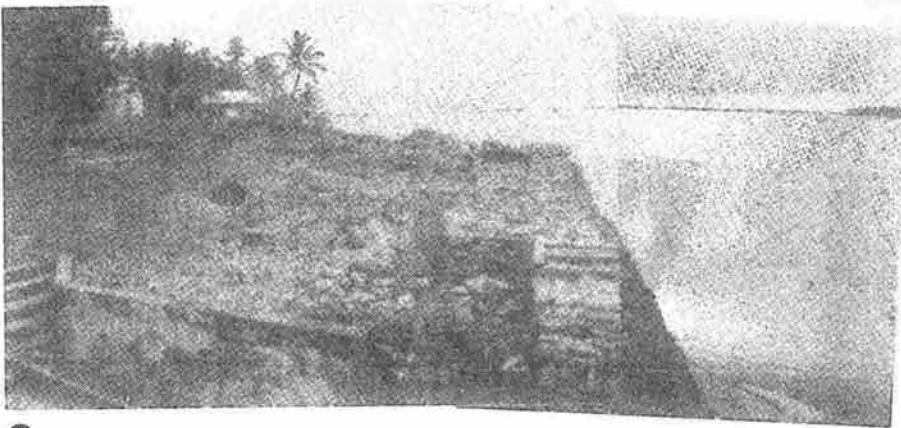
At the time of my visit on 7 and 9 December the above repairs had been completed along the boat channel - steps section of the wall and construction was underway to the southeast of the steps (Fig. 11B, 12). The boat channel - bridge wall (piggery area) was basically in the same condition as Brockliss found, except that a start had been made at the southern end to add a second layer of gabions. On the lagoonside several different segments of private wall were being constructed and gabions were also being used to build boat shelters and for reclamation purposes. (Fig. 13). There appeared to be no systematic placement or design for the lagoonside walls.

Figure 12: Fale (Fakaofu): A. Seawall 1 (Fig. 11B) behind boat channel looking north across conglomerate platform to Fenuafala in left distance. B. looking south from same position as in (A). Seawall has been raised and 'keys' added on landward side as per configuration in Fig 2D. C. Seawall 2 (Fig. 11B) additional gabions being added to top, looking southeast into lagoon.
