Survey of the Regional Distribution and Status of Asbestos-Contaminated Construction Material and Best Practice Options for its Management in Pacific Island Countries

Report for the Cook Islands

**Prepared for the Secretariat of the Pacific Regional
Environment Programme (SPREP)**

May 2015

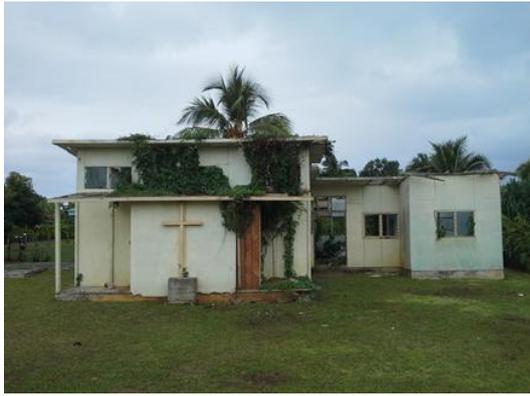
Photo 1 - Church in Aitutaki

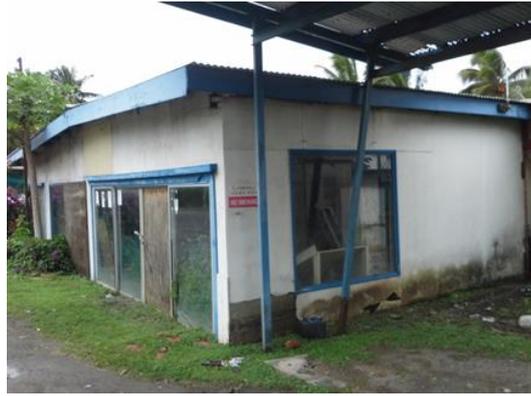
Photo 2 - Disused Shop – Arorangi, Rarotonga

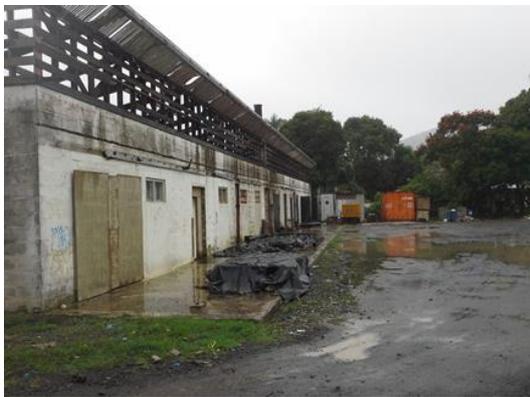
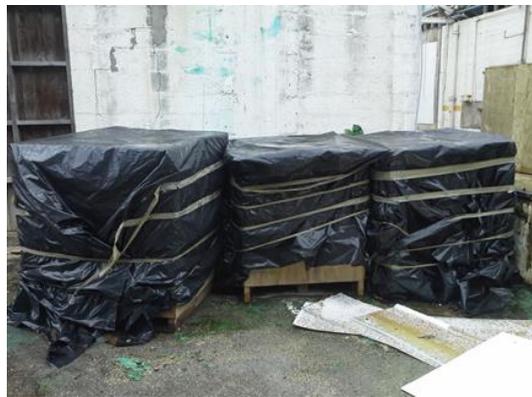
Photos 3 and 4 – Government Collection Point for ACM

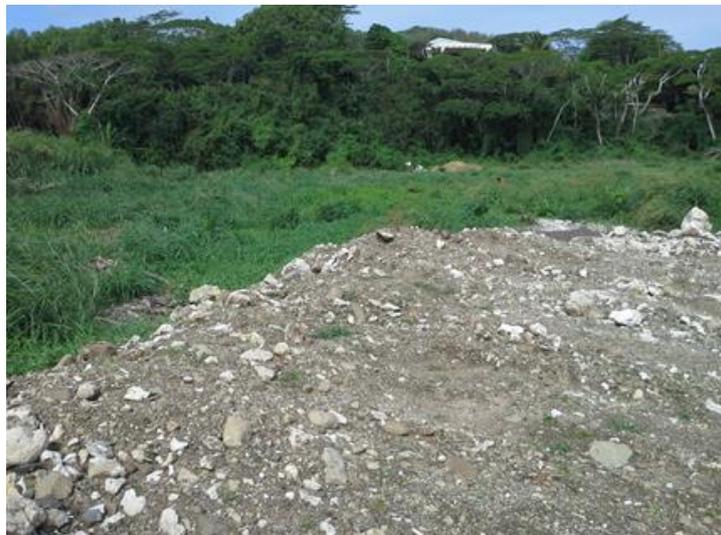
Photo 5 – Asbestos Contaminated Soil – Rarotonga Landfill

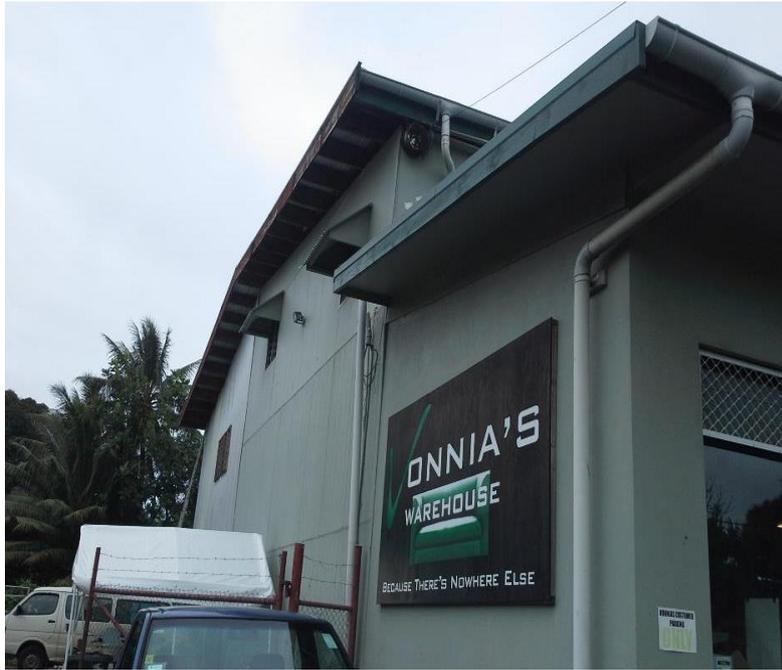
Photo 6 - Typical Commercial Building

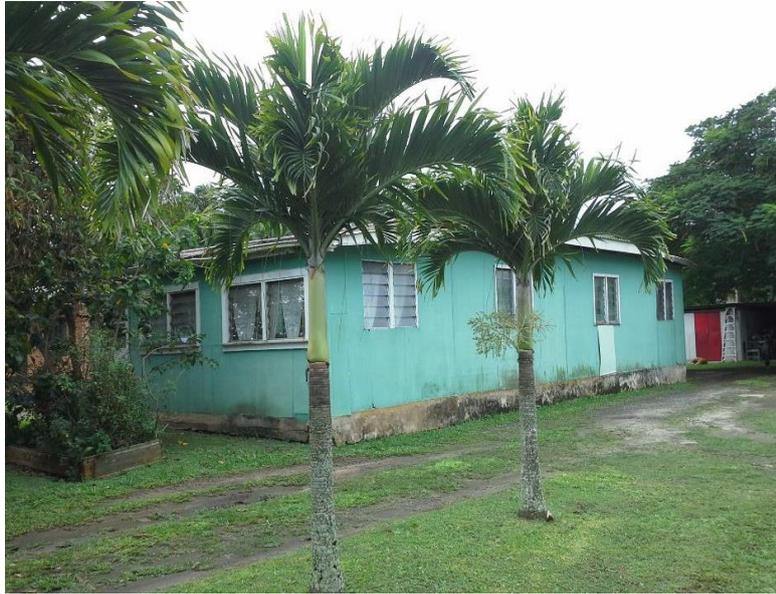
Based on the 2,670 properties surveyed, 89 residential buildings were suspected of containing PACM in the exterior material observed (77 with cladding only and 12 with roofs and cladding). An example dwelling is shown in Photo 7. Given the sample size and conclusions based upon it, if this estimate is extrapolated to include the remaining residential properties in Rarotonga and Aitutaki then, based on a 95% confidence with a margin of error of +/- 0.9%, the potential number of households in Rarotonga and Aitutaki to contain PACM would be 146 (of which 20 would also have roofs. Any roof suspected of being asbestos is usually confirmed, but a fibre board cladding can have other fibres in apart from asbestos. Based on the fibreboard that was analysed (including this survey and K2 results) about 50% was asbestos. If this figure is used then this would reduce the number to 73 houses with ACM.

Photo 7 - Typical Private Residential Building
