Survey of the Regional Distribution and Status of Asbestos-Contaminated Construction Material and Waste - Best Practice Options for its Management in Pacific Island Countries

Report for the Republic of the Marshall Islands

**Prepared for the Secretariat of the Pacific Regional
Environment Programme (SPREP)**

May 2015

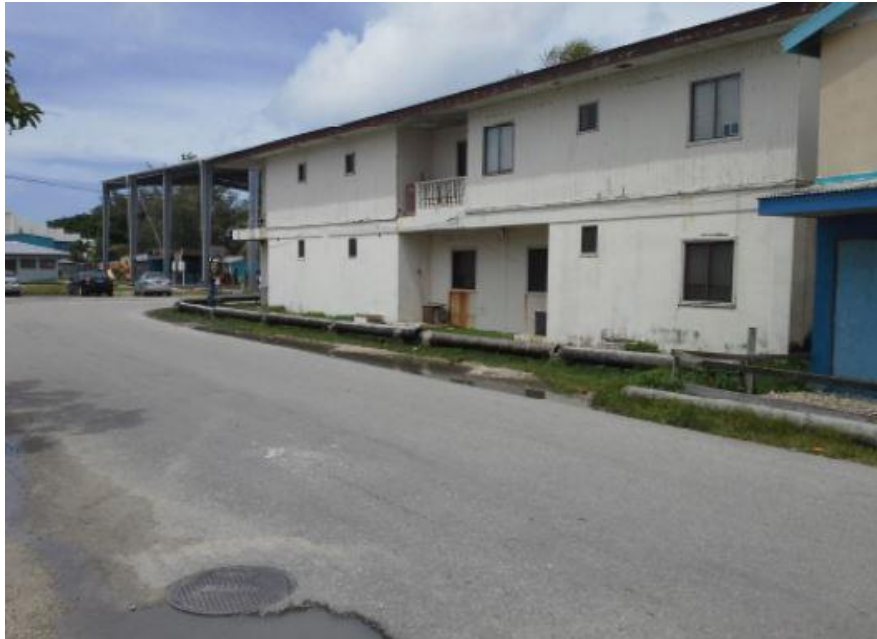
The majority of residential dwellings observed on Majuro were constructed using plywood, concrete blocks (often with cement plaster) and corrugated iron. Little or no asbestos-containing materials were observed. Photo 1 shows a typical building in Majuro.

Photo 1: Typical structure in Majuro showing cement cladding

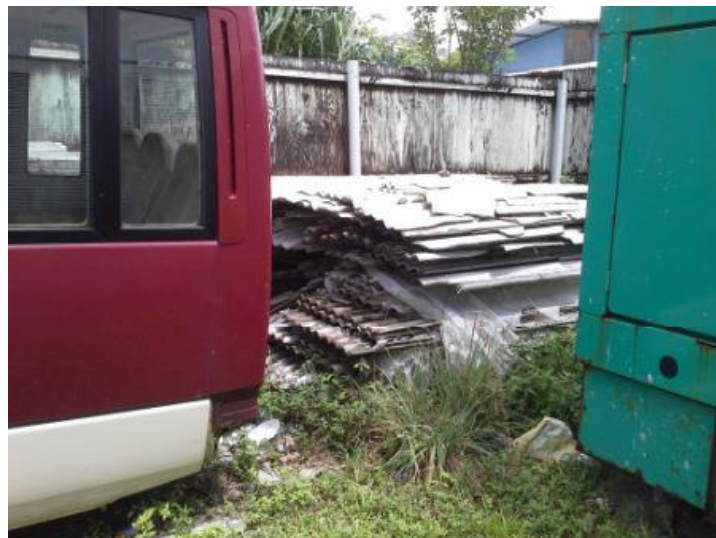
Site Name	Building Material Type	Risk Ranking Scores		
		ACM	Setting	Total Score
College of The Marshall Islands	Cement water pipes and corrugated cement roof boards	4	18	22
Ace Hardware	Corrugated cement roof	4	12	16
Vacant Residential Site	Corrugated cement roof	4	11	15
Majuro Japan Construction Company	Corrugated cement roof	3	6	9
Majuro Airport	Cement water pipes	4	3	7

Photo 2: Asbestos sheets at the College of MI

Site Name	ACM	Risk Score	Recommended Actions	Remedial	ACM Area (m ²) and/or Volume (m ³)	Estimated Cost (\$ USD)
College of The Marshall Islands	Roof Boards	22	Remove to Landfill		100m ²	\$4,300
College of The Marshall Islands	Cement pipes	18	Encapsulate		60m ²	\$1,380
Ace Hardware	Cement roof boards	16	Encapsulate		400m ²	\$33,600

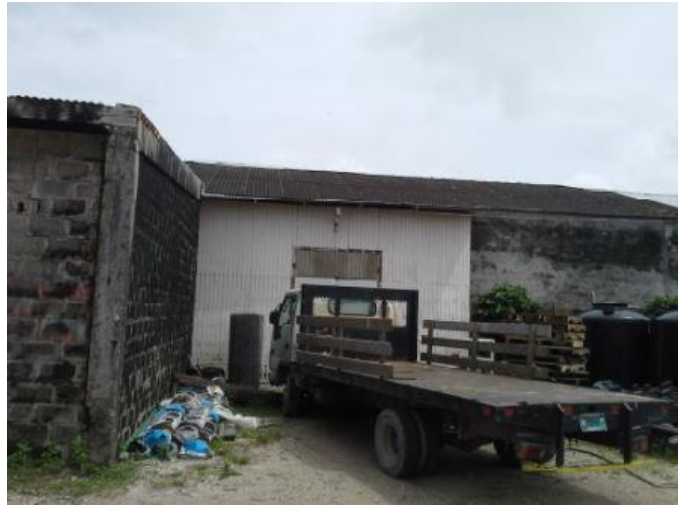
Photo 3: Asbestos roof cladding at Ace Hardware

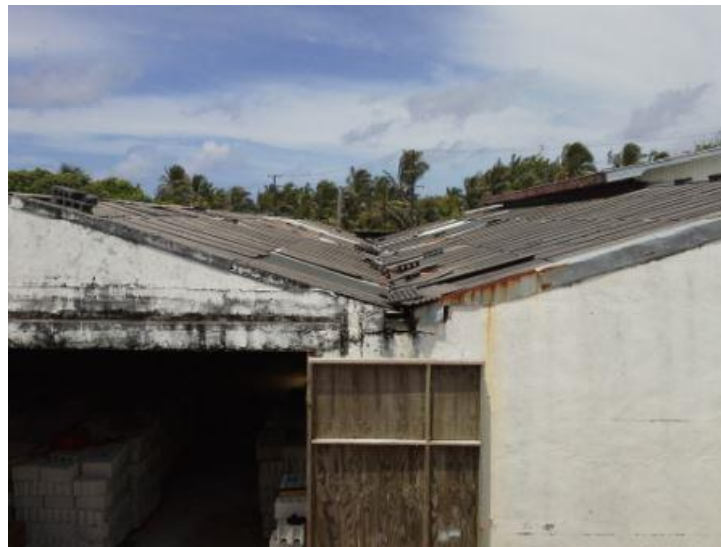
Photo 4: Damaged asbestos roof cladding at the Majuro Japan Construction Co.
