# **Survey of the Regional Distribution and Status of Asbestos-Contaminated Construction Material and Waste - Best Practice Options for its Management in Pacific Island Countries**

## **Report for Tuvalu**

**Prepared for the Secretariat of the Pacific Regional  
Environment Programme (SPREP)**

**May 2015**

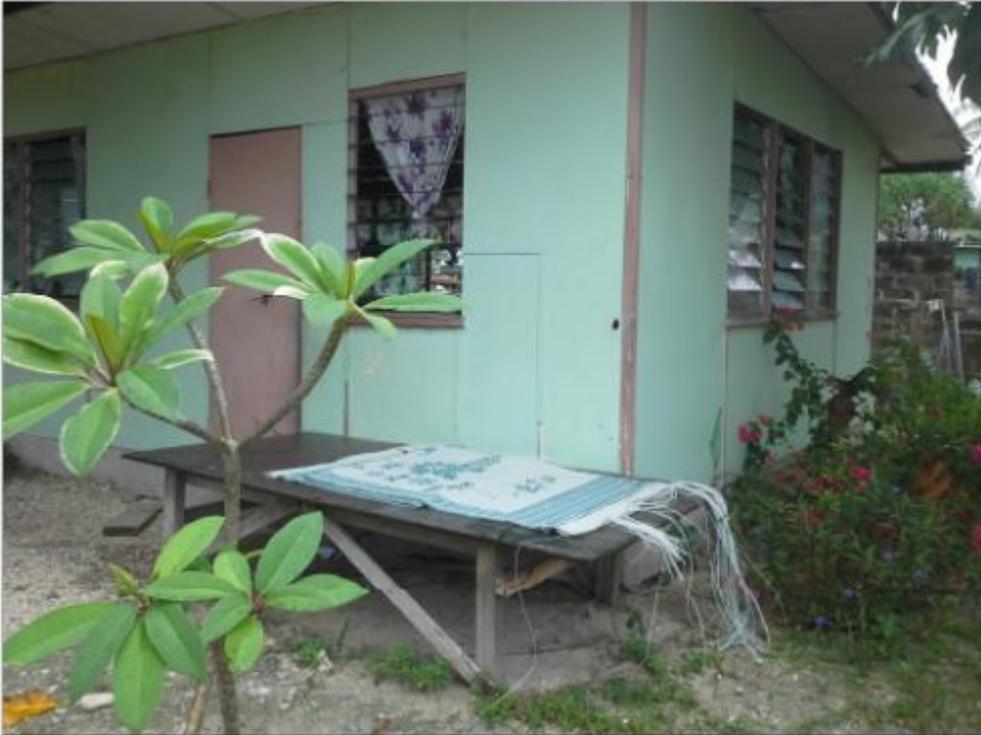
The majority of residential dwellings observed on Funafuti were constructed using plywood or fibre board, concrete blocks and corrugated iron, but fibre board external walls were the dominant type. Photo 1 shows a typical building in Funafuti. Most shade houses were constructed using traditional materials consisting of tree branches as the pillars and woven palm fronds as the roof cladding.

**Photo 1: typical structure in Funafuti showing fibre board cladding**

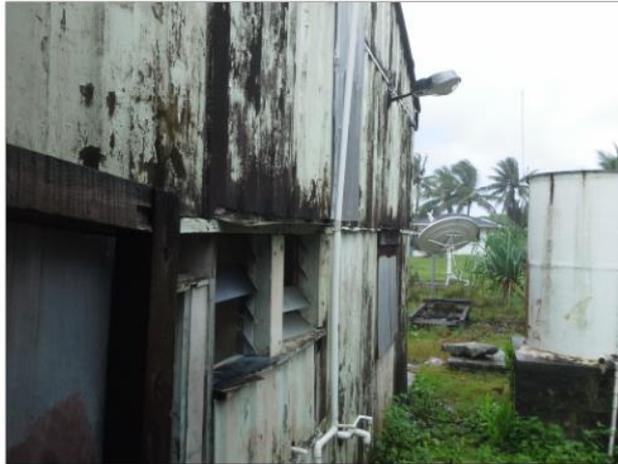
The risk ranking scores presented in Table 8 indicate that the survey has identified five sites that are considered to currently present a moderate risk of asbestos exposure to the occupants. Photos 2 and 3 show the old power station and Photo 4 shows the decaying asbestos roof on the meteorological station. Two further sites present a low risk. One of these is the Princess Margaret Hospital which would normally be considered a higher risk, but the only positive asbestos material there is loose fibreboard. Two further sites are considered to present a very low risk. This risk assessment is based on current conditions, ACM condition and site use observed at the time of the survey. Should these change over time, reassessment of the risk presented would be required.

**Photo 2: Wall cladding on the former power station**

Access to the ACM identified should be managed by the owners of the land to prevent unauthorised access and possible exposure to the asbestos.

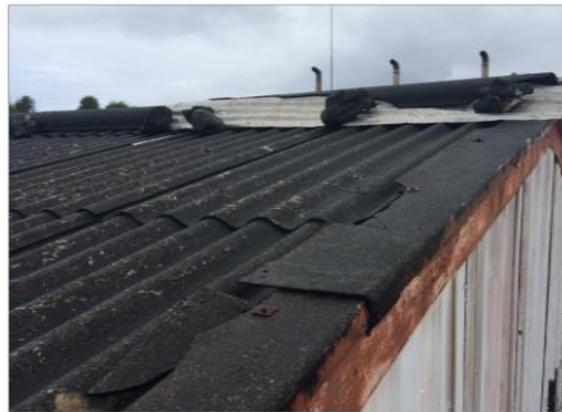
**Photo 3: Asbestos roofing material on the former power station**

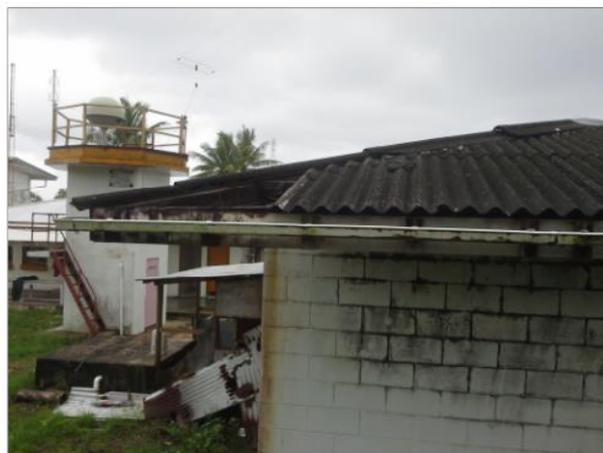
**Photo 4: Asbestos roof at the meteorological centre**
