Survey of the Regional Distribution and Status of Asbestos-Contaminated Construction Material and Best Practice Options for its Management in Pacific Island Countries

Report for the Solomon Islands

**Prepared for the Secretariat of the Pacific Regional
Environment Programme (SPREP)**

May 2015

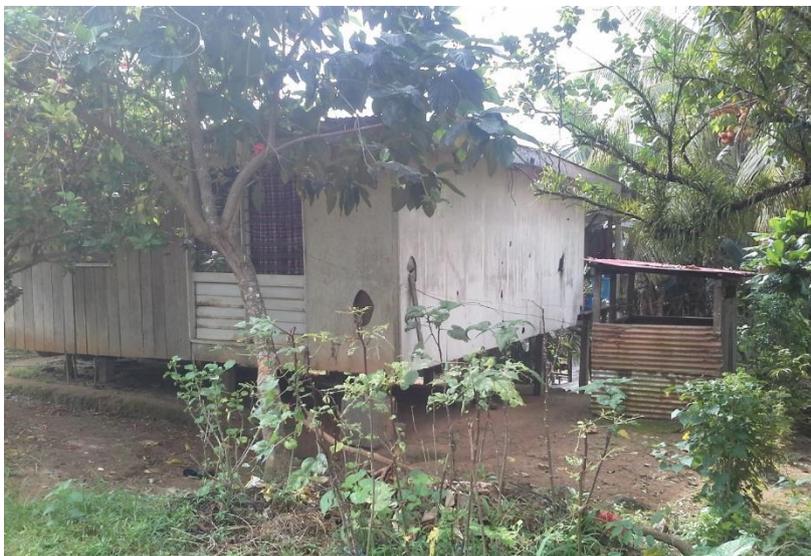
Photo 2: Typical residential structure made of fibre board or PACM

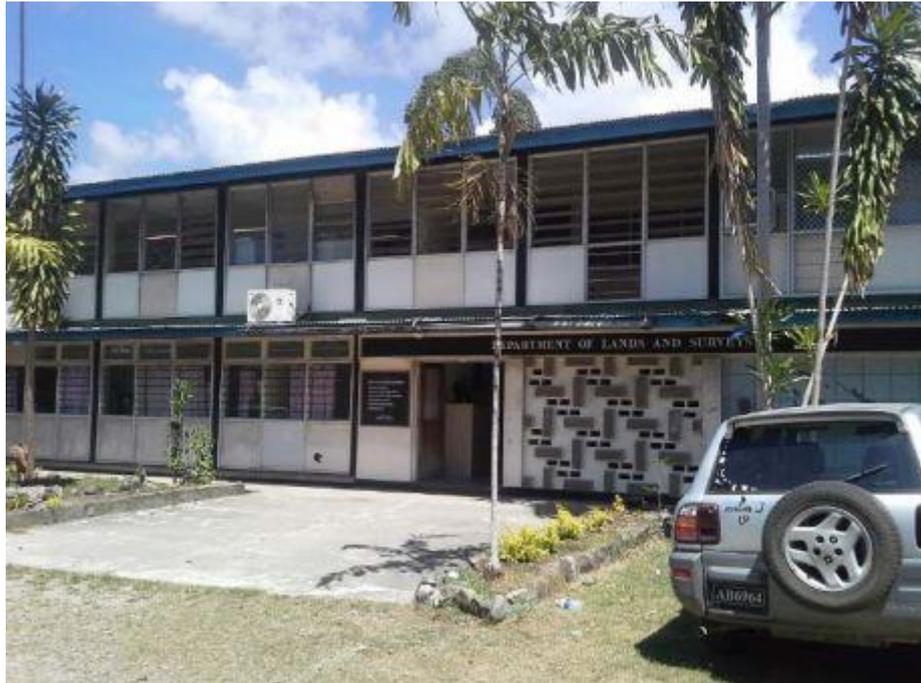
Photo 3: Lands & Survey Building – AC Panels

The risk ranking scores presented in Table 9 indicate that the survey has identified one (Land & Survey building) site that poses a high risk of exposure to occupants. Photo shows the building with the fibre board cladding along the front. In addition, the Ministry of Infrastructure & Development building presents a moderate risk to human health while five sites, including residential areas, are ranked as having a low risk to the occupants. The risk assessment is based on current conditions, ACM condition and site use observed at the time of the survey. Should these change over time, reassessment of the risk presented would be required.

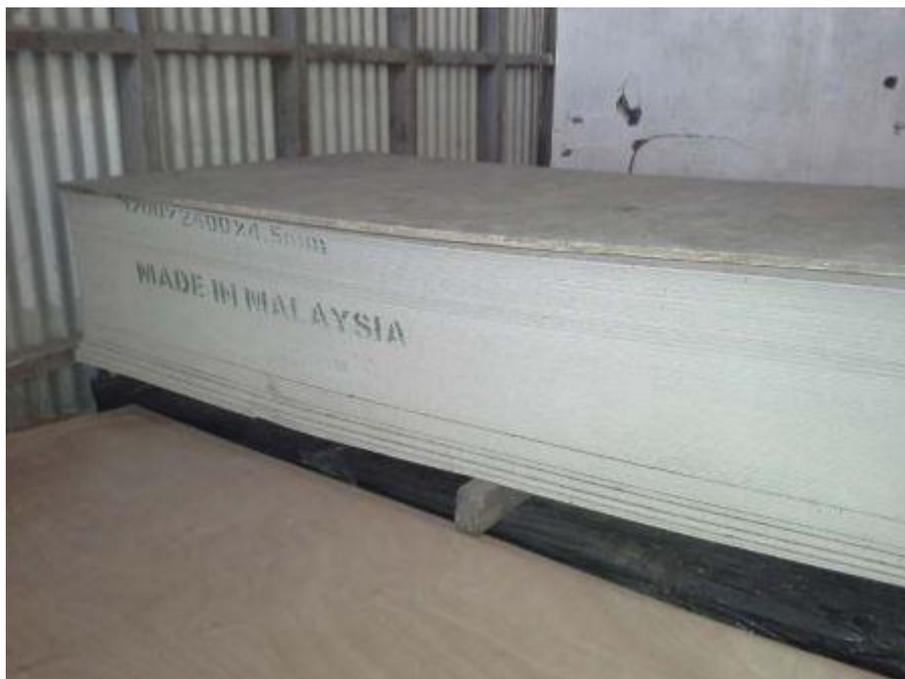
Photo 4: Asbestos cladding for sale in Gizo

It is important to note above that the ACM detected at the hardware store is new asbestos cladding that is being sold to the public for construction purposes.

A risk assessment was not carried out for the new asbestos cladding that was found on sale at a hardware store in Gizo because this could be used in a wide range of possible settings, some of which may be safe and some which may not. A photo of this material is shown in Photo 4 above, and it is recommended that the Solomon Islands Government acts quickly to have it removed from sale. In addition, any future imports should be banned.

It is also recommended that the Solomon Islands government act quickly to have the new asbestos cladding identified at a hardware store removed from sale. In addition, any future imports should be banned.

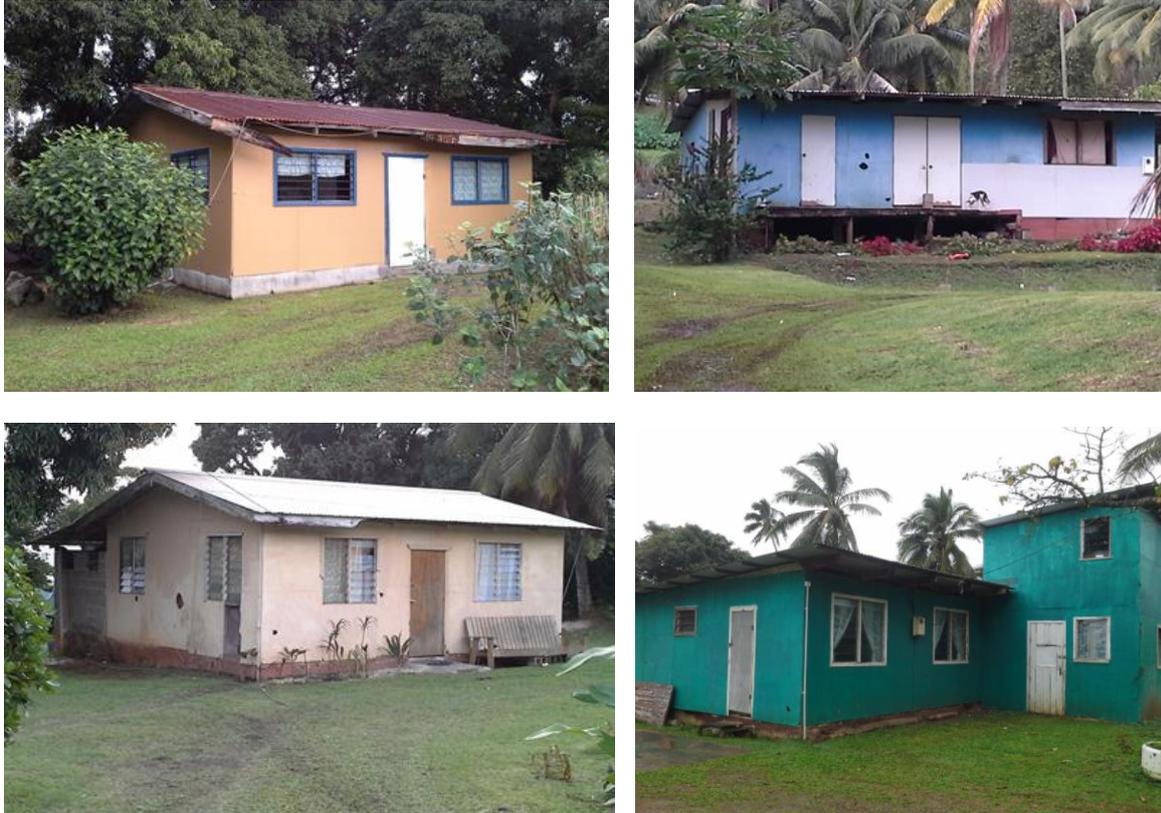
Photos 5-9 – Typical Residences with PACM Cladding
