# **Survey of the Regional Distribution and Status of Asbestos-Contaminated Construction Material and Best Practice Options for its Management in Pacific Island Countries**

## **Report for the Kingdom of Tonga**

**Prepared for the Secretariat of the Pacific Regional  
Environment Programme (SPREP)**

**May 2015**

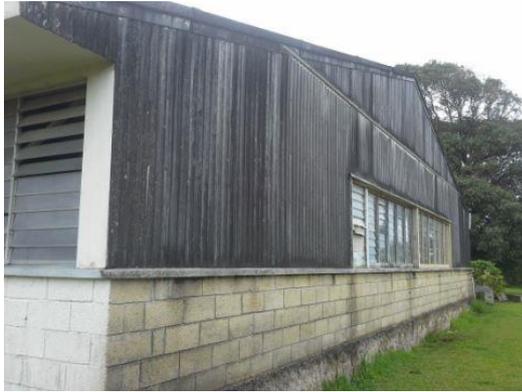
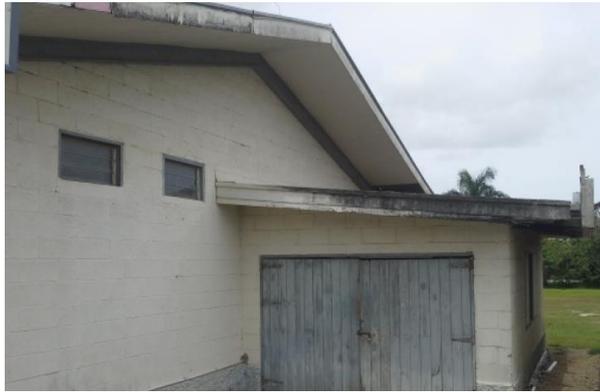
**Photos 3 and 4 – Tonga Post**

Photos 3 and 4 below are of the Tonga Post complex. There are several commercial buildings with asbestos and some loose asbestos.

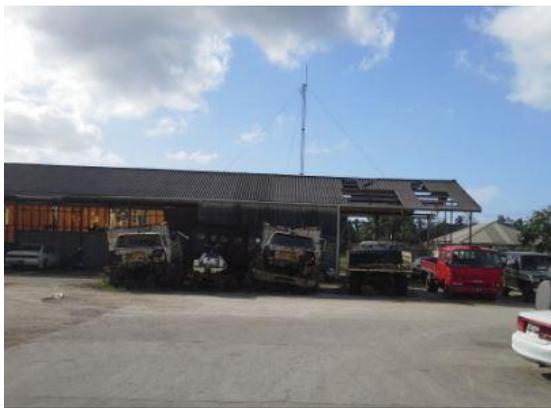
**Photo 5 – MOI WOF Centre**

Photo 5 below shows the MOI WOF Centre with an asbestos roof and Photo 6 below shows the MOI Workshop.

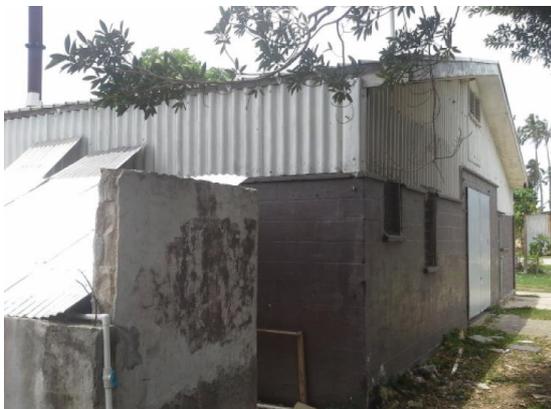
**Photo 7 – Industrial 01 Building**

Photo 7 below shows the Industrial 01 Building cladding and Photo 8 shows cladding on the Small Business Centre Office. Both sets of cladding are damaged.

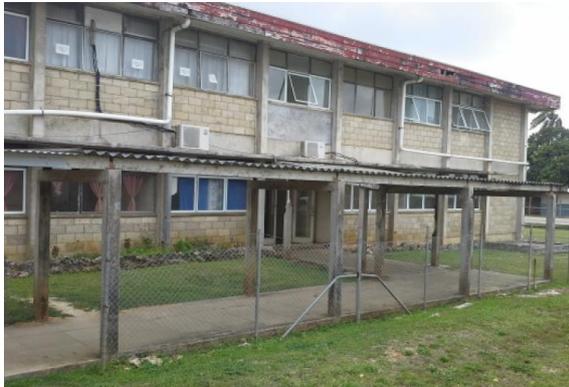
**Photo 11 – Vaiola Hospital**

Photo 9 shows the Vaiola Hospital Walkway Roof in Tongatapu and Photo 10 shows one of the Prince Ngu Hospital Roof in Vava'u. This hospital has four asbestos roofs as well as some loose asbestos. The total roof area is about 3100 m<sup>2</sup>.

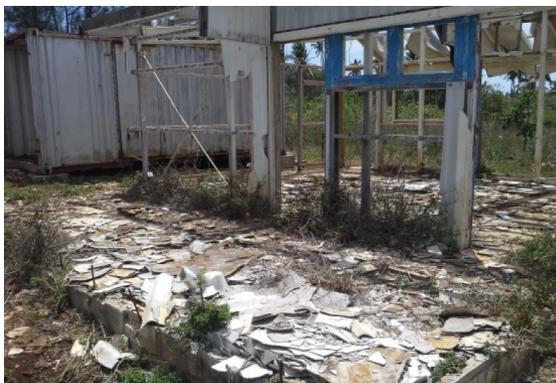
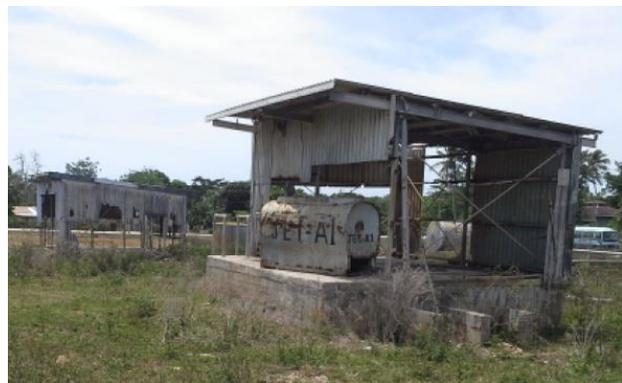
**Photos 13 and 14 – Vava'u Former Bulk Fuel Terminal**

Photo 13 and 14 show the Vava'u Former Bulk Fuel Depot. There is significant damage and signs of vandalism, stock grazing in areas with ACM. There is loose ACM over most of site and off-site towards school and on playing fields. The site has been derelict for at least 15 years and is not fenced. It is relatively exposed topographically, i.e. top of hill, and it receives wind flows directly. There is a school approximately 100m away to east. Residential areas are on two sides within 50m. Discussions with MOI indicated that there is a tender to purchase the land and they were unsure who owns land now. Pacific Energy has a sign near the site but this relates to an active fuel terminal nearby.

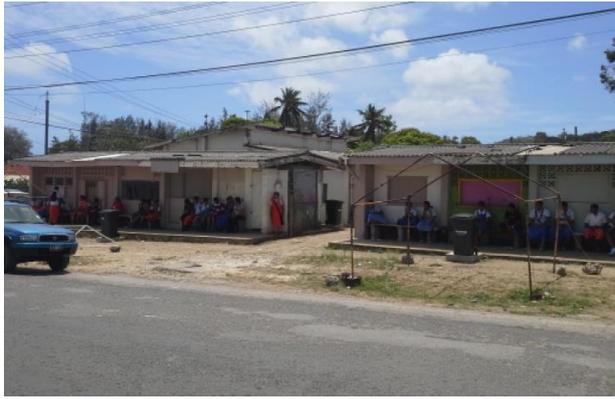
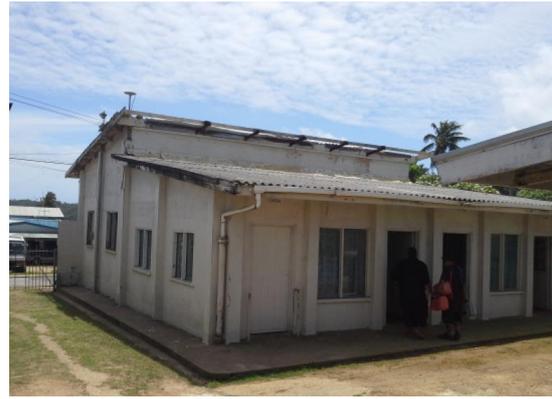
**Photos 15 and 16 – Former Neiafu Market.**

Photos 15 and 16 show the Neiafu former market. There are damaged ACM roofs on several buildings and ACM fragments observed on ground across the road from the southern building. This former market is still widely used.
