# Vulnerability and adaptation (V&A) assessment for the water sector in Majuro, Republic of the Marshall Islands

Vulnerability and adaptation (V&A) assessment for the water sector in  
Majuro, Republic of the Marshall Islands. Apia, Samoa : SPREP, 2014.

p. cm. (PACC Technical Report No.5)

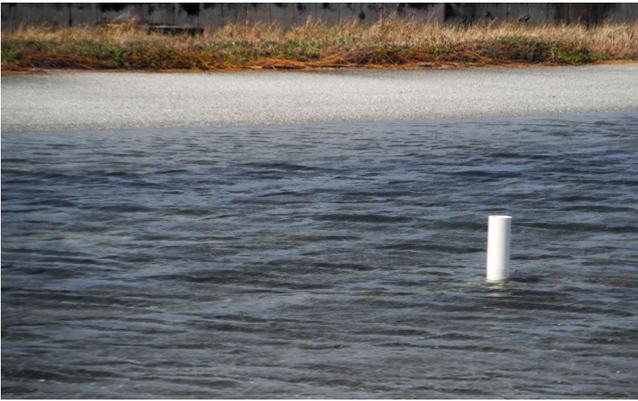
The catchment design includes air vents (Figure 6) along both shoulders of the runway, which allow hydrostatic pressure, generated underneath the airport pavement during high tides, to escape. Recent site observations conducted by Majuro Water and Sewage Company (MWSC) and Amata Kabua International Airport (AKIA) indicate that most air vents are currently operating, though more regular maintenance needs to be prioritised.

Figure 6. Air vent.

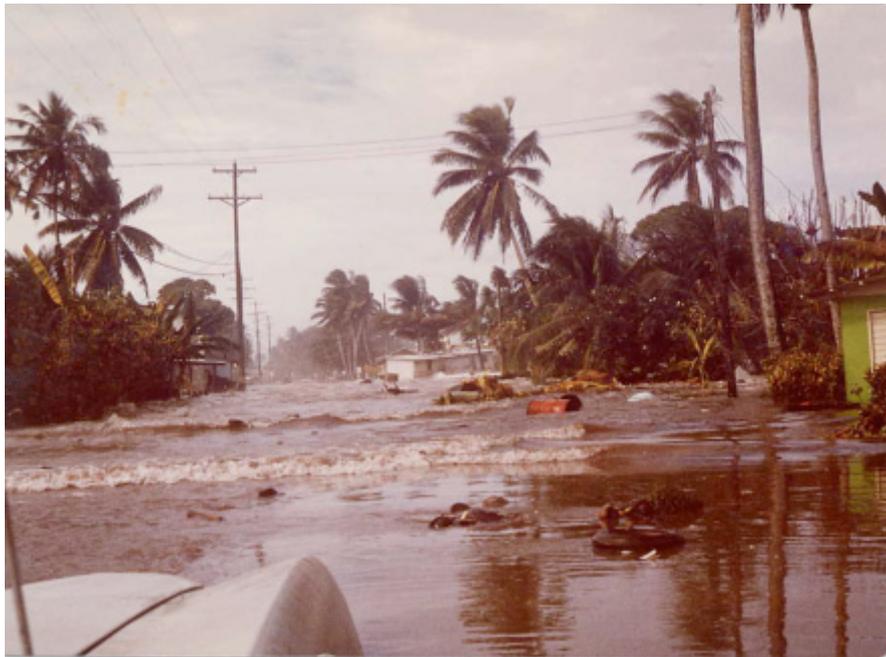
Figure 18. Flooding in Majuro D.U.D. November 1979 (Spenneman, 2002).

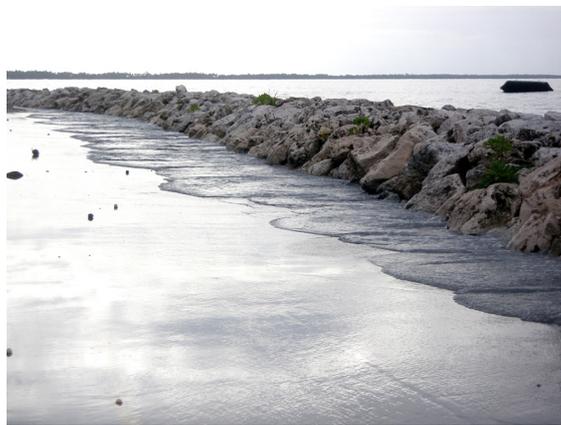
Figure 19. Flooding airport road, February 2011 (photo courtesy RMIPA).

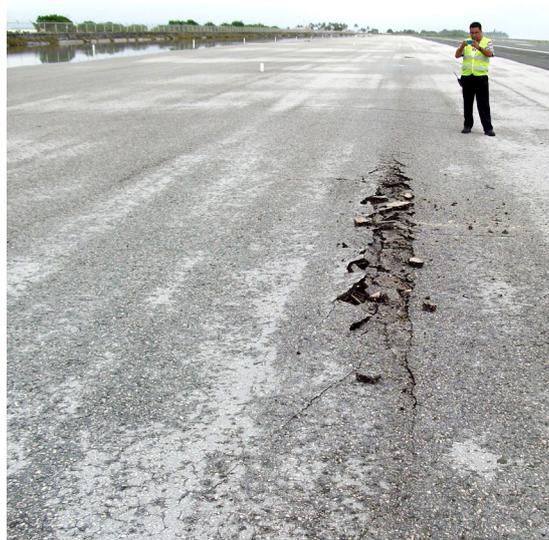
The raised sea level generated hydrostatic pressure beyond what the runway air vents designed in 1979 were able to accommodate. The resulting damage to the airport pavement surface, shown in Figure 20, has prompted discussion among airport officials about boring for sediment samples of the ruptured areas for the purposes of further study.

Figure 20. Hydrostatic pressure damage to the Majuro airport catchment, caused by upwelling during the February 2011 king tide (photo courtesy RMIPA).

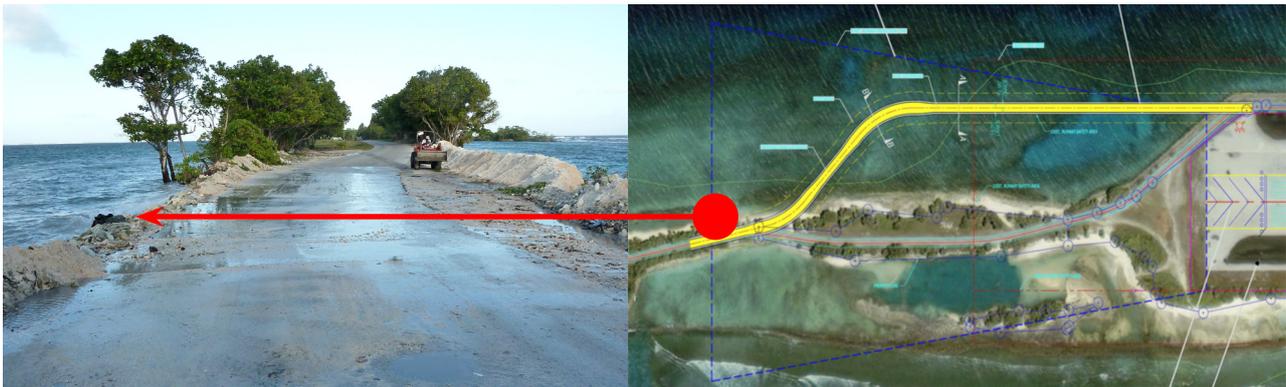
The distribution lines from the airport catchment to Rairok and D.U.D. households were found to be highly vulnerable to tropical cyclones, storm surges and sea level rise. Despite low sensitivity to contact with water, salt or otherwise, scouring of the aboveground roadway and loss of landmass along the lagoon foreshore would expose the underground services lines (i.e. water, telecommunications, electricity) to potential disruption and damage. This has already occurred at one section of the Majuro roadway near the airport (Figure 22).

Figure 22. Erosion at airport road realignment project (images courtesy Murray Ford and MIPA).
