Rehabilitation, Monitoring and Extension of Landfills in an Atoll Environment.

Abstract

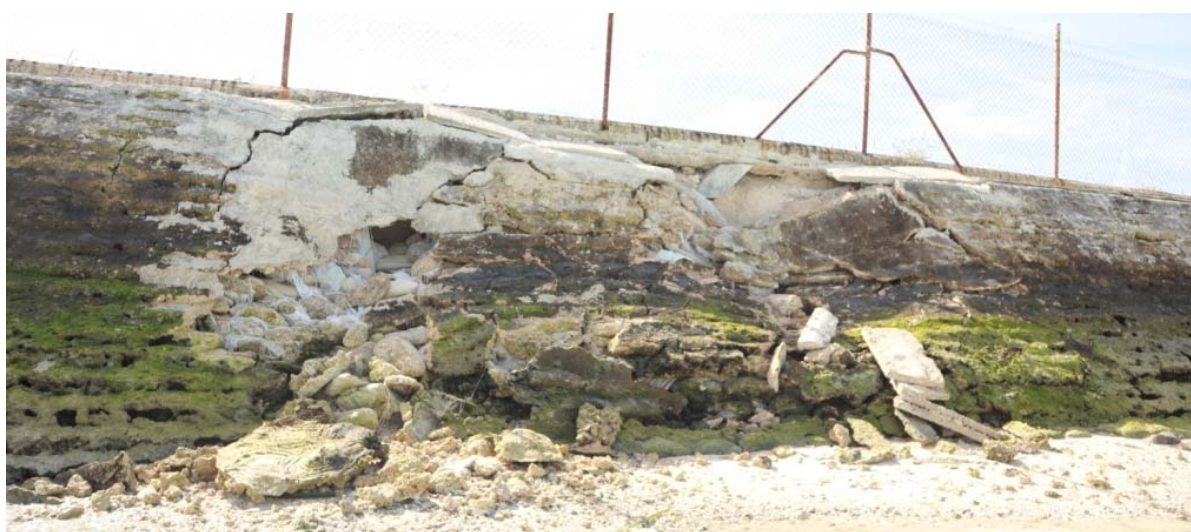
Figure 3 collapsed landfill sea wall at low tide, Bikenibeu landfill, Tarawa

By 2024 the original landfill walls are in various states of repair, and at Bikenibeu the situation is serious, with cracks having been apparent for several years, although some small-scale patching efforts have been made to slow down degradation. In January and February 2024, after sustained - and unusual - west and north-westerly winds during the previous three months, the Bikenibeu landfill wall suffered major damage in three parts, one section very severe. At the time of this wall damage occurring, a new round of tests were conducted to try and determine the impact of this damage, and see if leakage from Bikenibeu was markedly increased. Of particular interest is that Bikenibeu landfill is not yet half full, and still contains a large body of water where the waste dumped has not yet filled the cell to above mean sea level. Figure 3 shows the damage to the landfill seawall, and it can be clearly seen that the concrete skin has no structural support, and is merely resting on the sand wall.

It can be seen that the wall collapses inwards; the black hole - showing a void - at the centre left of the figure shows that there is nothing behind the concrete skin anymore. Two factors may be at work here: that the sea has infiltrated between the gaps in the sand bags that made up the concrete skin, and slowly washed the sand away, as no geo-textile or other membrane was placed under the bags during construction. Also, the passage of leachate through the wall, and the chemical reaction involved, may result in some loss of sand through the calcium carbonate going into solution. Photos taken during the wall construction clearly show that the concrete skin had no structural support whatsoever apart from that provided by the sand underneath. The wall was constructed twenty years ago, and has now reached the end of its life. In spite of this dismal condition of the wall - seen in Figure 3 - the January 2024 water test results at Bikenibeu were largely similar to the 2023 results, themselves not markedly different to the tests conducted a decade earlier.

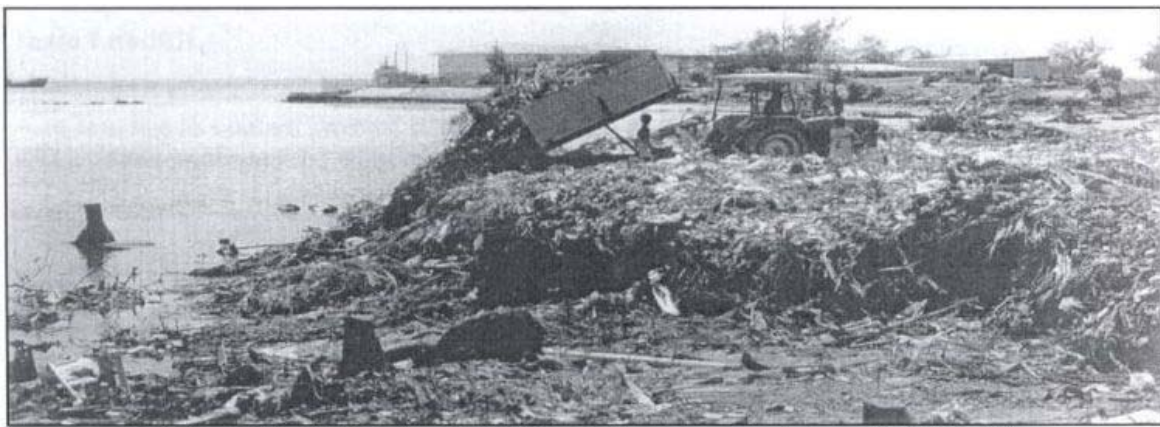
Figure 4 Betio landfill c. 1990 prior to construction of a containment wall in 1997

Two of South Tarawa's three landfills are now full, Betio and Nanikaai. At the third, Bikenibeu, the wall is in a perilous state. A Materials Recovery Facility (MRF) was set up in 2004 on a government-owned site of reclaimed land next to the Port of Betio, where aluminium cans, PET bottles, used lead-acid batteries, e-waste and scrap metals have been processed since 2005. In 2021 Cabinet ordered the recycling operations to vacate the site to allow the Kiribati Ports Authority to expand as the Port itself had become severely constrained. In order to move the MRF and its operations, a new site was required, ideally also close to the Port. Land availability in Tarawa is very tightly constrained, and as noted, Betio Island where the port is located has a population density of over 10,500 persons/km². The existing Betio landfill covers an area of 2.27 hectares, and was enclosed with a wall in 1997 after being an open beach dump for many years prior to that, see figure 4 below. With
