Summary Report – Site Photos and Observations

This report provides photos and descriptions of key waste management facilities and equipment in Tuvalu, as requested by SPREP. The purpose is to highlight the current conditions and identify areas where support and improvements are needed under the GEF ISLANDS Pacific Project.

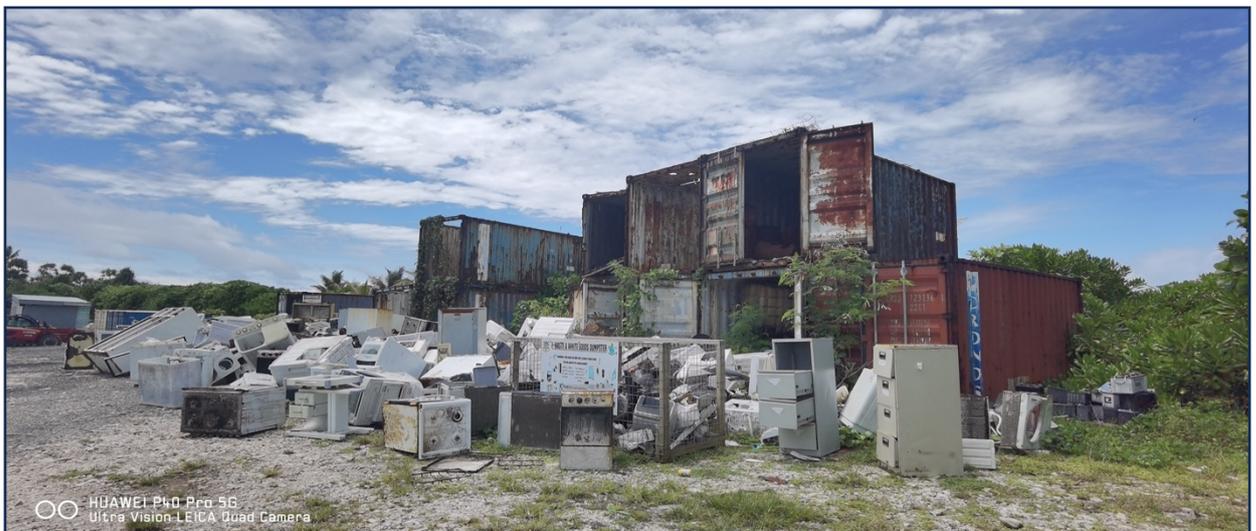
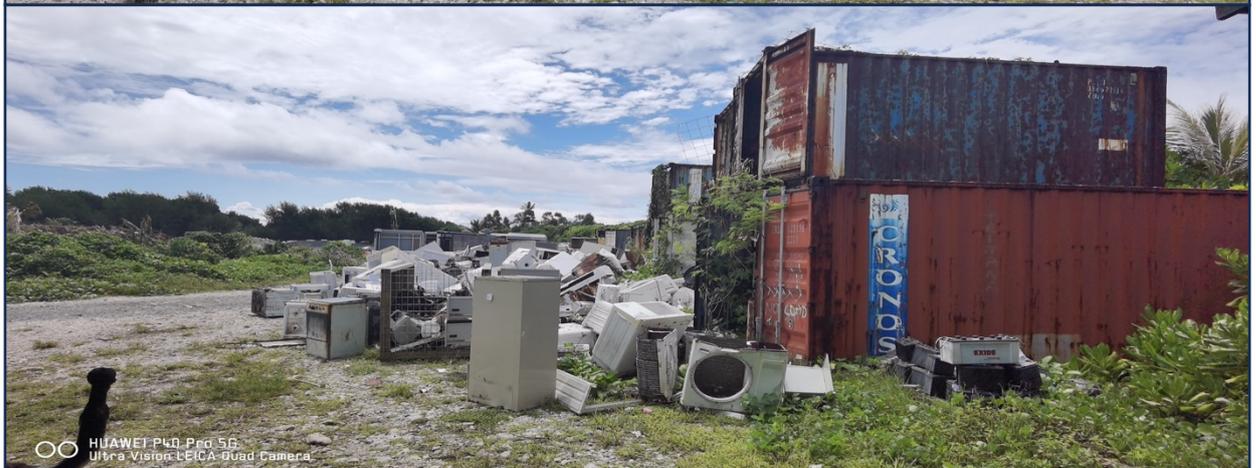
1. Condition of Old E-Waste Containers

- **Observation:** The containers previously used for e-waste storage are now in poor condition. They are rusted, damaged, and no longer secure. As a result, much of the e-waste is dumped outside, exposed to weather and unsafe handling.
- **Concern:** This situation increases environmental risks and is not a safe or sustainable option for storing e-waste.
- **Photo Captions:**

- Containers are no longer suitable for e-waste storage.
- The proposed renovation site requires major upgrades to serve as a safe and secure e-waste facility.
- Oil storage is limited, and there is a strong need for more IBC tanks, safety kits, and spill-response measures.

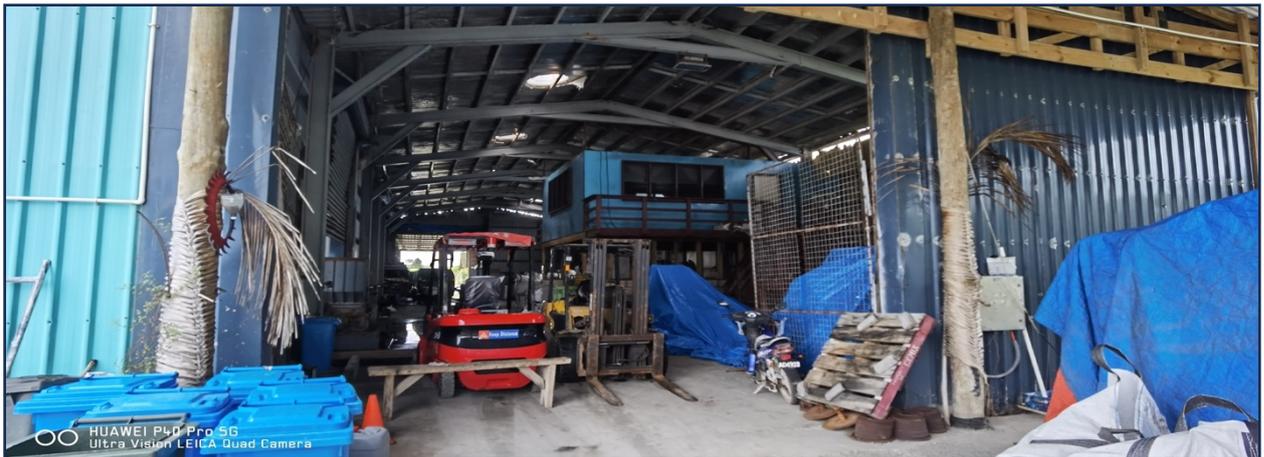
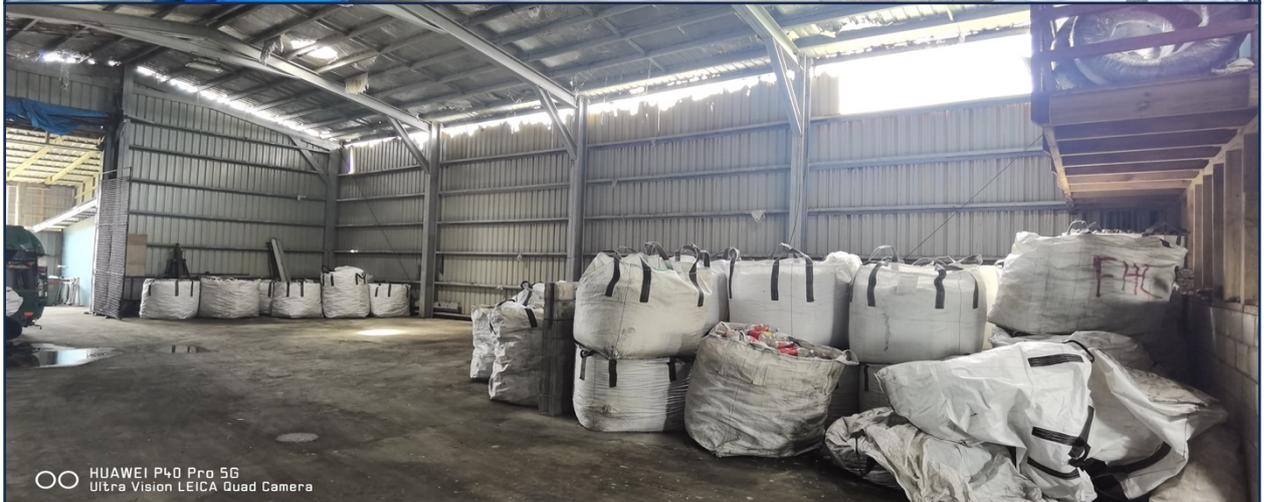
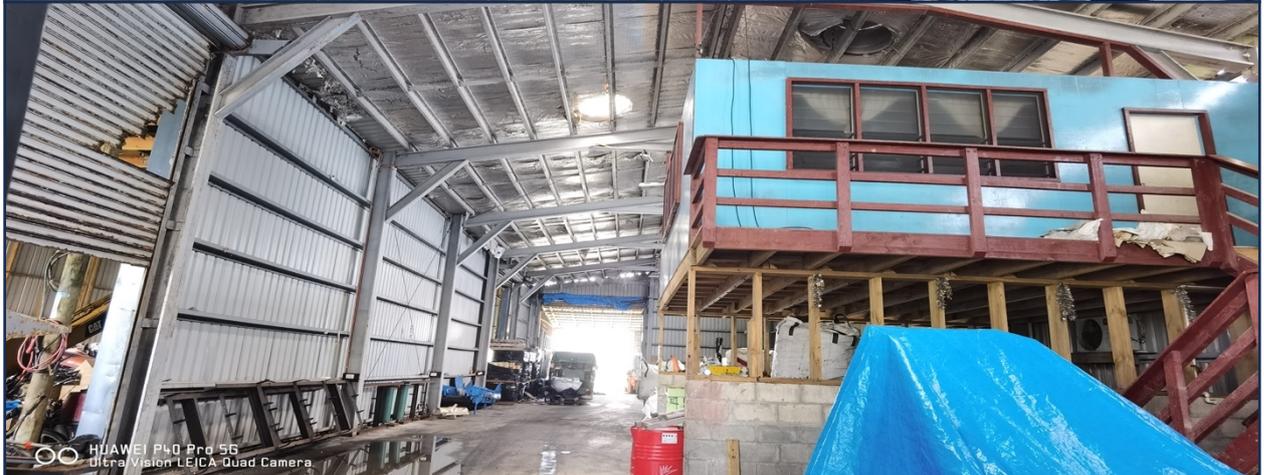
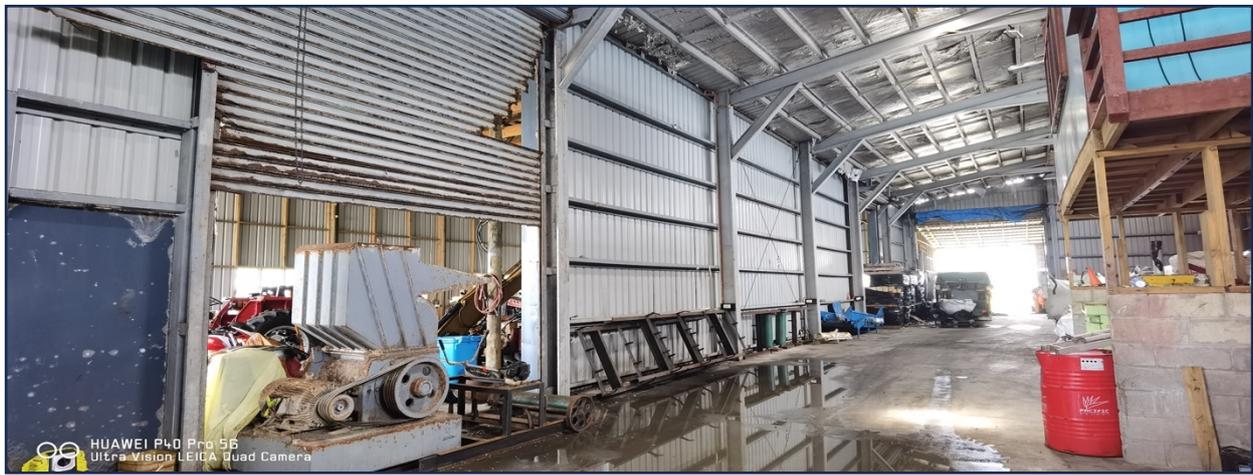
2. Proposed Renovation Area for E-Waste Storage Facility

- 1) **Observation:** The site identified for renovation is currently in very poor condition. It is being used to store mixed waste and is not safe or suitable in its current state.
- 2) **Plan:** With renovation, this facility could serve as the central e-waste storage hub, including space for:
 - a) Safe storage of e-waste.
 - b) Housing machinery such as the e-waste baler, truck, and related equipment.
 - c) Organized preparation of shredded e-waste for export (with the possible use of containers for overseas shipment).
- 3) **Photo Captions:**

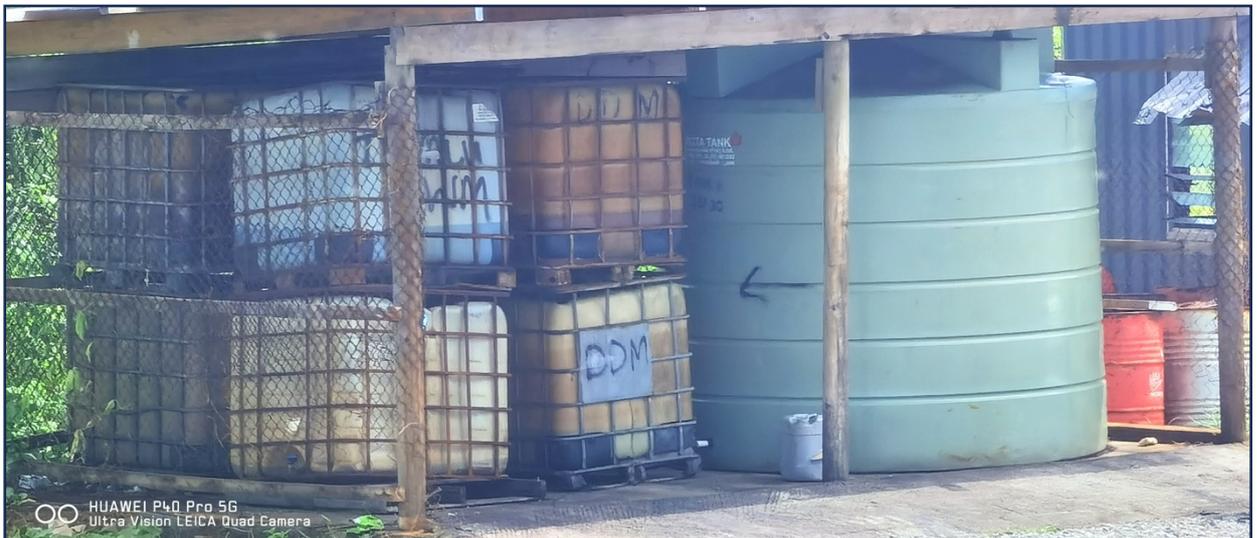
3. Oil Tanks at the Department of Waste Management

- Observation: The Department of Waste Management currently has 8 Intermediate Bulk Container (IBC) tanks for oil storage. Out of these, only 2 are in good condition, while the remaining 6 are leaking and unsuitable for safe use.

- a) Replacement of leaking IBC tanks with new ones.
- b) Additional IBC tanks to increase storage capacity.
- c) Safety kits for handling and transferring oil (e.g., spill kits, absorbent pads, protective gear).
- d) Spill prevention equipment for use at the wharf during loading and transfer operations.
- e) Training and safety support for workers handling oil shipments.
