Landfill Construction, Operation and Leachate Management for Low-lying Coral Atolls

Alice Leney

Pacific Reef Savers Ltd, New Zealand

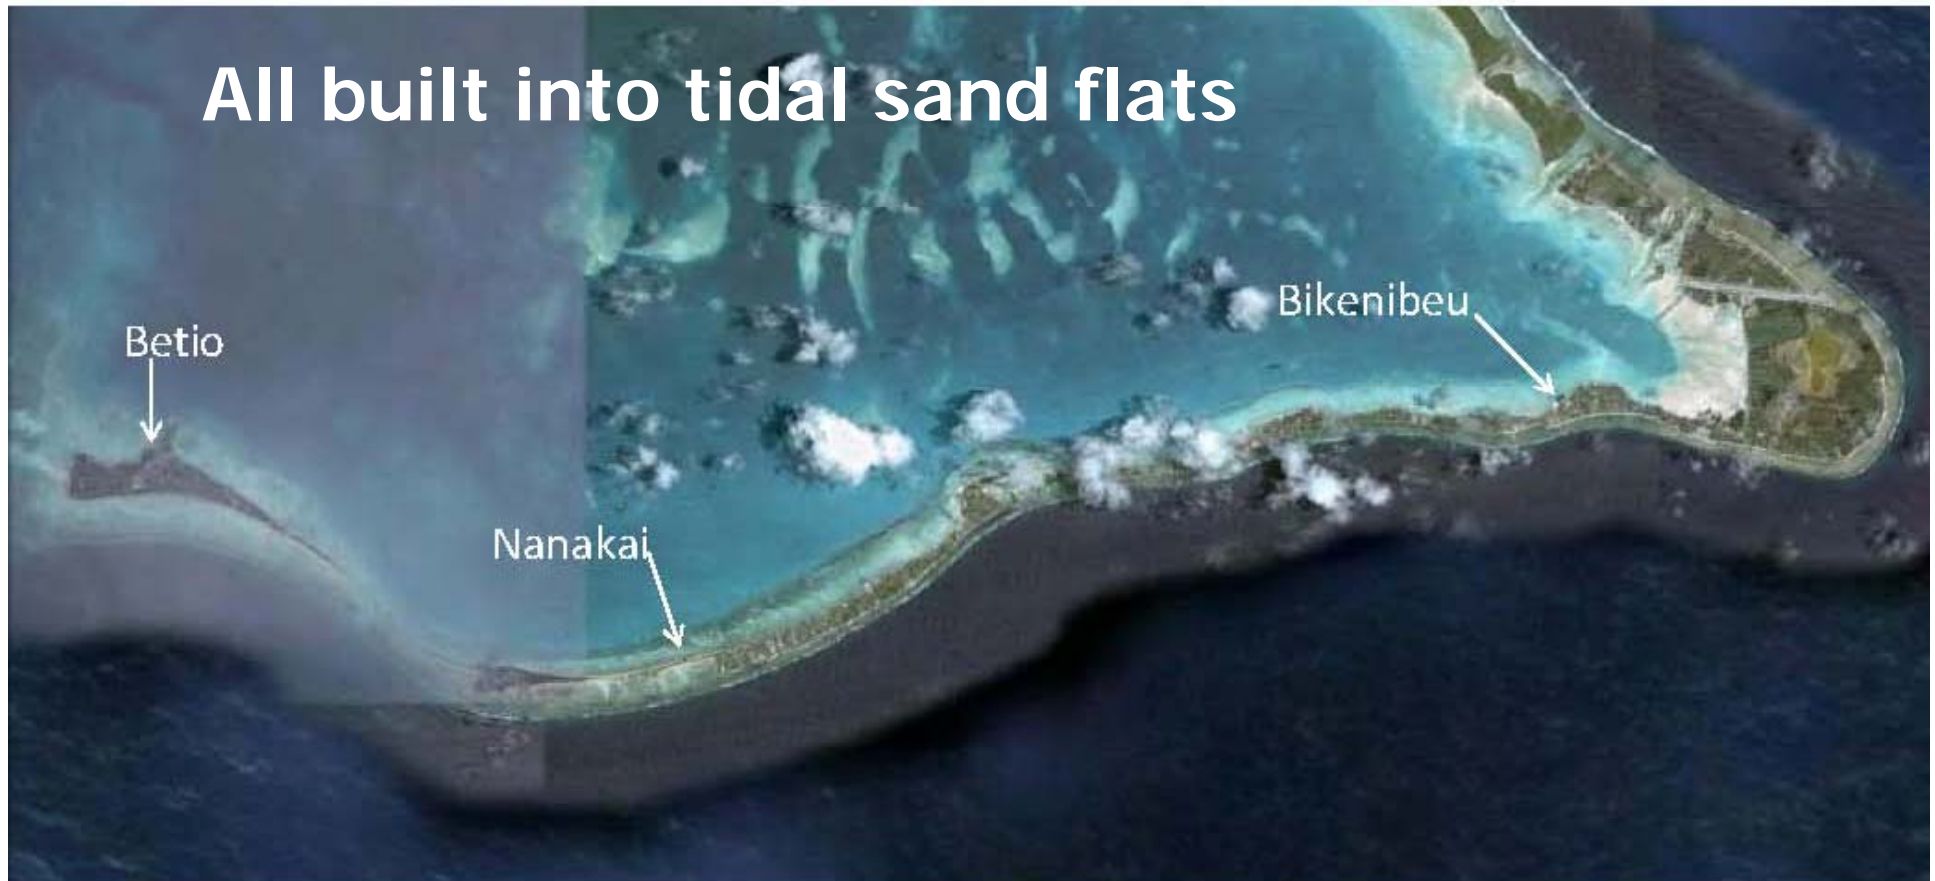
Location of three landfills on South Tarawa

All built into tidal sand flats

1. Betio Landfill: historical sea-side tip, enclosed in 1997;
2. Nanikai landfill, purpose built in 2004, operating for 20 years;
3. Bikenibeu landfill, purpose built in 2004, unused for 7 years, opened in 2012.

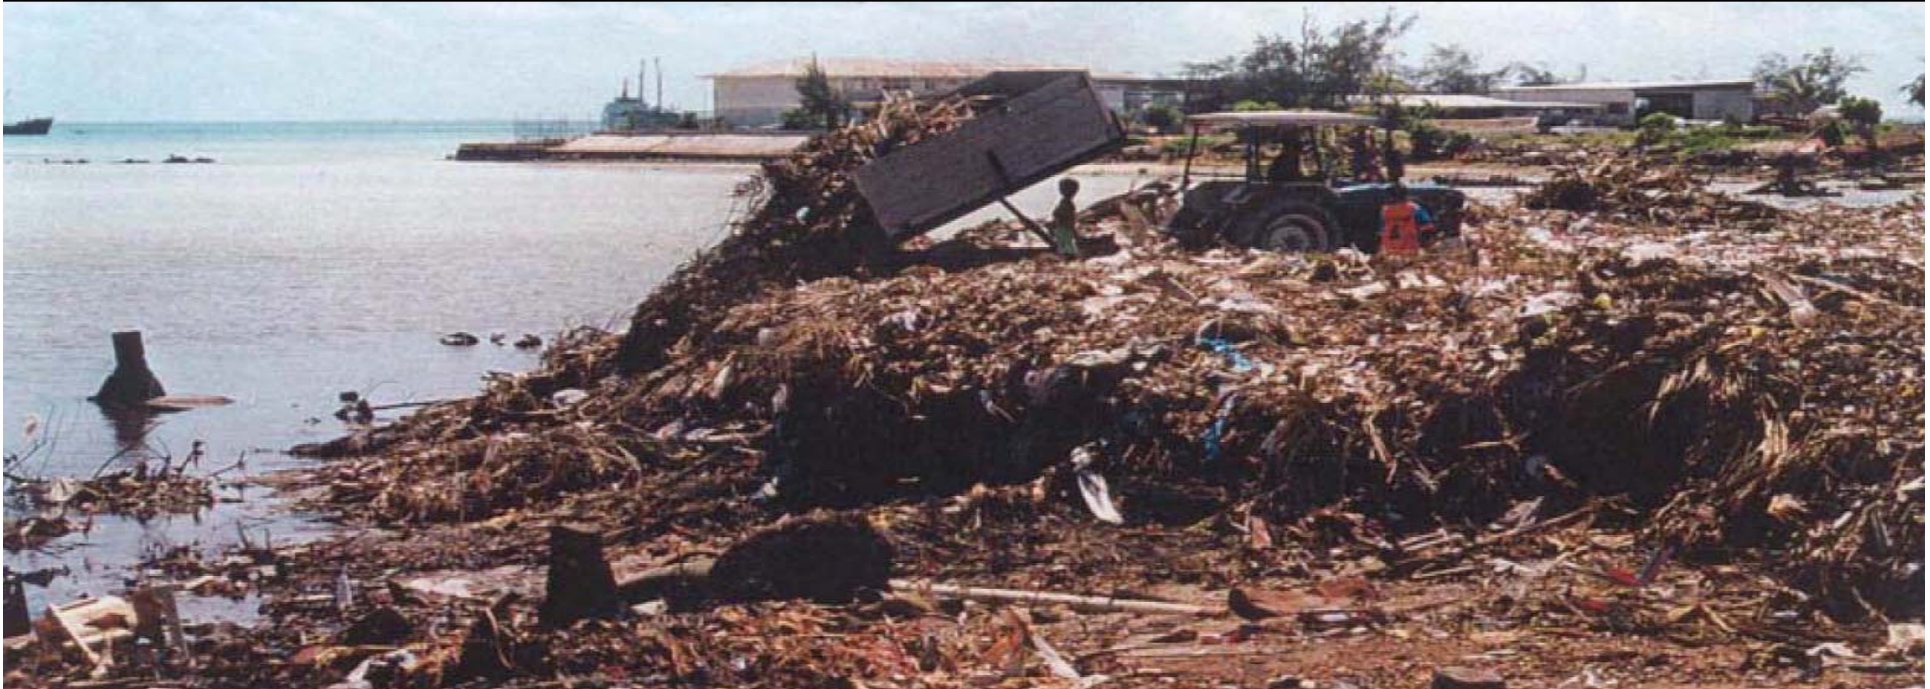
Betio Landfill in 1990

Area was a tip from the beach into the sea; Betio was the only industrial and commercial centre.

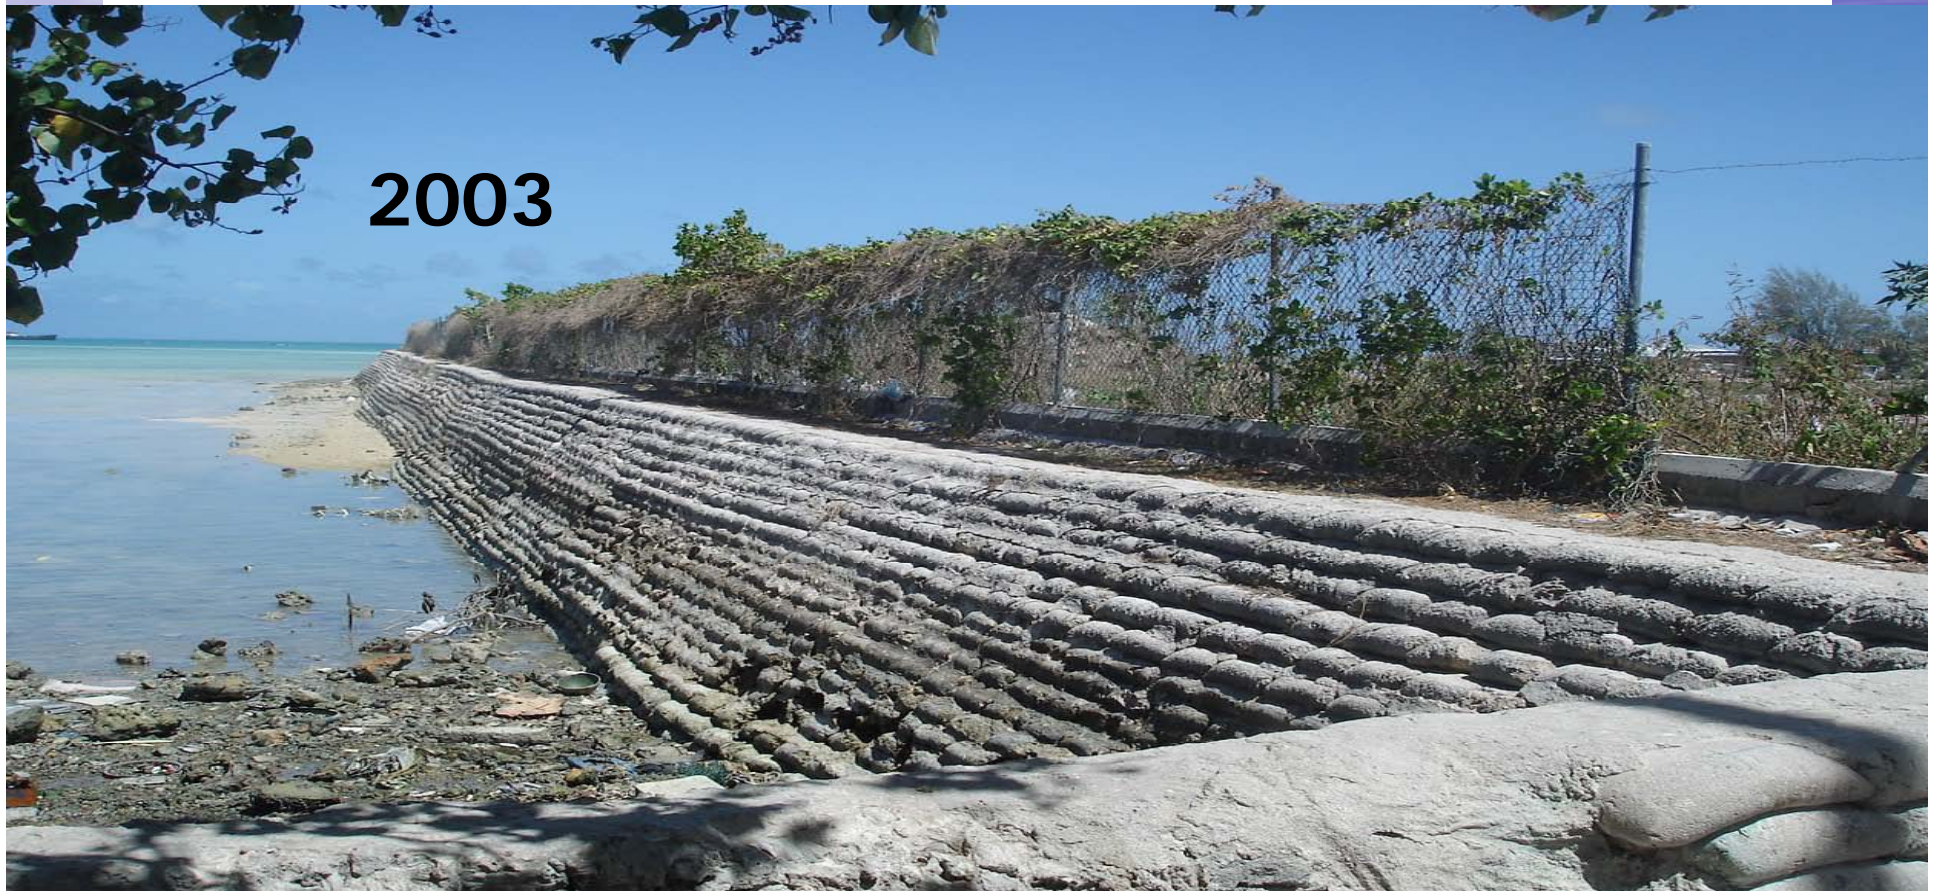
Improvements to Betio Landfill

- Historical tip enclosed by a sea wall in 1997;
- SAPHE project installs fence and leachate pumps in 2003;

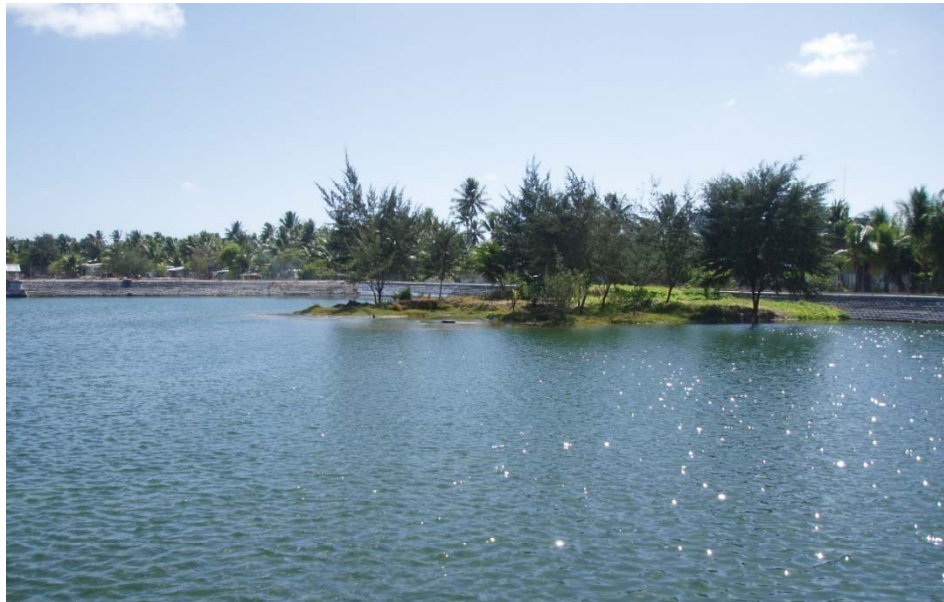
**Bikenibeu Landfill 2010:
Full of water once built;
Used as Fish Farm for
several years**

- Built 2005: remained full of water;
- Opened in 2012 with assistance from MFAT;
- Capacity: 35,000m³
- Current fill rate: around 2,000m³ per year compacted;
- Expected time to fill: 8 years, as long as there are other landfills operating

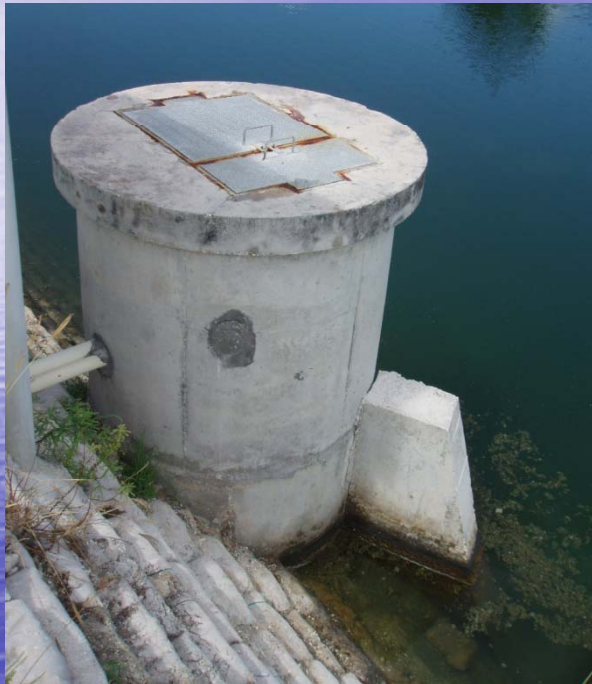
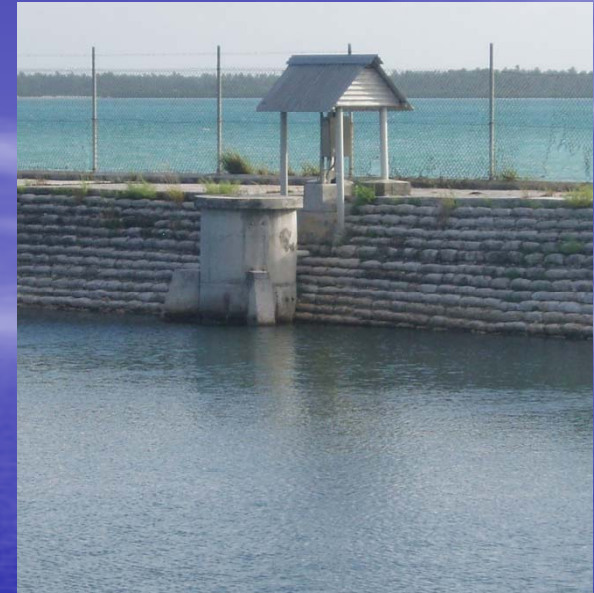
Installed Leachate Systems:

Each landfill had a sump and 2 kW pump with float switch, pumping leachate out of the landfill into the local sewer which in turn pumped untreated leachate onto the ocean-side reef. All quickly failed.

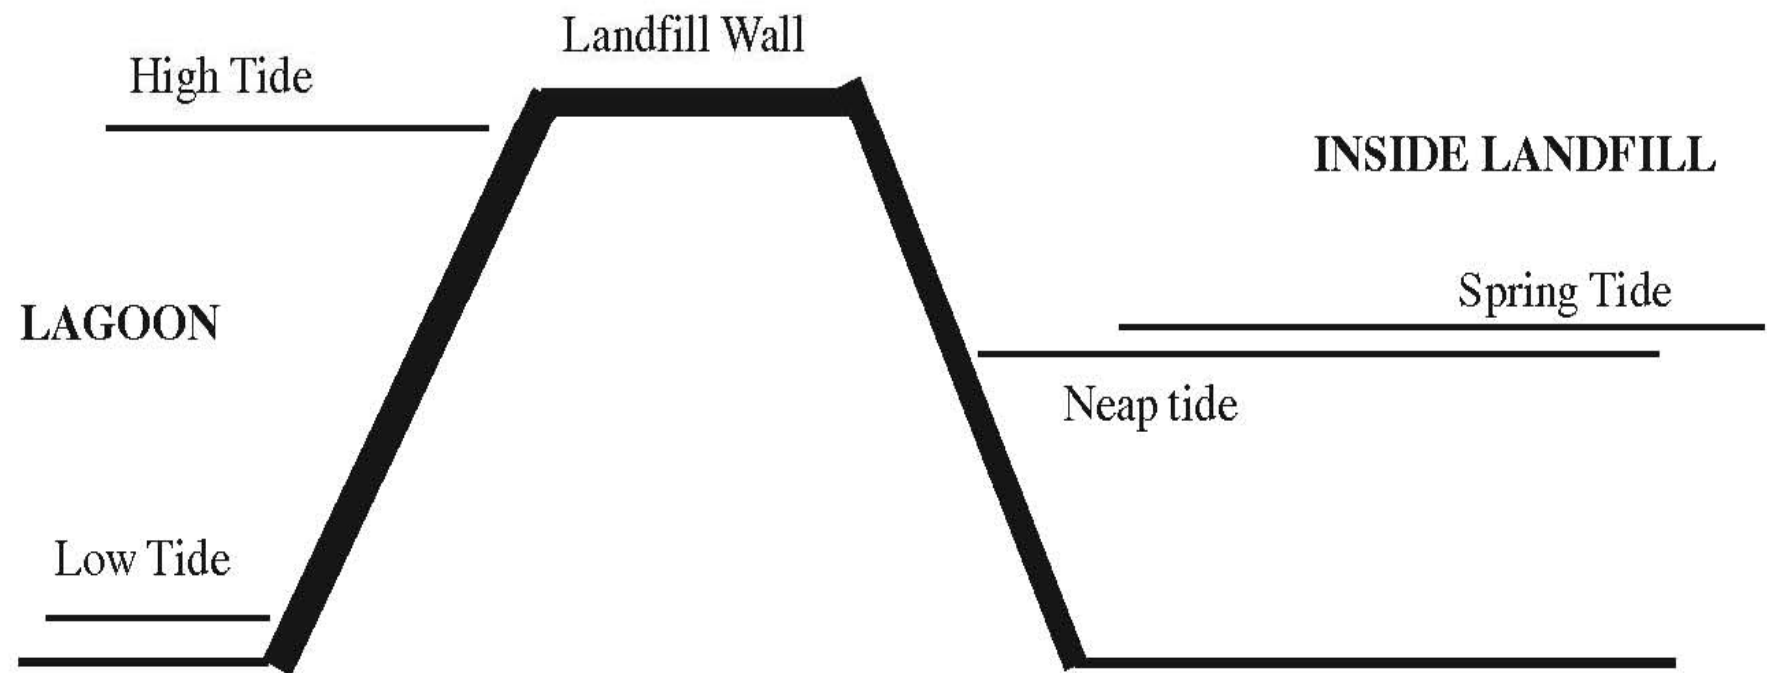
Water Levels in the Landfill

- Water in landfill is above low tide and below high tide;
- During a 10-month drought water level appeared to be stationary;
- Water level did not *appear* to move during a 12-hour tide cycle;
- Local well water is well known to observably move during a daily tide cycle;

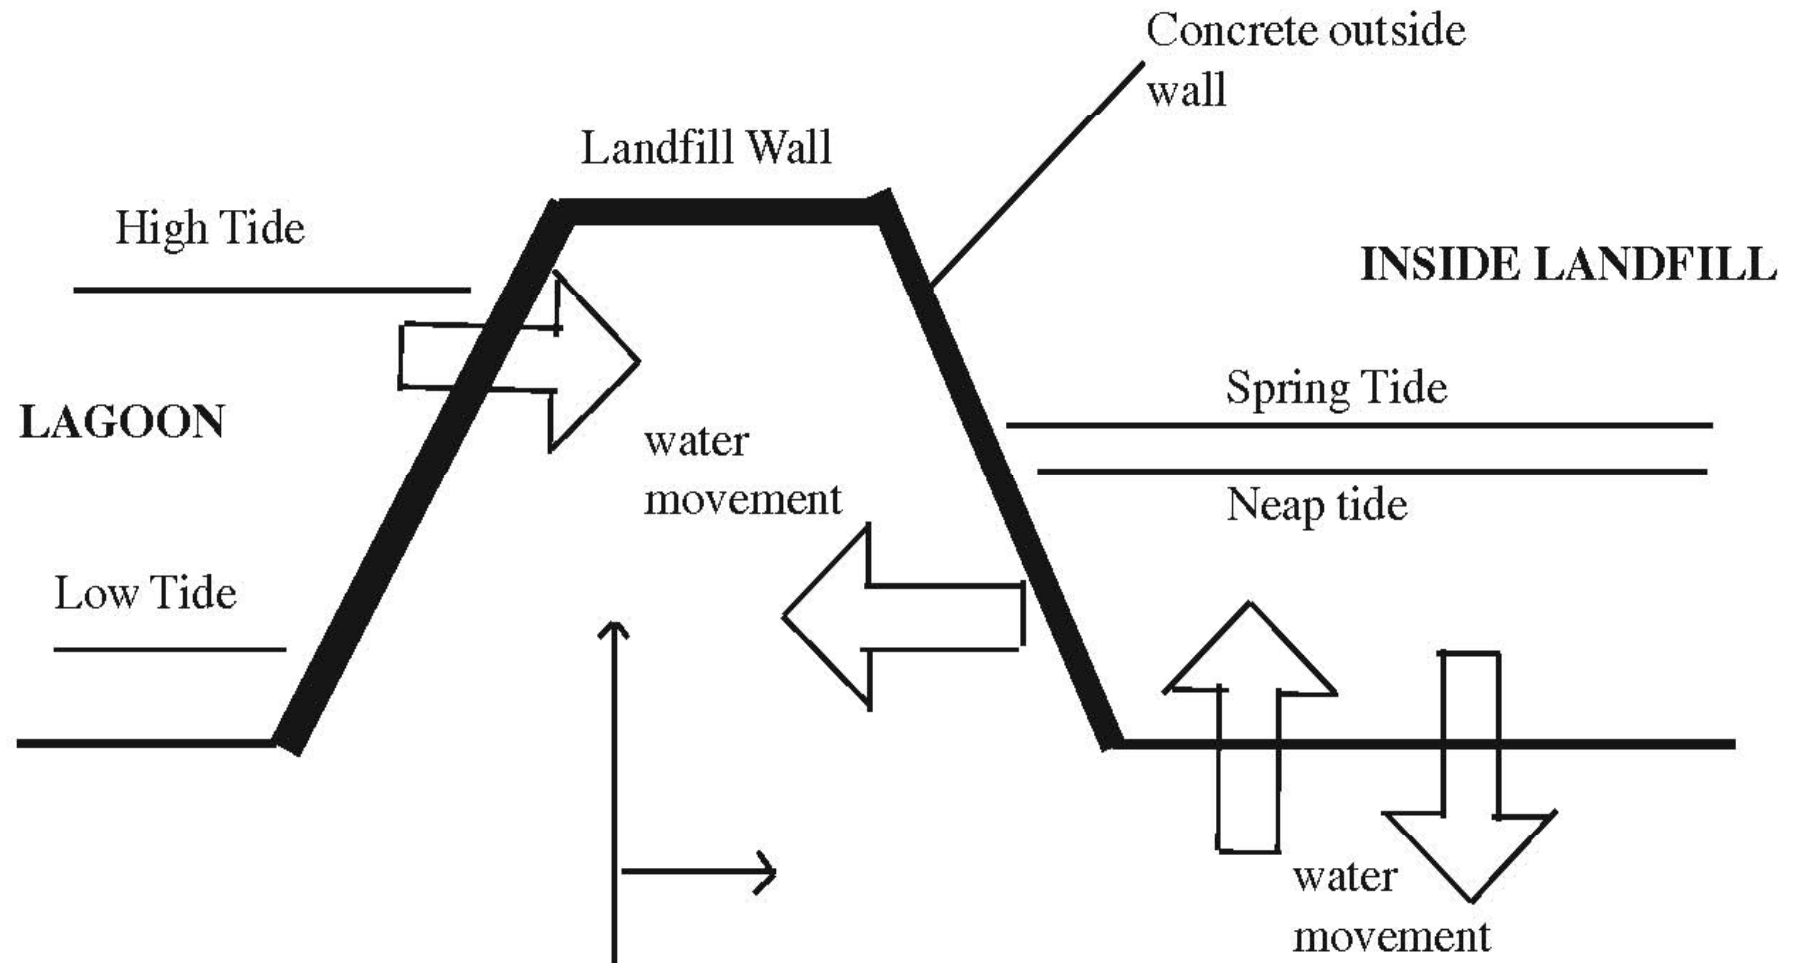
Water movement through the landfill wall

Sand (Calcium Carbonate) inside the wall and the floor of the landfill

- The dataset is very short, ideally would be at least one whole lunar cycle;
- The authors are not water specialists, but have consulted closely with those who are;
- Water is moving across the landfill wall in both directions driven by a hydraulic gradient;
- The landfill wall dampens out the tidal hydraulic gradient to a significantly greater extent than the land dampens the well movement;
- Leachate cannot be pumped out of the landfill, as the sea will come in as fast as you can pump it out.

- The sand-filled landfill walls are acting as a filter;
- Coral Sand – Calcium Carbonate – is chemically treating the leachate;
- It is essential to allow water to move across the wall for landfill operation;
- Landfill wall design and construction must take this into account in this environment;
- Traditional leachate management system of sumps and pumps is no use, will be expensive and cause external pollution.

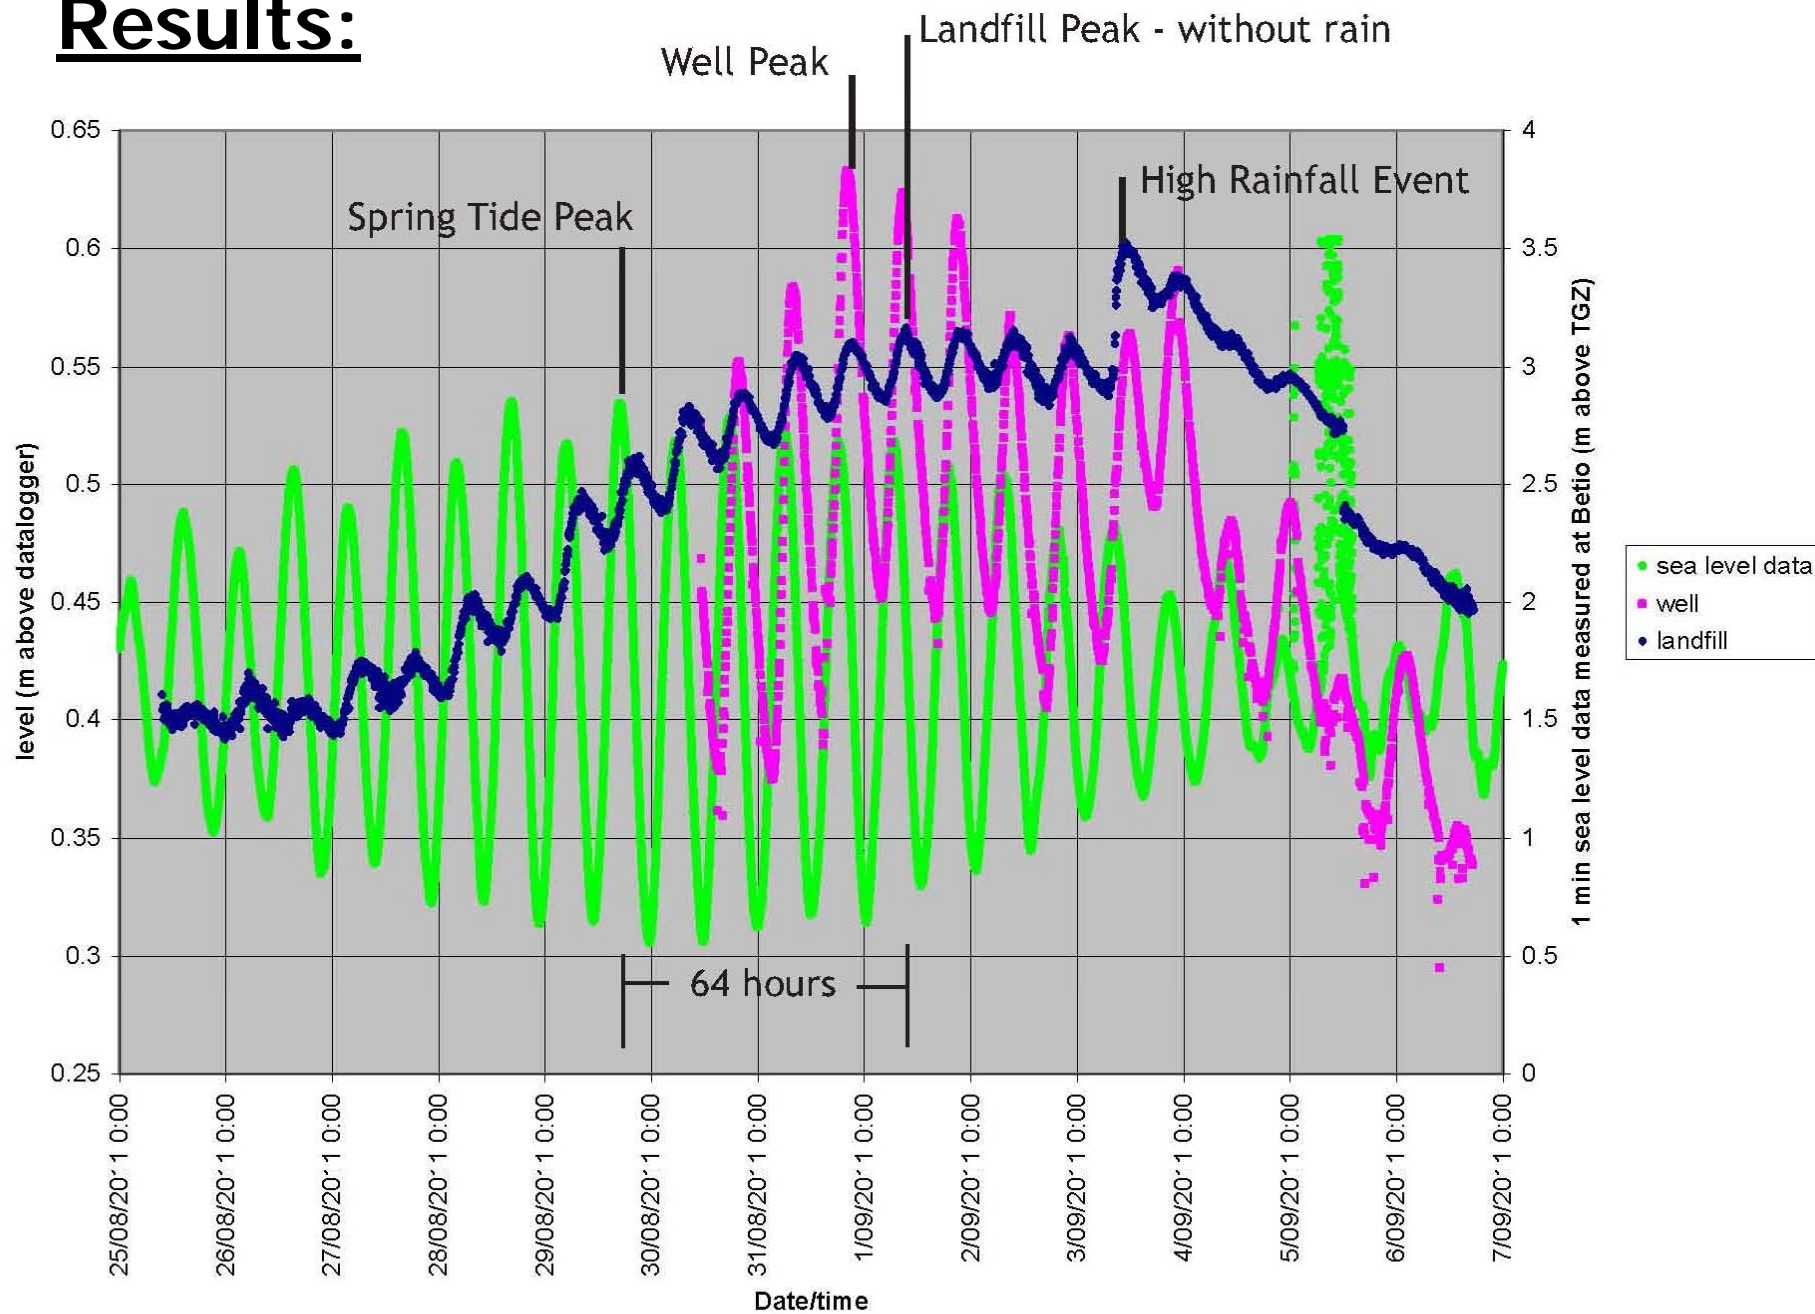
Results:

- a) **Water levels in the landfill vary by about 20 – 40mm (3/4 – 1.5 inches) - without rainfall added - with time taken for maxima and minima change about 6 hours (similar to the tide);**

- b) **Water levels in the well vary by about 200 – 240mm (normally about 200mm) over a similar 6 hr period between maxima and minima;**
- c) **The ratio varies, but is around five to eight times the movement of the well water compared to the landfill water level;**

- d) **The tidal range is of the order of 2 – 2.5m, roughly 100 times the movement of the landfill water, and 10 times the well water movement**
- e) **The peak water levels in both landfill and ground (discounting rainfall) are several days after the peak tide, an unexpected result, but clearly shown from both data loggers.**

- f) **Water levels in both landfill and well are affected by rainfall i.e. the pattern diverges from the modulated tidal changes, for example after the rainfall on 3rd and 6th September.**

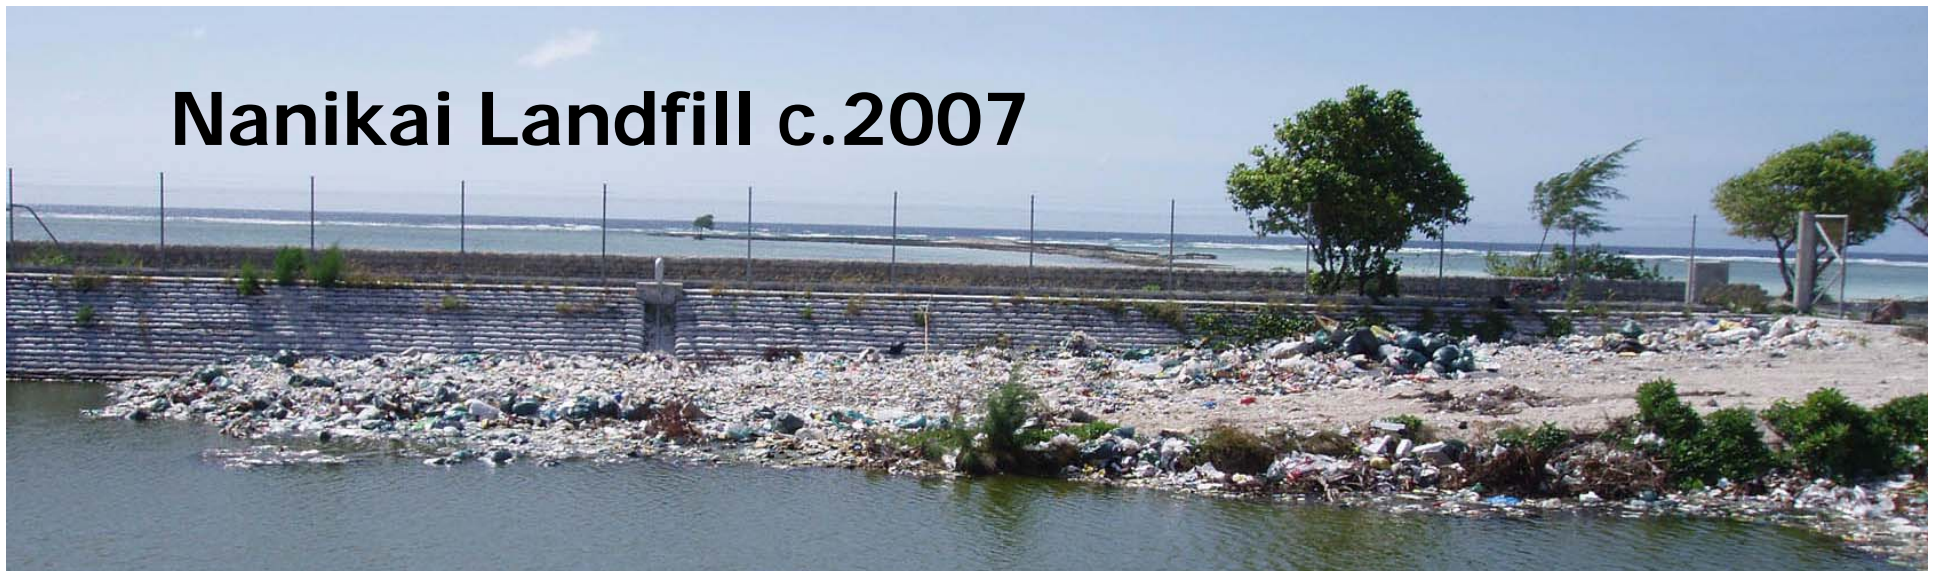
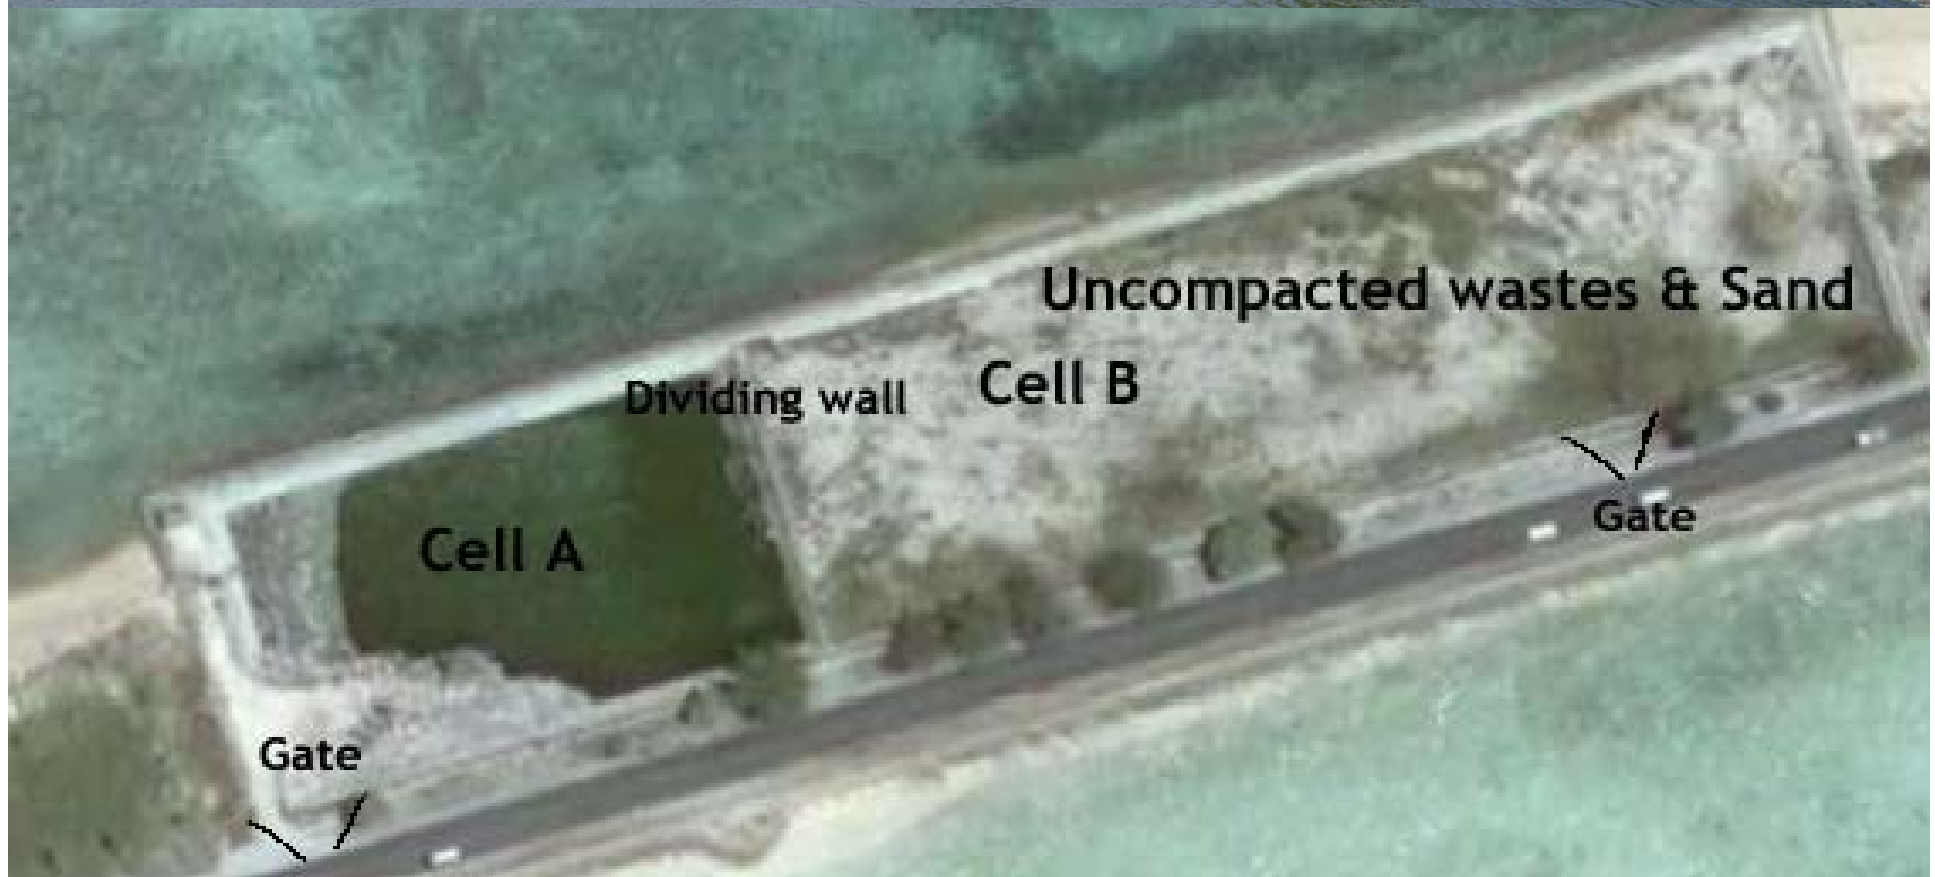
Nanikai Landfill c.2007

- In April 2011 access to landfill no longer possible as waste spilling out of gates;
- From June to September 2011 the east cell was cleared and all waste dumped into west cell;
- Landfill has reached capacity by early 2023

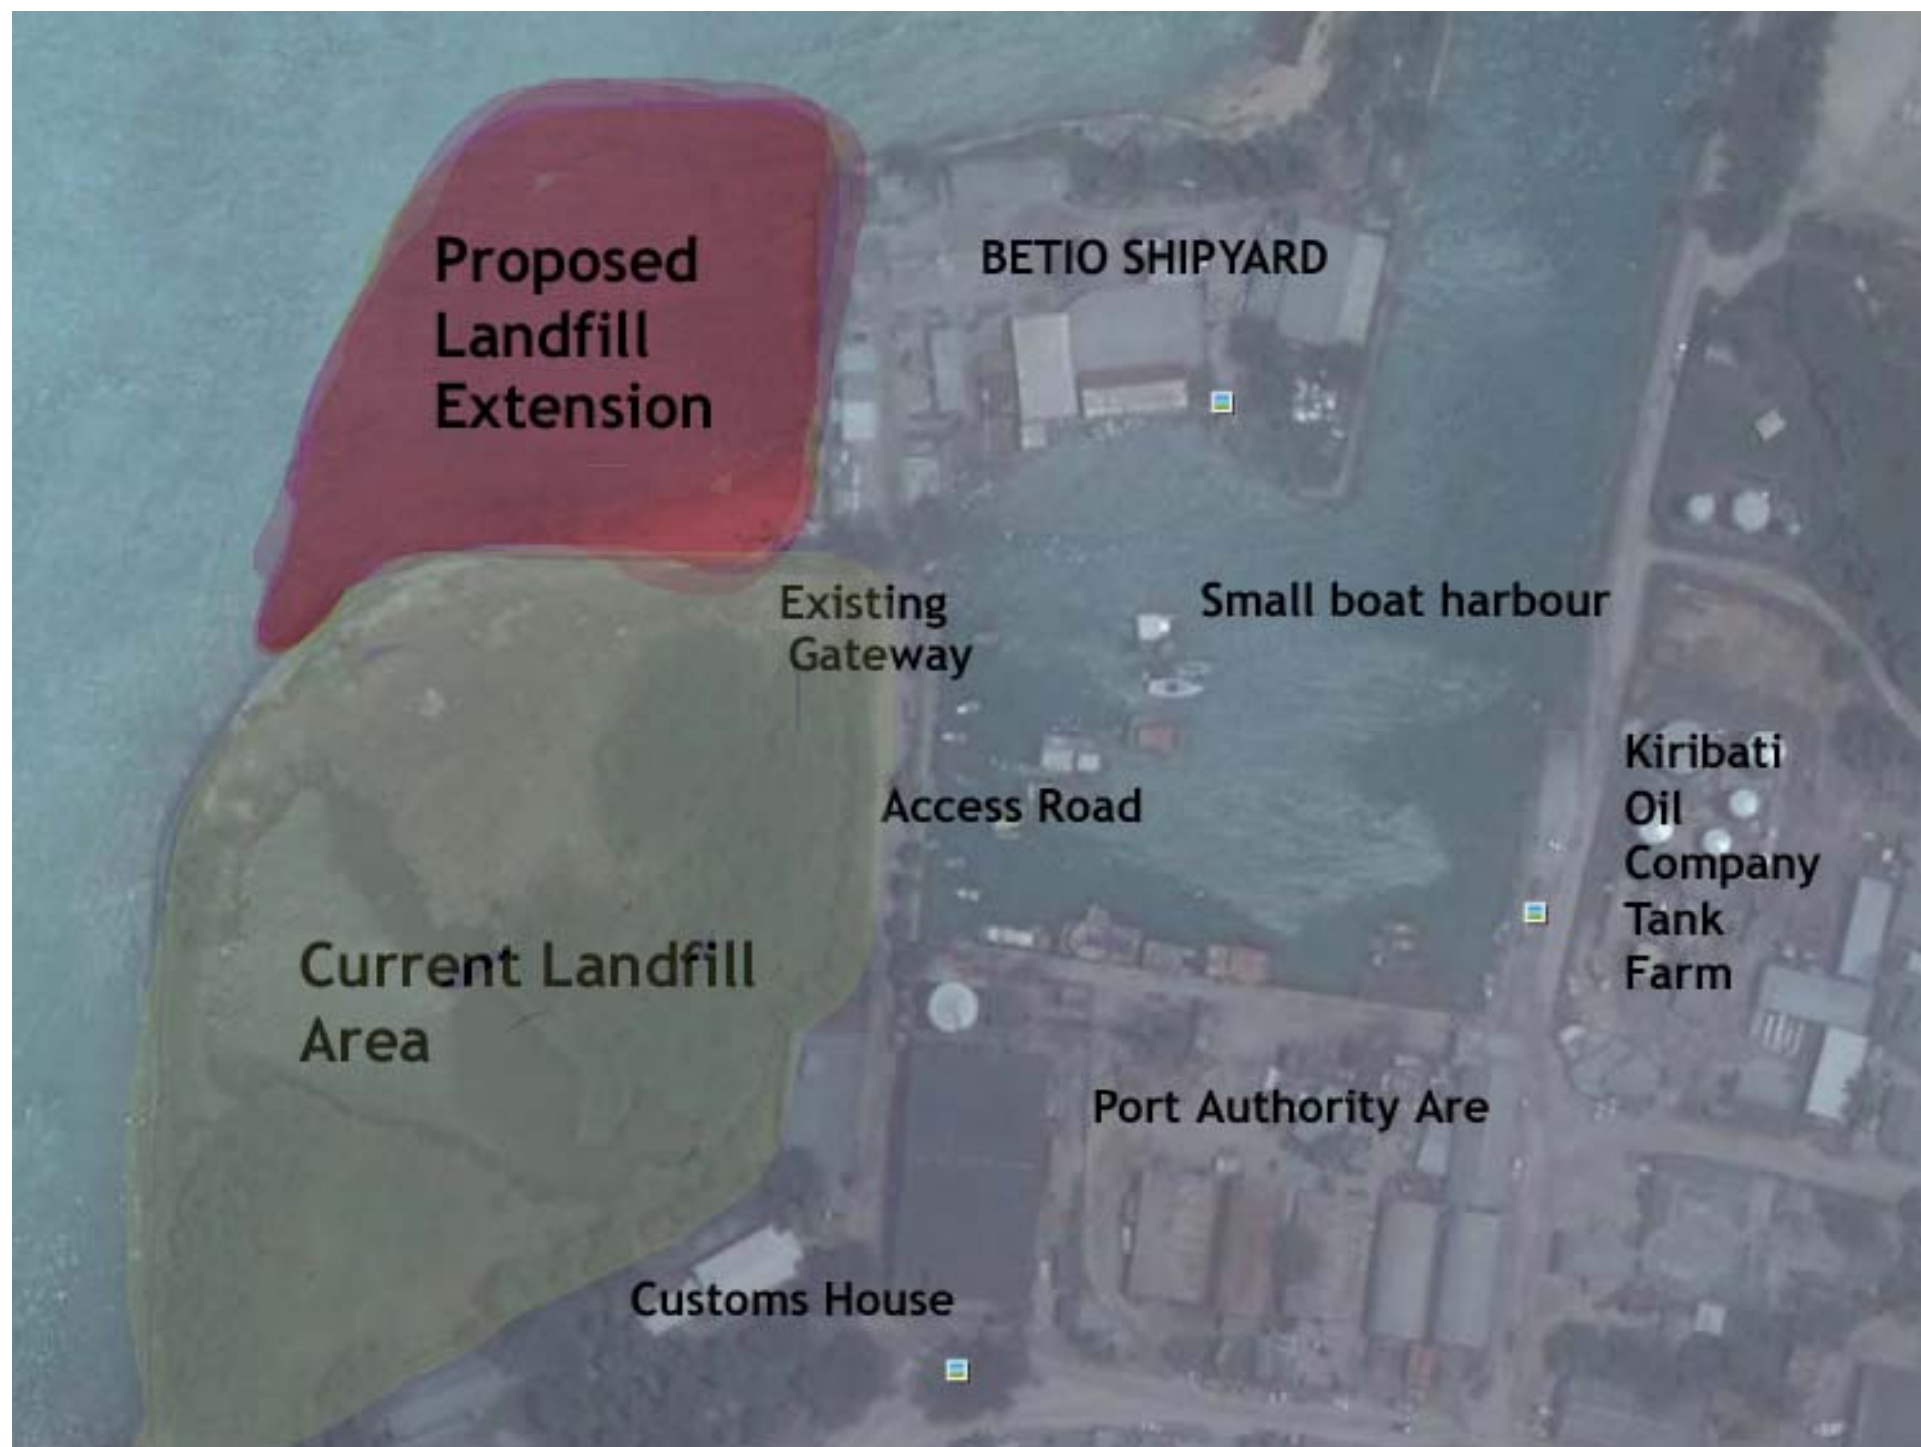
**Proposed
Landfill
Extension**

- Initial capacity: 54,000m³
- Remaining capacity: ? Maybe two years – 3,000m³?
- Betio will need extending soon, expected to the northwards, alongside existing site, using same access road and gatehouse.

**Current Landfill
Area**
