Existing and Proposed Extension to
Gabion Seawall Protection
in Tokelau:

Environmental Impact Assessment

by
Roger McLean

January 1993

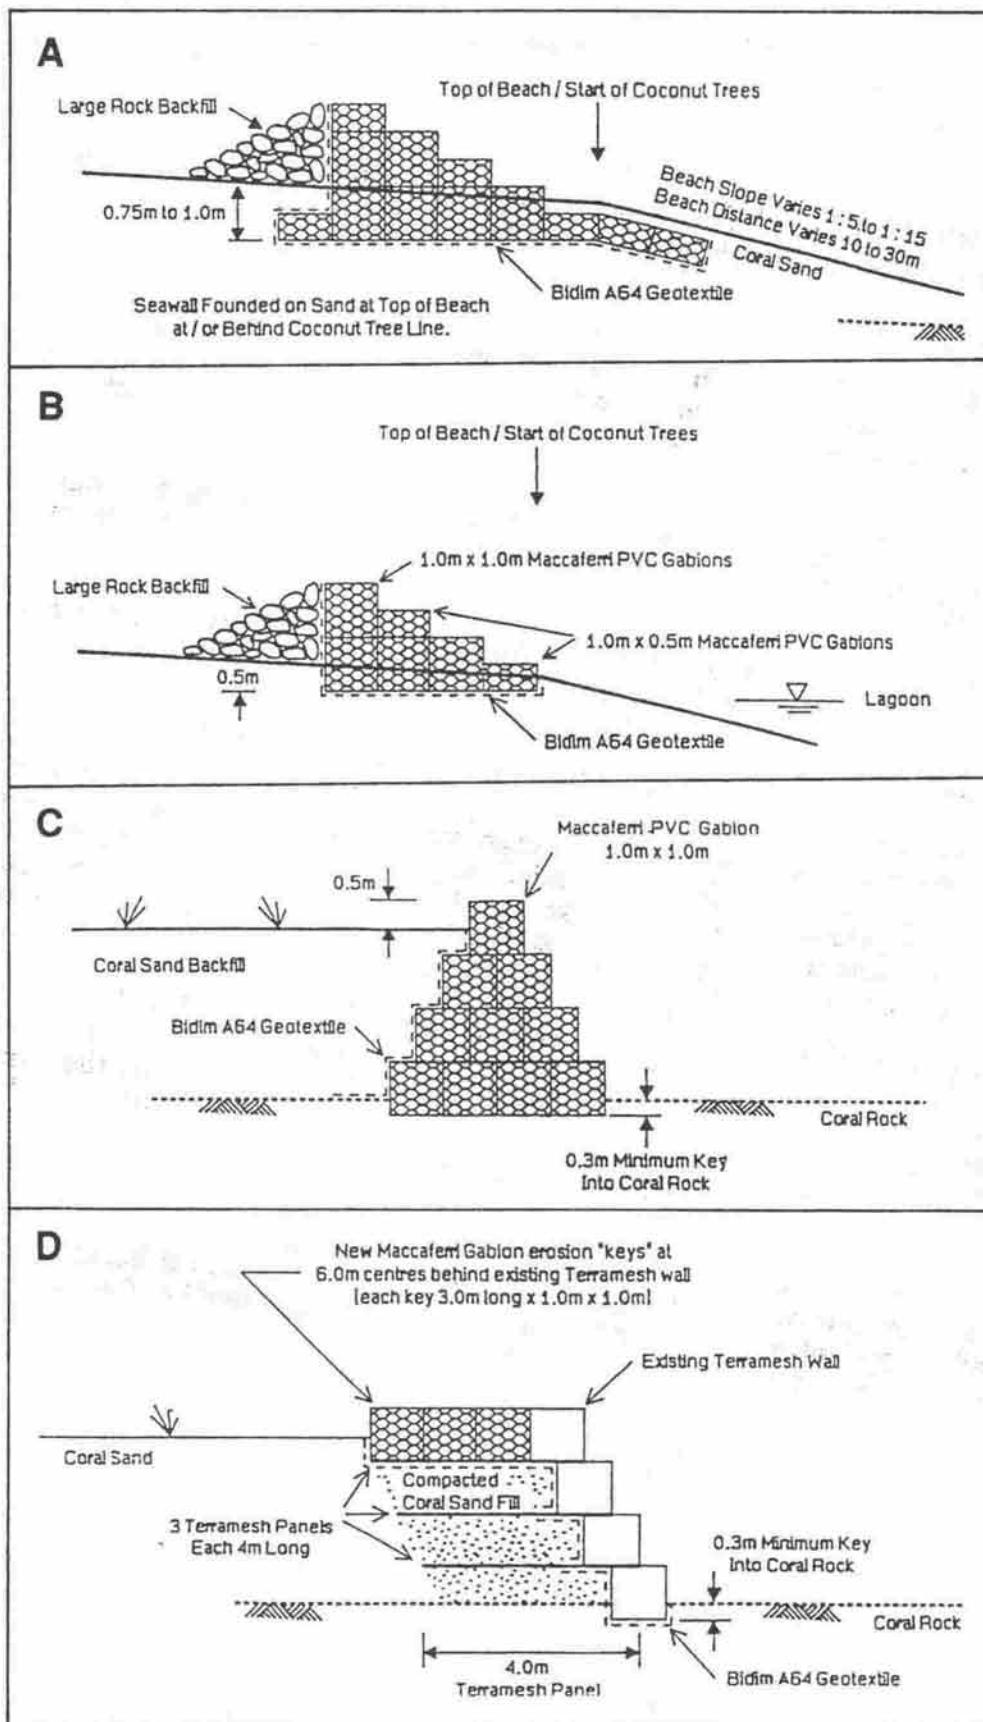
On Nukunonu and Atafu the gabions were designed for placement just inland and above the top of the existing beach to complement and extend the existing beach profile and enable higher energy events to be dissipated whilst ensuring that wave energy reflection would not compromise the existing beach regime. In other words a 'natural' beach was to be maintained against and seaward of the seawalls.

On Fakaofu (Fale) the seawalls were designed essentially as a retention system or physical barrier and retaining structure. This because the natural beach system had already been lost over the years due mainly to wave reflection from stacked coral rubble walls and other shore structures.

Figure 2: Gabion seawall designs for Tokelau.. A. Configuration for foundation on beach sand for oceanside of Atafu and Nukunonu. B. Modified configuration for lagoonside of Atafu and Nukunonu. C. Mass gravity wall for all new construction on Fale (Fakafo). D. Terramesh configuration for foundation on hard coral where no beach exists at Fale showing extra gabion keys. (After Brockliss, 1992).

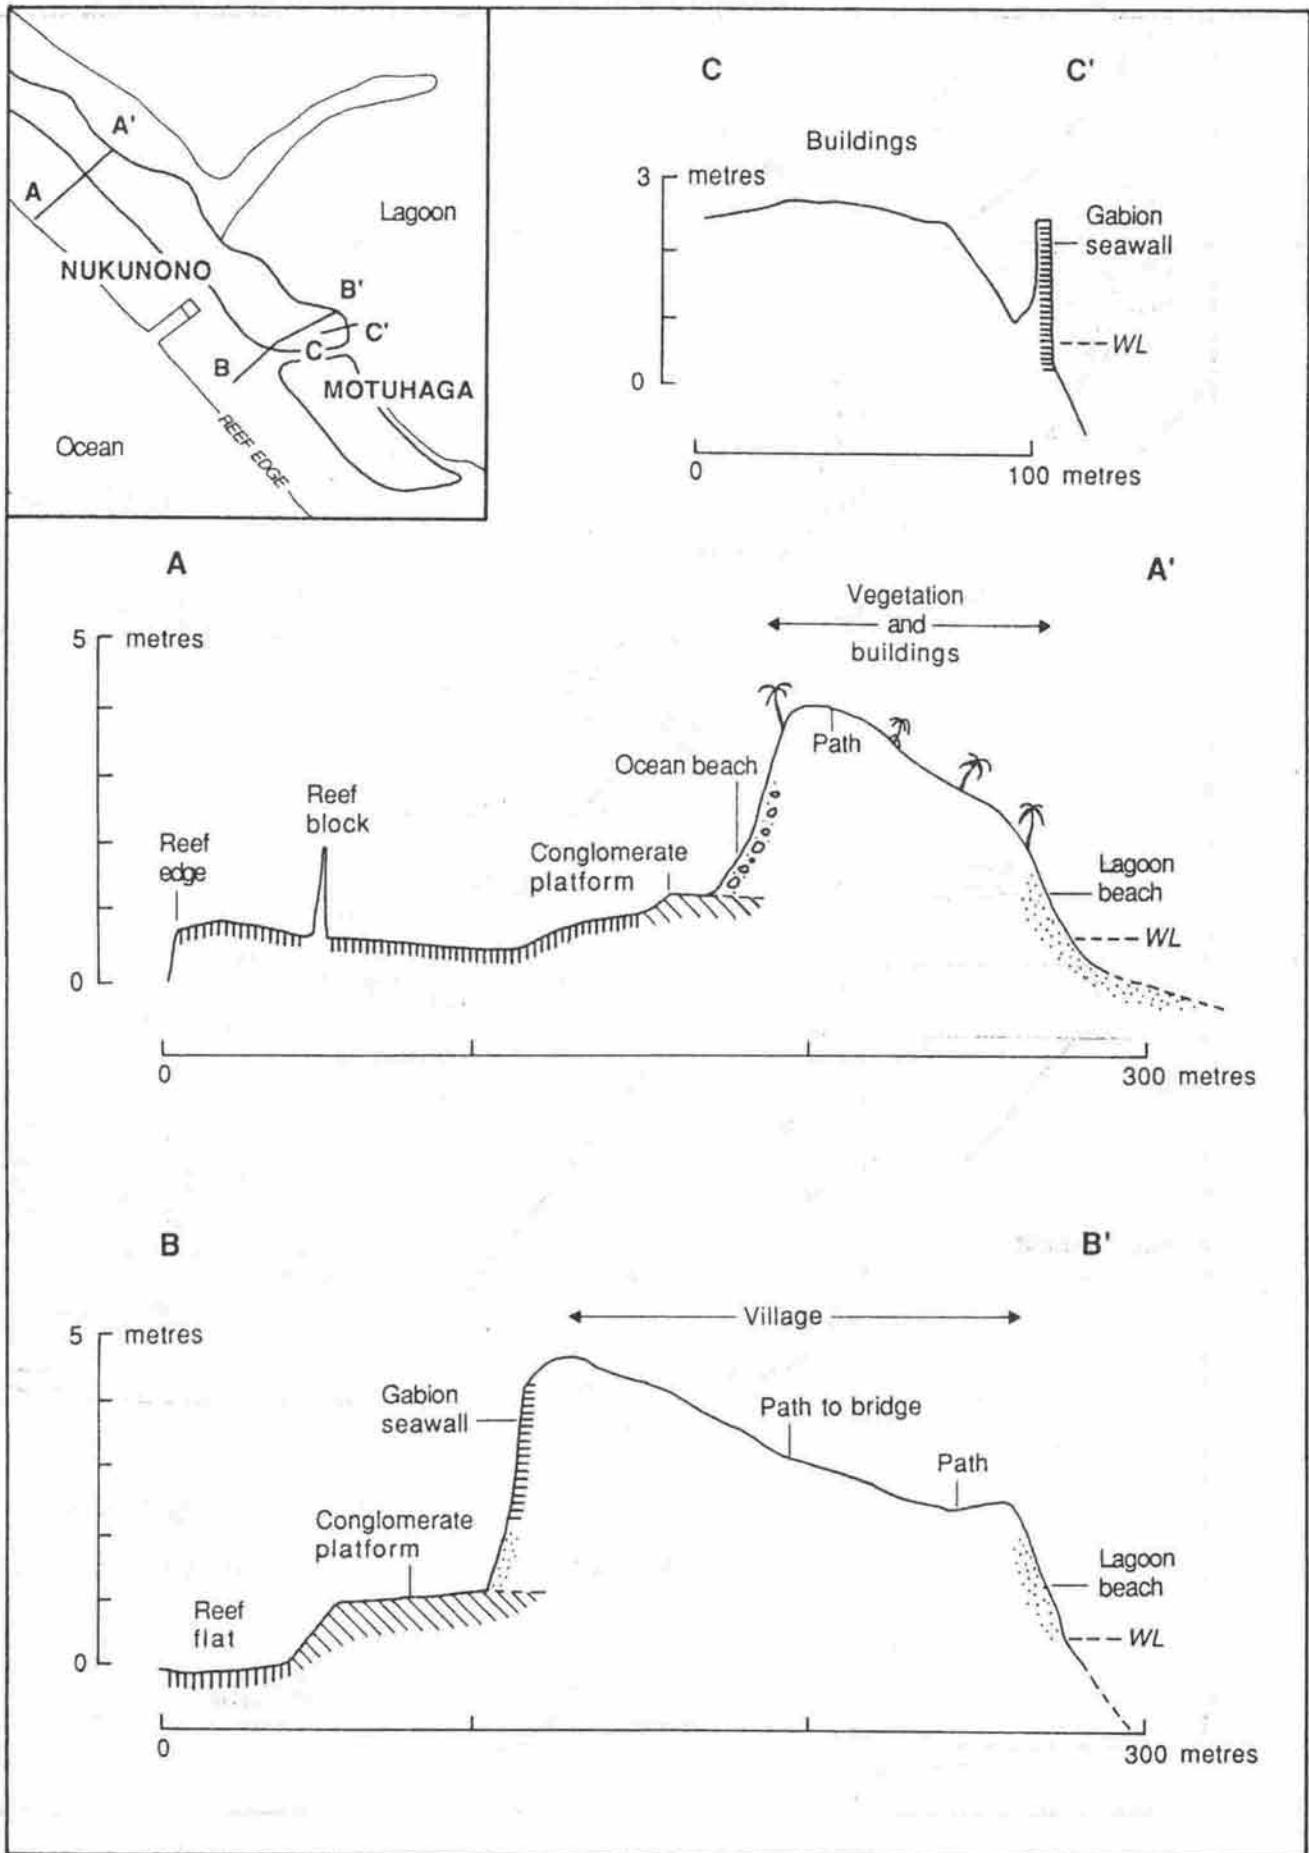
The motu reach the maximum elevation of 3-4 m above reef flat level along the oceanside and the surface dips gradually to the lagoon (Fig. 8). Outcropping along the oceanside is a 10-50 m wide solid conglomerate platform which separates the active reef flat from the beach. The islands have been built on this platform which is not exposed on the lagoonside. Large exposures of conglomerate platform occur on the reef both to the north and south of the village motu.

Figure 8: Nokunonu surveyed cross-sections. Transect B passes over the section of seawall shown in Fig. 9C and transect C includes the seawall shown in Fig. 9F.

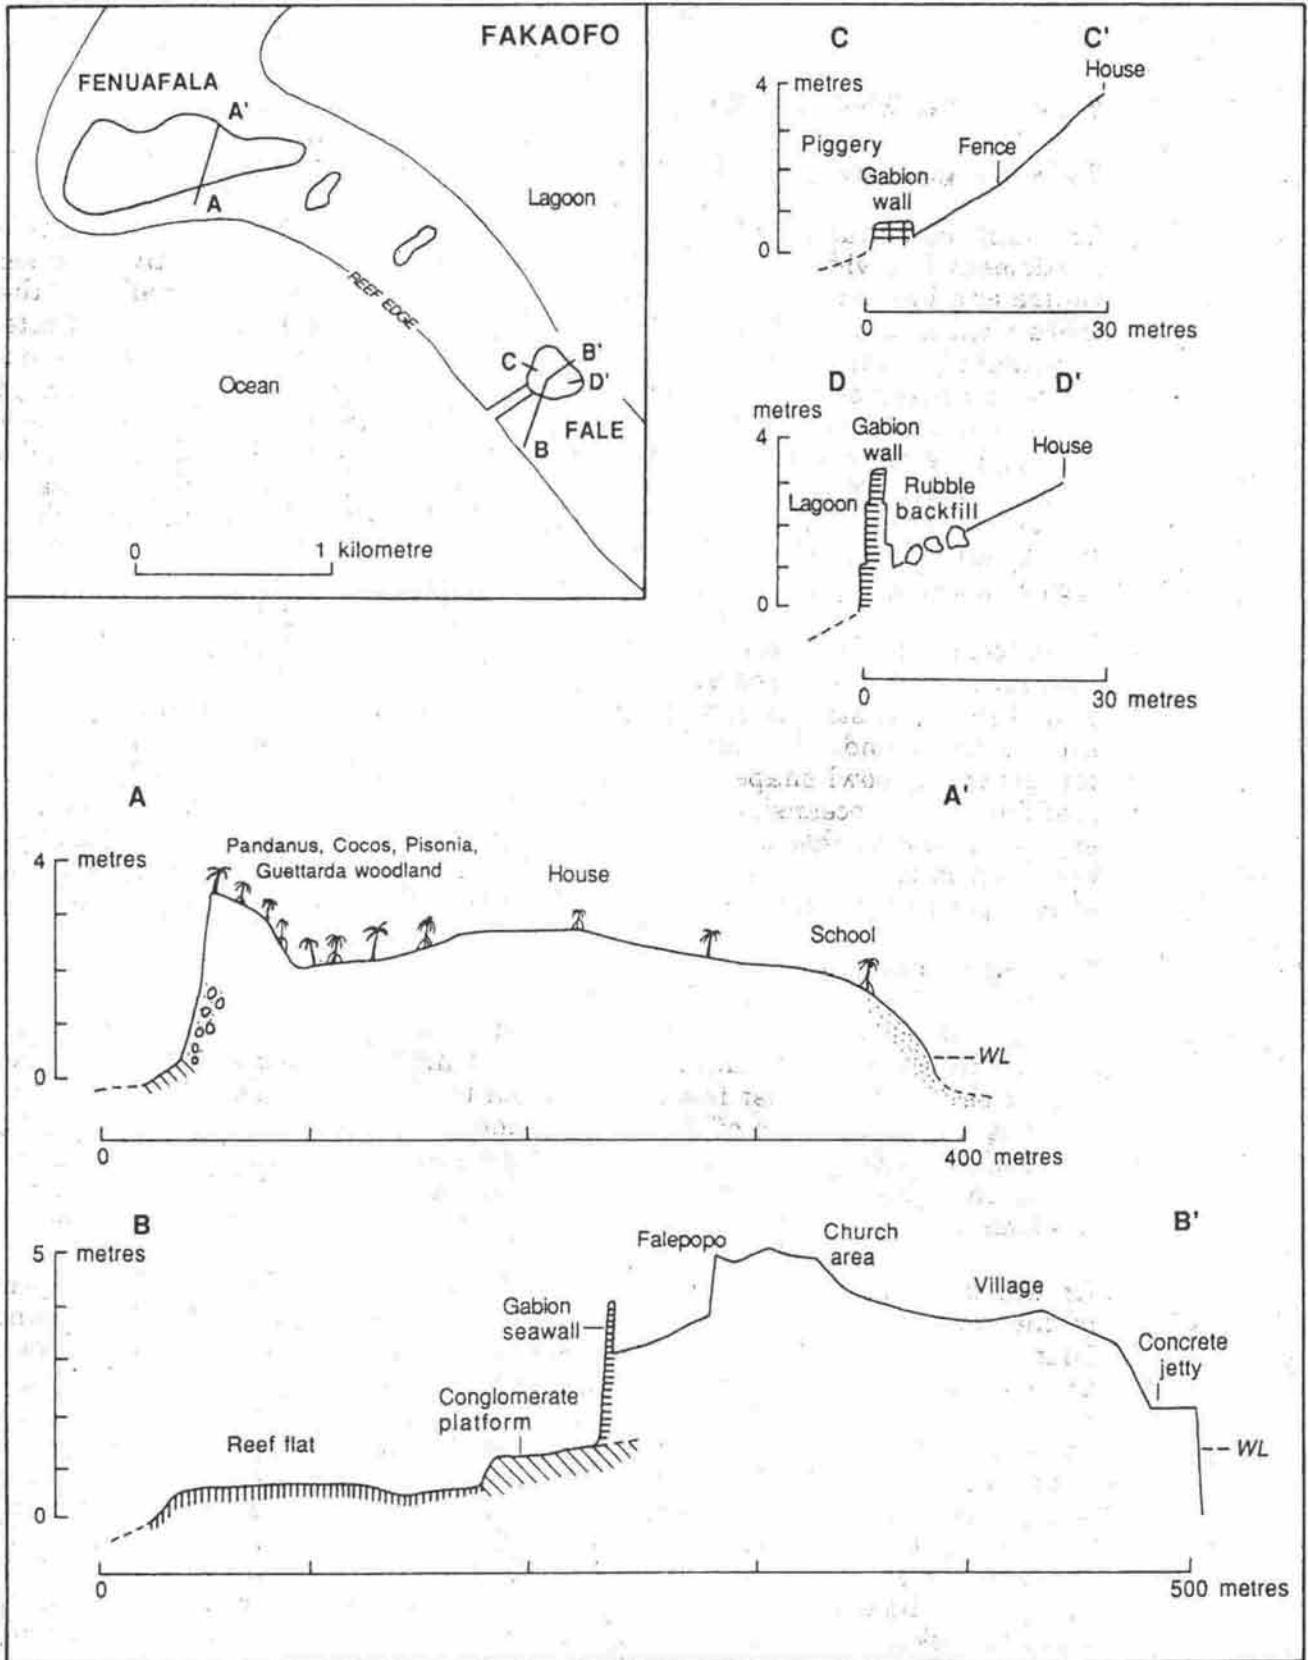
The lagoon shoals towards Fenuafala and there is evidence to indicate that sedimentation is continuing to the west of Tuimanuka reef and along the island's lagoon shore. Southeast from Tuimanuka the lagoon deepens such that on Fale there is an abrupt drop off from the island into the lagoon. Along the southern shore of Fenuafala drift is directed eastwards and the island is continuing to build out in that direction. Between Fenuafala and Fale net drift also appears to be predominantly from west to east, that is from the oceanside into the lagoon.

Figure 10: Fakaofu: Surveyed cross sections on Fenuafala and Fale.
