# Vulnerability and adaptation (V&A) assessment for the water sector in Majuro, Republic of the Marshall Islands

Vulnerability and adaptation (V&A) assessment for the water sector in  
Majuro, Republic of the Marshall Islands. Apia, Samoa : SPREP, 2014.

p. cm. (PACC Technical Report No.5)

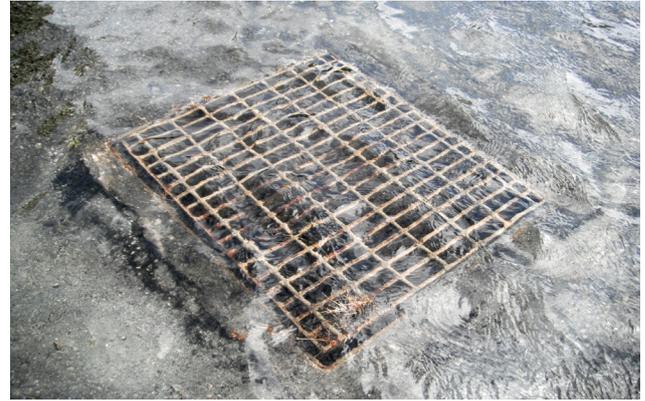
There are rainwater collection depressions along the length of both shoulders of the runway. Each depression has a screen-topped sump (Figure 7) and reticulated piping that directs water eastwards under gravity to the next

Figure 7. Screen-topped sump.

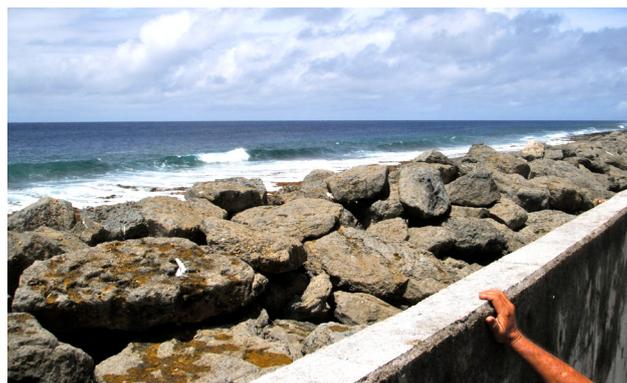
The runway catchment is protected by armor rock across both ocean and lagoon coastlines. The ocean side is protected by a 20 cm thick, 1.5 m high concrete wall (Figure 8) that was constructed after a 1992 typhoon. After its construction, a 15 m section of the wall was damaged in 1995 due to heavy seas, and subsequently repaired. There is also a 1 m security wall with fencing buffering the catchment on the lagoon side (Figure 9).

Figure 8. Ocean-side concrete wall and armor rock.

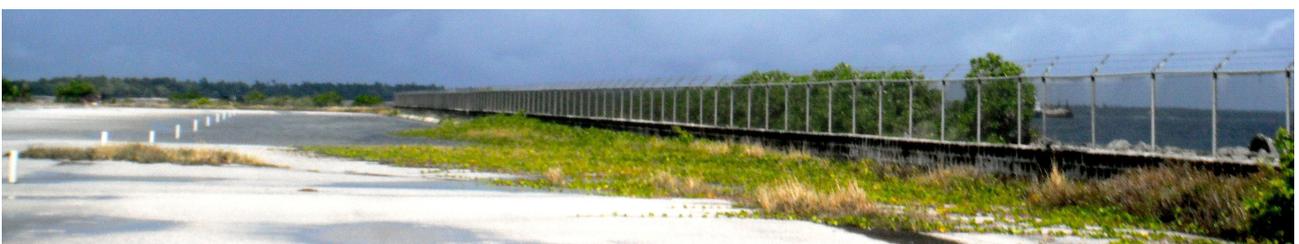
Figure 9. Lagoon-side wall on the right. White air vents are also seen to the left.
