# **Survey of the Regional Distribution and Status of Asbestos-Contaminated Construction Material and Best Practice Options for its Management in Pacific Island Countries**

## **Report for the Kingdom of Tonga**

**Prepared for the Secretariat of the Pacific Regional  
Environment Programme (SPREP)**

**May 2015**

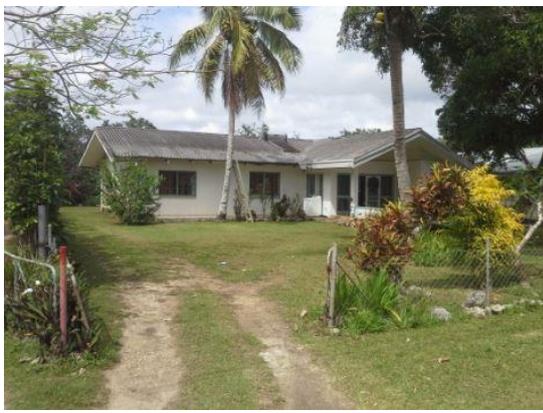
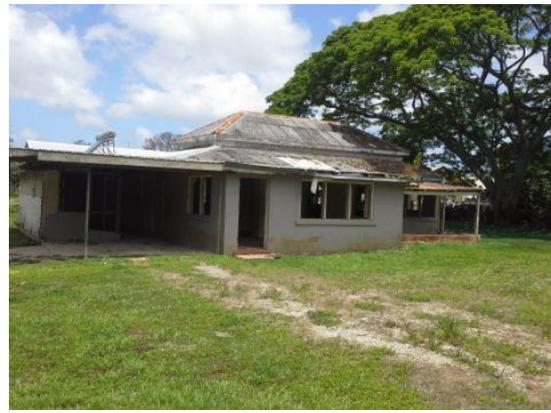
Photos 1 and 2 – Typical Residential Dwellings

The majority of residential dwellings observed on both Tongatapu and Vava'u were constructed of concrete blocks, bricks, weatherboard and corrugated iron. Typical residential dwellings in Tongatapu are shown in Photos 1 and 2 below.
