Ship Groundings in the Pacific Islands Region

Issues and Guidelines

by
G. L. Preston, R. D. Gillett, M.A. McCoy, P.A. Murrell and E.R. Lovell

*Prepared for publication by the South Pacific Regional Environment
Programme. Printed with the financial assistance of the Australian
Agency for International Development (AusAID)*

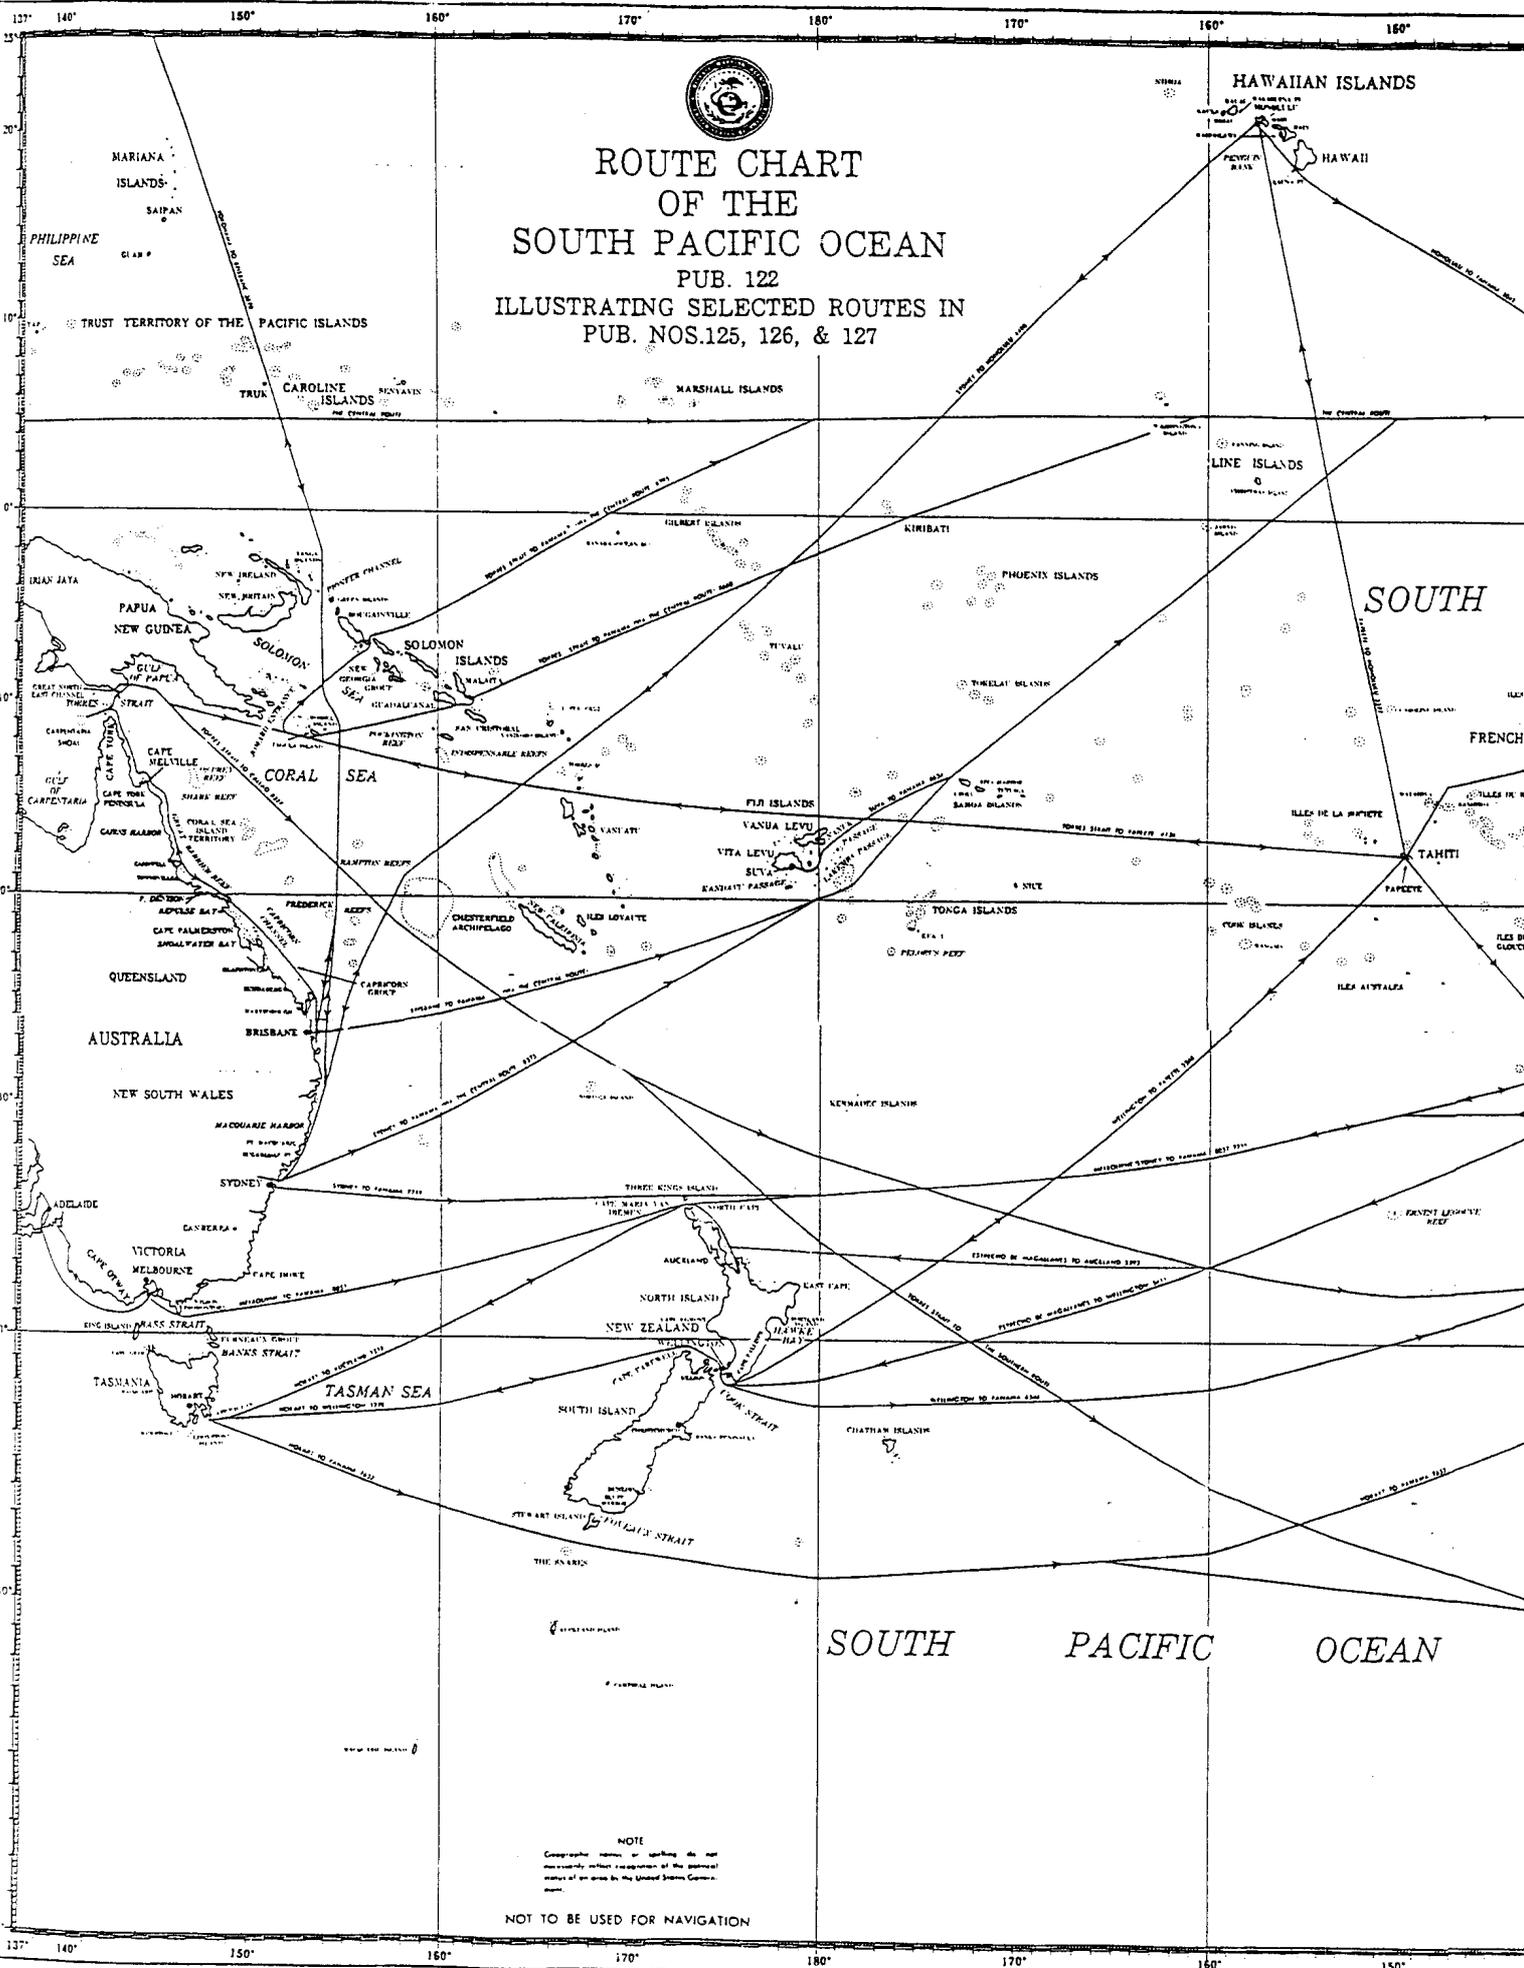
ROUTE CHART
OF THE
SOUTH PACIFIC OCEAN
 PUB. 122
 ILLUSTRATING SELECTED ROUTES IN
 PUB. NOS. 125, 126, & 127

International shipping on established routes transects the region in several well established "shipping lanes", which are shown in figure 1 (inside front cover). In general, those routes attempt to take advantage of the shortest distance between points of departure and destination while minimising the necessity of passing in close proximity to islands or hazards to navigation such as submerged reefs. Because of seasonal weather patterns, proximity to intermediate ports and other factors, there is sometimes more than one major route between the same two points.

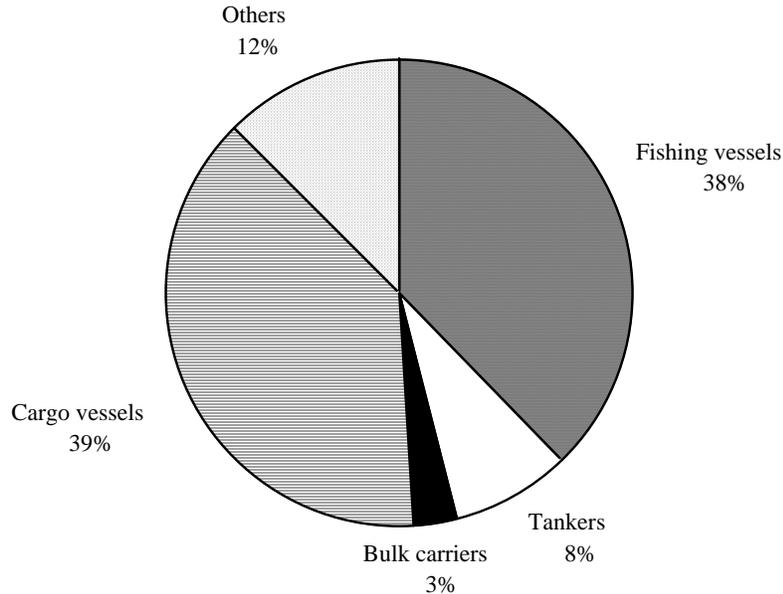
Figure 2: Ship groundings in the Pacific Islands region since 1/1/1976, based on the LMIS Casualty Register, by vessel category.

The distribution of groundings by vessel type is illustrated in figure 2 below.

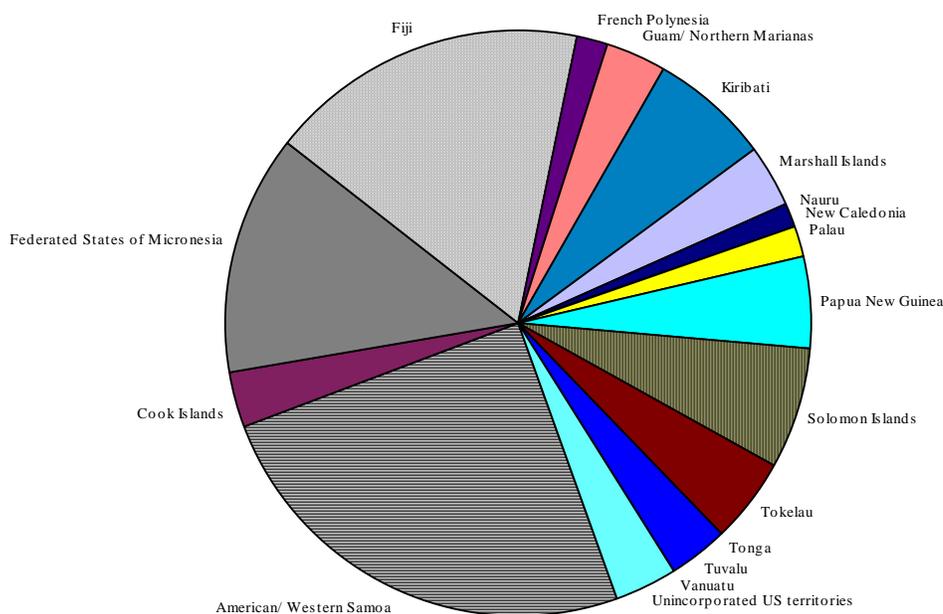
Figure 3: Ship groundings in the Pacific Islands region since 1/1/1976 based on the LMIS Casualty Register, by country.

Table 2 and figure 3 (opposite) show the geographic distribution of grounding events.
