**STATE OF KOSRAE, FEDERATED STATES OF MICRONESIA**  
**WASTE NEEDS ASSESSMENT SUMMARY**

**February 18-25, 2023**

**Angela Sandoval, P.E., Freely Associated States Circuit Rider**

**US Environmental Protection Agency, Region IX**

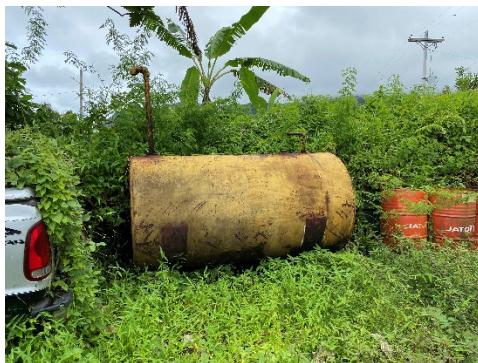
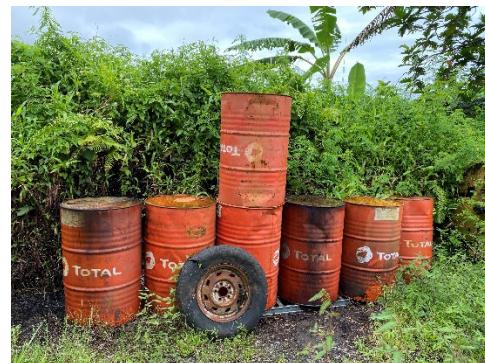
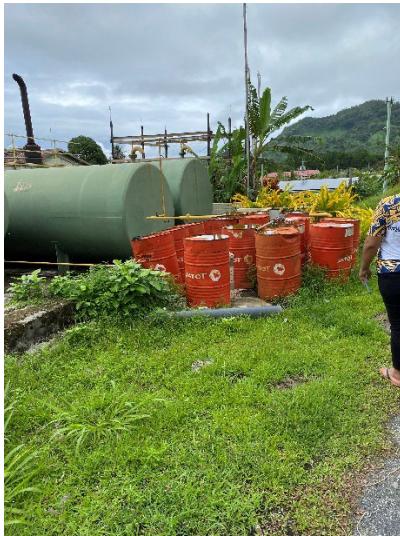
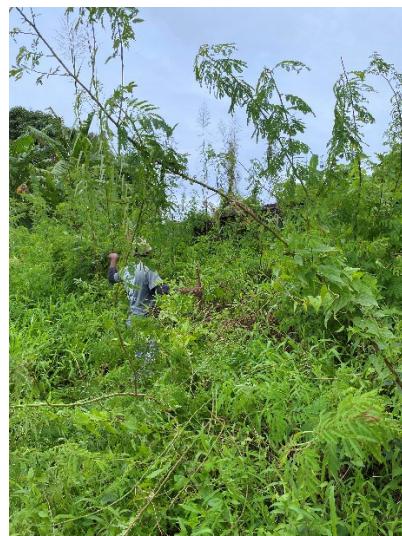
1. KUA Power Plant Tofol [Estimated Total of 8,000 gallons of Waste Oil]— Waste oil has been accumulating at the power plant for reportedly over 10 years. The container types storing this oil is varied but includes both 55 gal drums and larger tanks ranging in an estimated size of 450 gallons to 2,500 gallons. The condition of these storage containers also varies from almost new to extremely corroded and likely leaking. Many of these containers have been claimed by vegetation overgrowth and could not be visually inspected. At this location, approximately thirty-eight (38) 55-gallon drums of waste oil were identified throughout the property, examples shown in the included photos. Additionally, at least 3 other larger tanks were identified containing waste oil totaling approximately 6,000 gallons. All these drums and tanks are outside, exposed to the elements, mostly lack properly labeling, and not secondarily contained. It is recommended that Kosrae attempt to pursue shipments of waste oil off-island either through the company utilized by other FSM Utilities such as the Chuuk Public Utilities Corporation Power Plant or investigate utilizing the newly available Moana Taka Partnership, once available to FSM. Additionally, it is recommended that all drums should be properly labeled, identifying the contents (ex. "Used Oil") and the date generated, and placed inside secondary containment, as well as removal of the vegetation overgrowth so that regular visual inspection can be performed, and leaks can be identified and addressed in a timely manner.

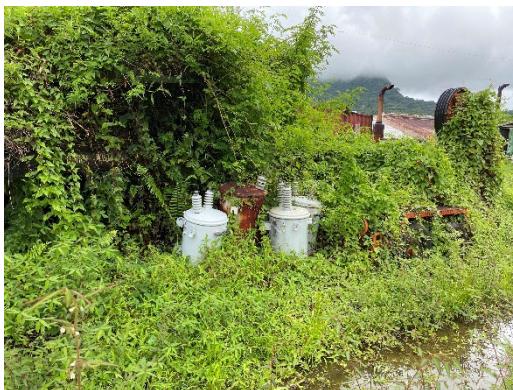
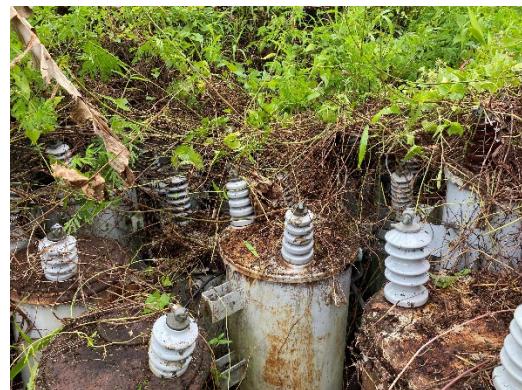
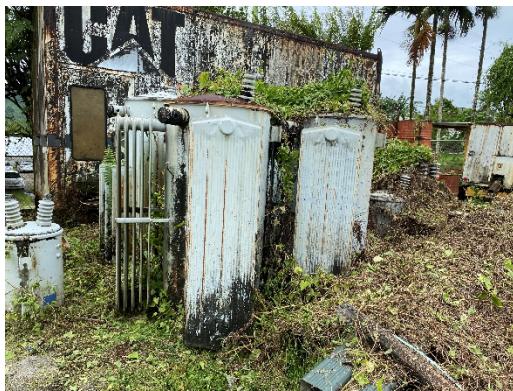
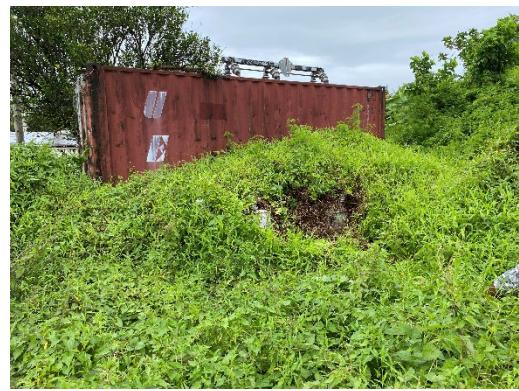
2. KUA Power Plant Tofol [Estimated amount of waste oil unknown]- This location is also being used as electrical transformer accumulation area. Approximately 50 retired, out-of-service, electrical transformers with oil are being stored in several locations throughout this property. These transformers are reported to not contain PCBs, but this should be verified through documentation or sampling. The transformers are exposed to the elements and not secondarily contained and in some areas covered by vegetation.

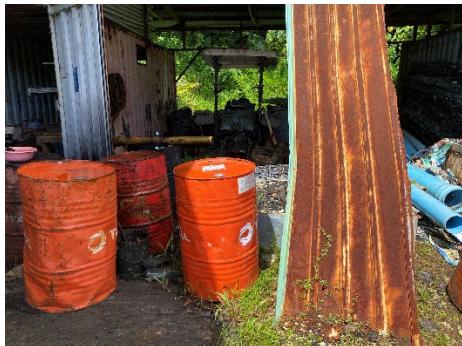
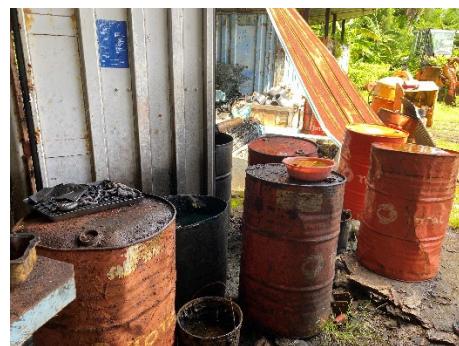
3. Department of Transportation Tofol [Estimated Total of 550 gallons of Waste Oil]- This location also has a small accumulation of waste oil drums. At the time of the site visit, approximately 10 drums of waste oil were identified. Similar to the Power Plant site, all these drums are outside, exposed to the elements, mostly lack properly labeling, and not secondarily contained. It is recommended that all drums should be properly labeled, identifying the contents (ex." Used Oil") and the date generated, and placed inside secondary containment.

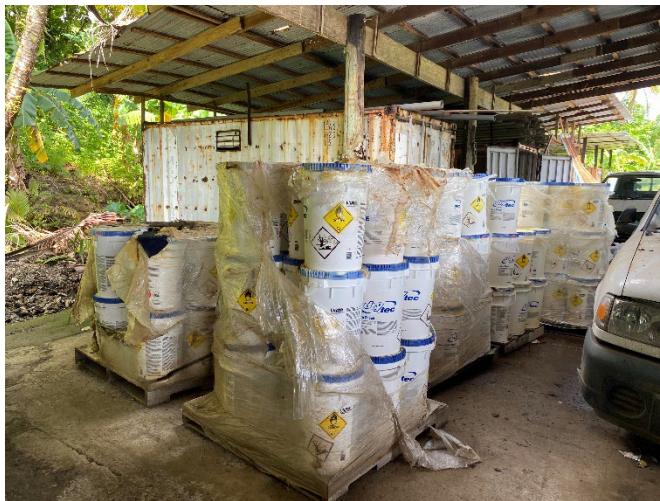
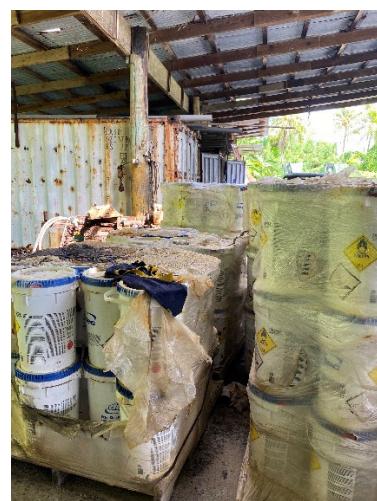
4. Department of Transportation Tofol [Estimated Total 90 five-gallon buckets of Chlorine Product Storage] – This site has also been burdened with storing the chlorine disinfection supply materials for the Utwe Public Water System. It was reported that this inventory has been stored here for over a year and is causing corrosion to nearby metallic objects. The material is being stored outside but on a concrete pad which has a roof. The inventory being stored seems excessive for the current consumption rate. It is recommended that further investigation be completed to find out if the product was substantially over ordered or if the amount being used at the Utwe PWS is not appropriate for the disinfection needed for protection of public health. Most importantly, this product should NOT be stored near combustible or flammable materials, and ideally in as cool and dry location as possible with good ventilation. Attention should be paid to the expiration date or shelf life of this product, as this product will decompose faster in hot and humid atmospheres.

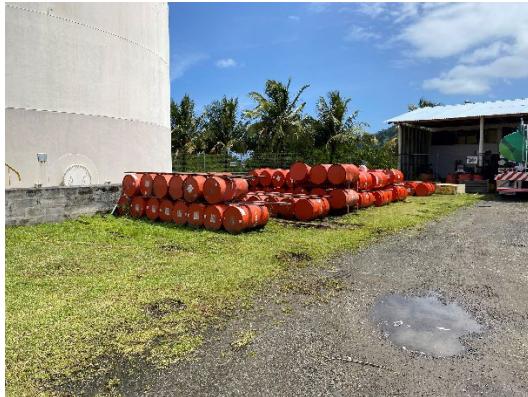
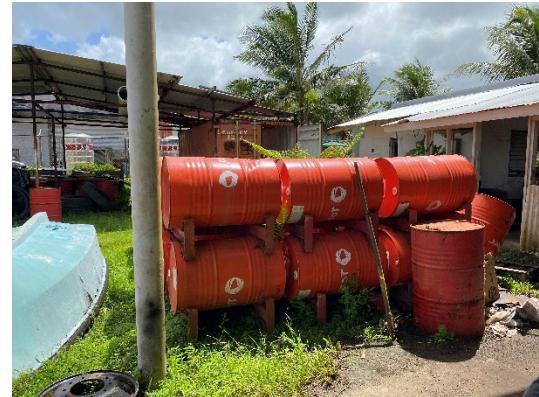
5. Port Fuel Farm – The visit to this site did not identify any substantial waste needs, as it was minimal, however, large quantities of new oil product are being stored here. Most of the oil product storage is in 55-gallon drums exposed to the elements and not secondarily contained. It

is recommended that all drums be stored in an area with secondary containment. This area is especially at risk due to the close proximity to the ocean/lagoon.
