Trip Report

Hospital Regional Eduardo Ximenes Baucau

22August2022

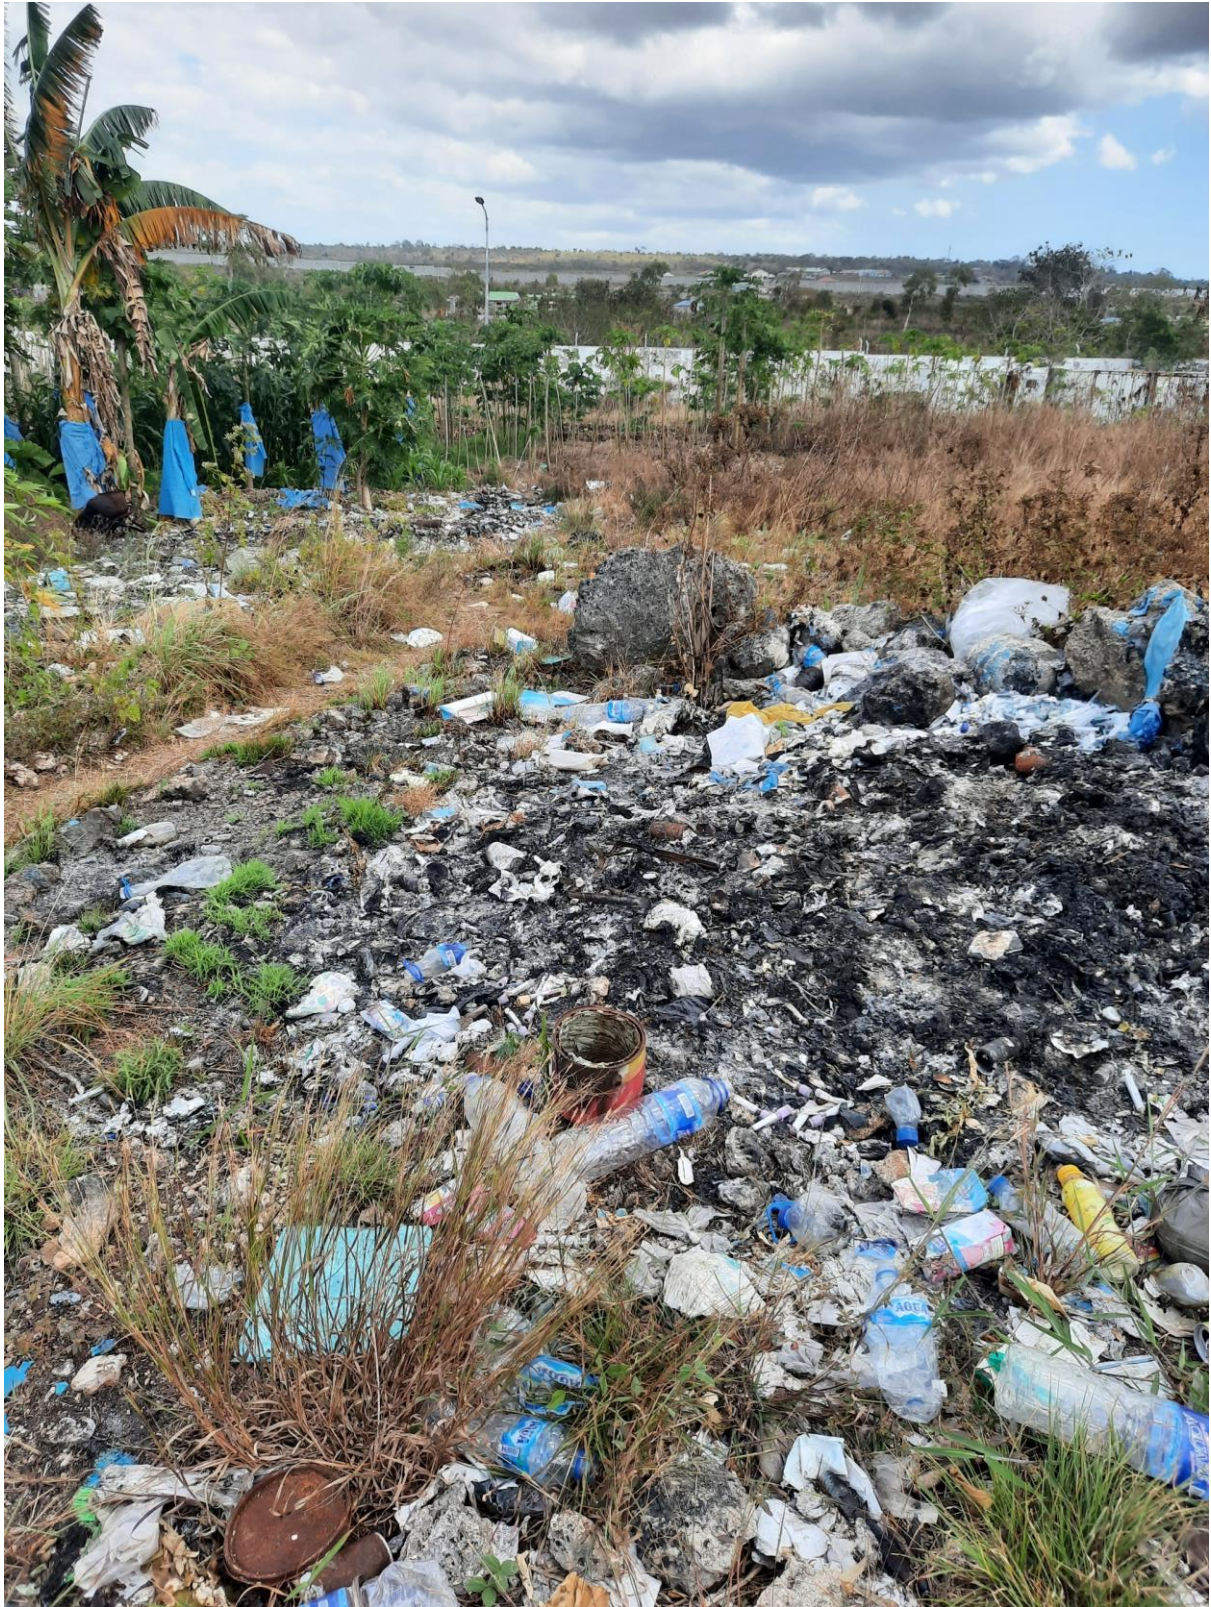
This area consists of two smaller burn locations separated by a short path between them. ~~The area is approximately ten by twenty-one meters [210 square meters] in size.~~ (Figure 1) Partially burned healthcare waste is on the surface, as there is no excavation or depression located in the area. The

waste includes sharps and infectious wastes, blood and blood products, all visible on the ground surface. Directly south of the area is a small grove of roughly 15 well-kept banana trees.

Figure 1: Burn Area West, Baucau Hospital, Baucau, Timor Leste, August 22, 2022, Photo taken by Lance Richman

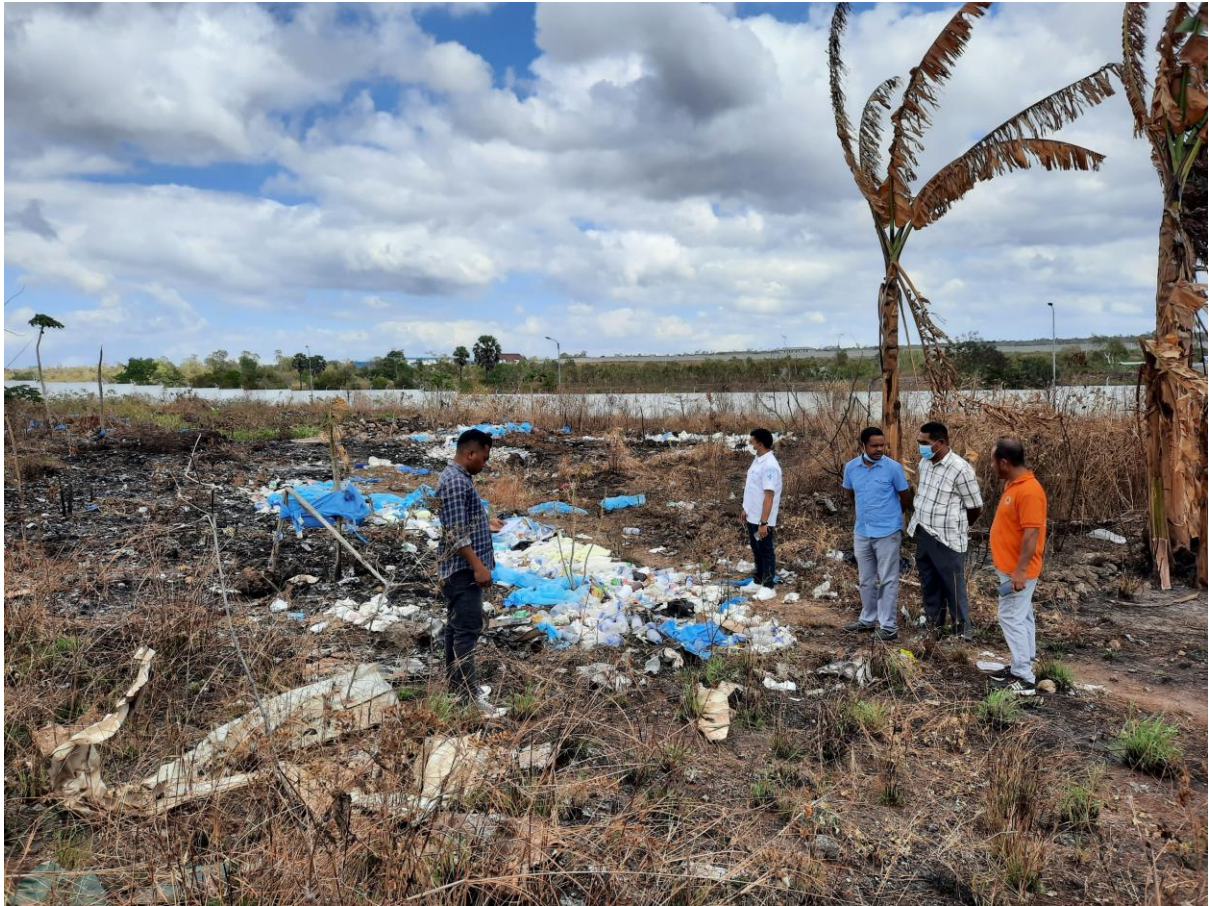
This area consists of an elongated, eggplant shaped area with the southernmost section located in a depression surrounded by rocks. The area contains both burned and unburned material, included sharps as well as blood products. (Figure 2)

Figure 2: Burn Area Southwest, Baucau Hospital, Baucau, Timor Leste, August 22, 2022, Photo by Lance Richman

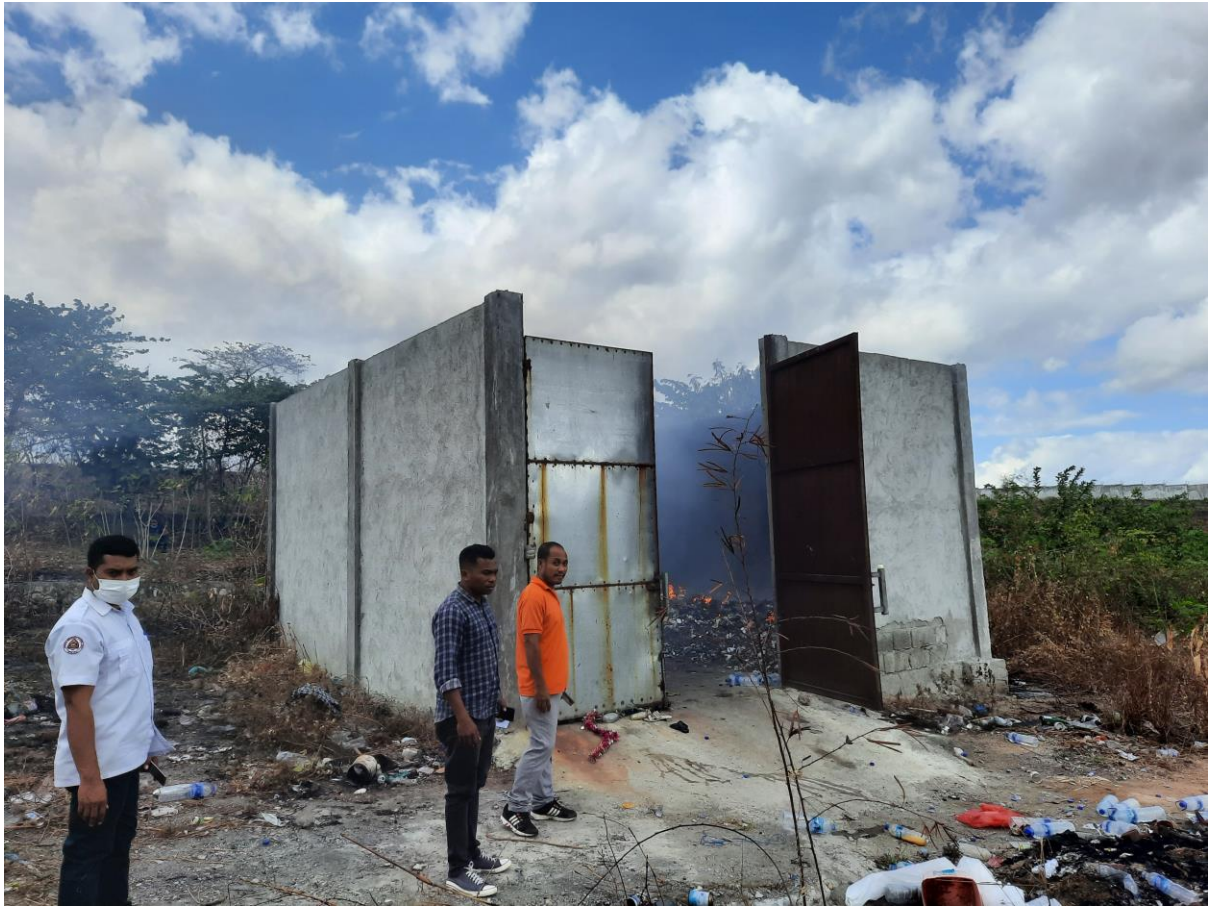
This facility consists of a concrete slab approximately 100 meters square with a four-meter-tall concrete wall and a metal gate to access inside the enclosure. HCW is burned directly on the pad, there are no emission controls. (Figure3) Unaware of any ash disposal location.

This facility was actively in use.

Figure 3: Hospital West Burn Facility [WHO funded], Baucau Hospital, Baucau, Timor Leste, August 22, 2022, Photo taken by Lance Richman

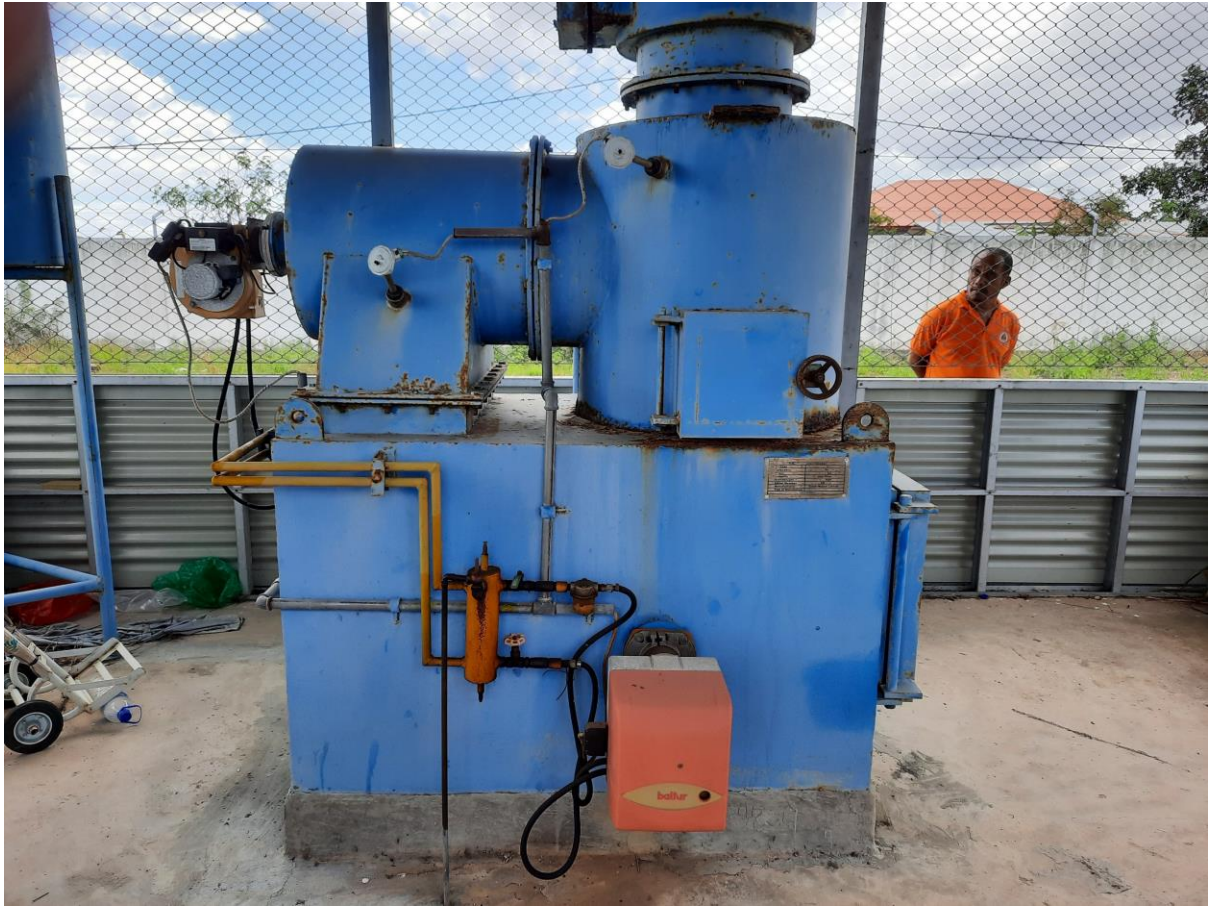
This dual chambered facility was located east of the hospital on a concrete pad, enclosed in wire fencing. (Figure 4)

I was informed that this incinerator was in use for some time, but then it failed and there were no spare parts provided to fix it. It appeared to have not been in use or accessed for a number of years.

Figure 4: Hospital East Incinerator [Chinese funded], Baucau Hospital, Baucau, Timor Leste, August 22, 2022, Photo taken by Lance Richman

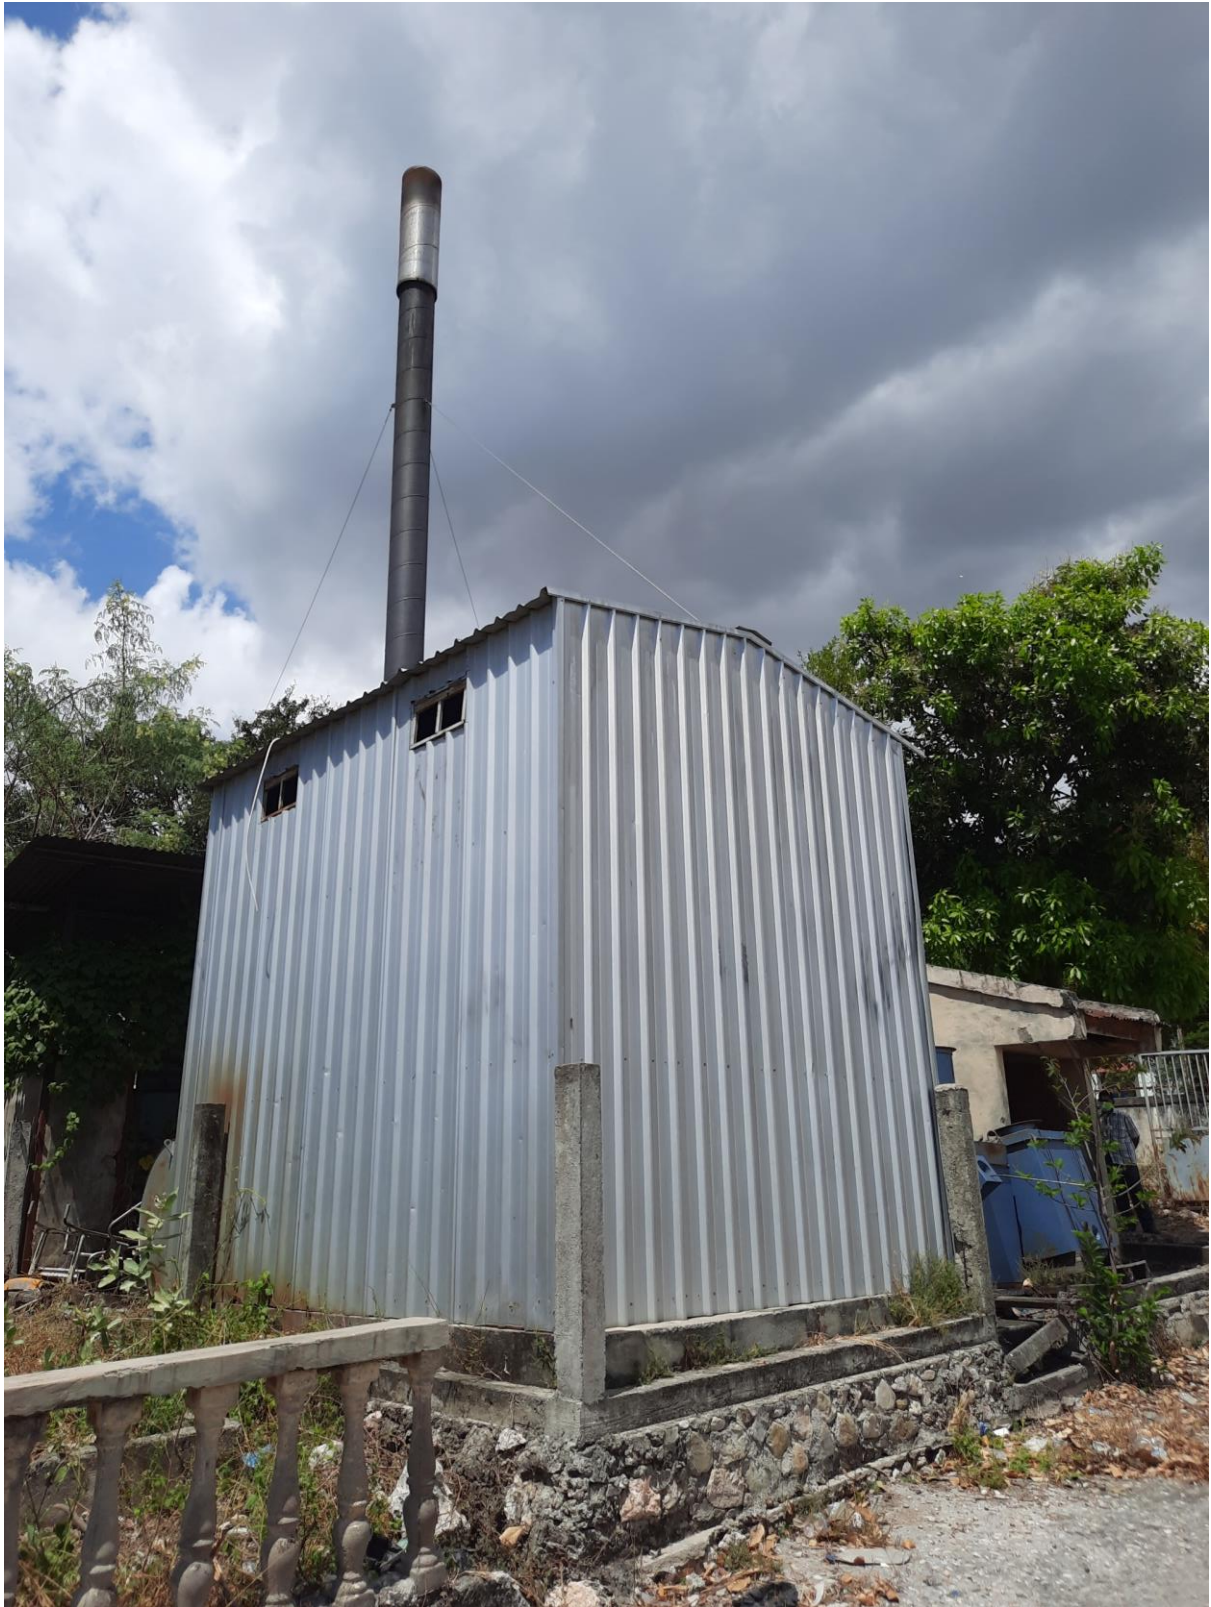
This facility was located at the old Baucau hospital location. The incinerator is housed in a sturdy building in good shape. (Figure 5) I did not see the incinerator inside the structure as I was unable to access the building, but I was able to see the stack. I was told that this facility was procured for use at the hospital in 2014. I did notice some soot on the stack; however, I was unable to confirm that it was commissioned.

Figure 5: Old Hospital Housed Incinerator (USAID funded), Baucau, Timor Leste, August 22, 2022, Photo taken by Lance Richman

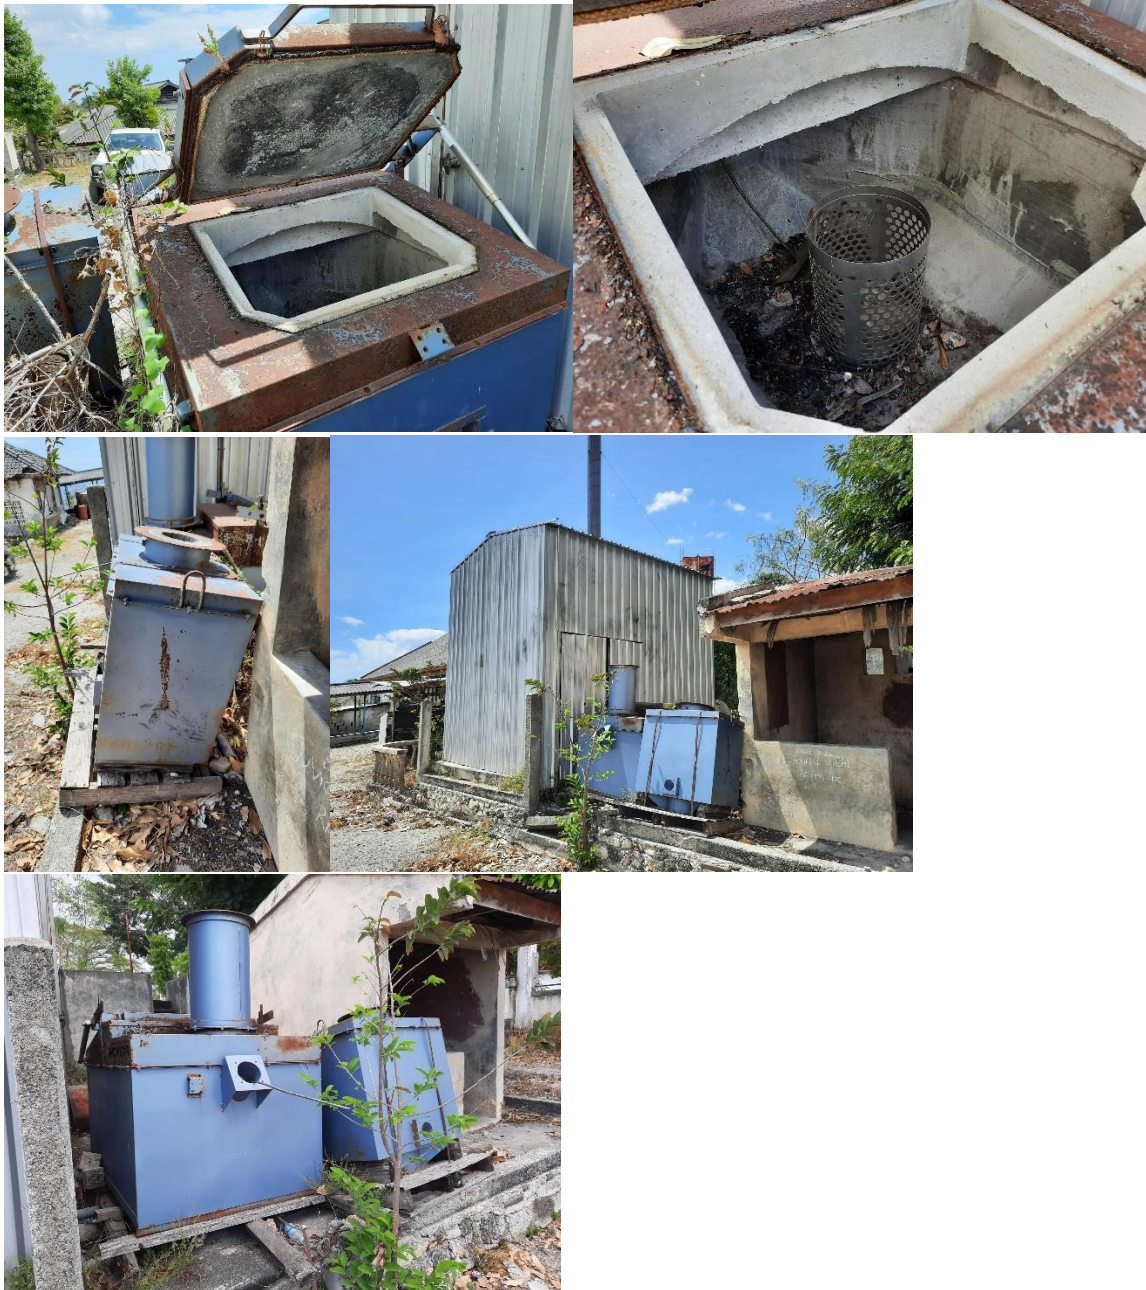
Next to the incinerator housing were parts of an incinerator chamber, both lower and upper, for an INCINER8 facility. The parts were in relatively good condition, with some rust. (Figure 6) However, I was informed that the parts had been outside, with no covering, since delivered to that location back in 2015. The parts had never been assembled or used.

I was told that the burners and electronics were located inside one of the hospitals buildings that we were unable to access.

Figure 6: EU/PW Incinerator Parts located at the old Baucau Hospital, Baucau, Timor Leste, August 22, 2022. Photos by Lance Richman

While repairing the incinerator is needed, without training and spare parts as well as building of local staffs' capacity to undertake repairs, any positive outcomes will not be sustainable. The long-term sustainability of these investments requires capacity building of local staff as well as the provision of needed spare parts.
